U.S. Department of Energy Office of Environmental Management

Accident Investigation Report

Phase 1

Radiological Release Event at the Waste Isolation Pilot Plant on February 14, 2014

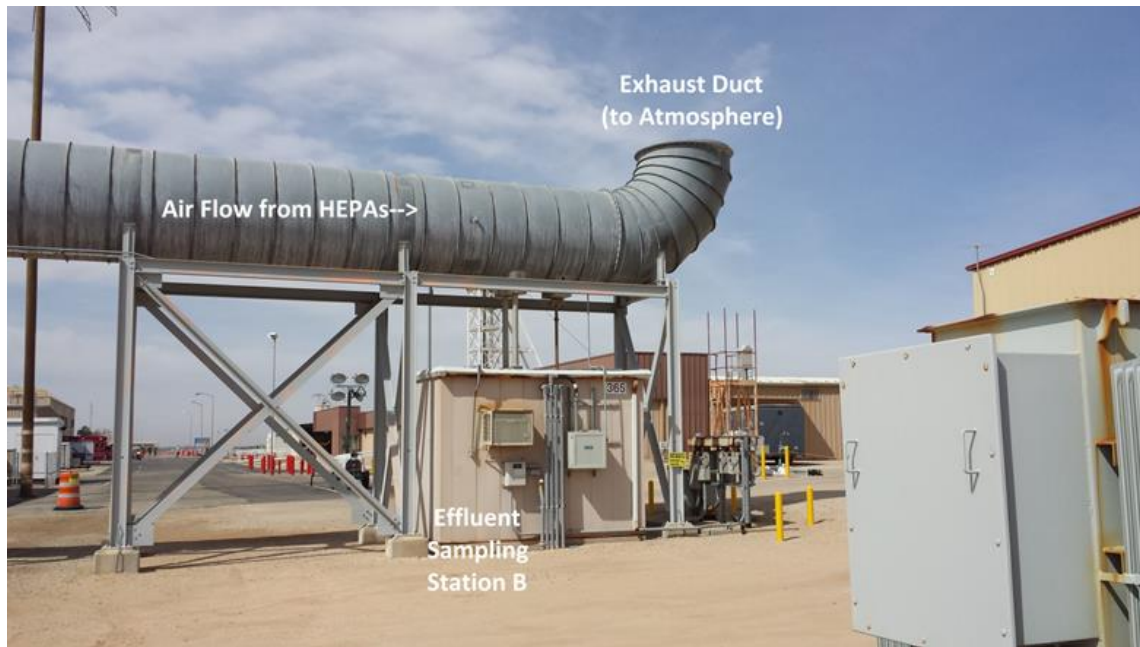
Figure ES-3: Station B and Exhaust Duct

Results from analysis of filters from the effluent sample station downstream of the HEPA filters (Station B) and at the discharge point to the atmosphere (Figure ES-3) were reported at 0915 and indicated 28,000 dpm alpha and 5,900 dpm beta contamination. This was the first indication that there was a release of contamination downstream of the HEPA filters to the environment.

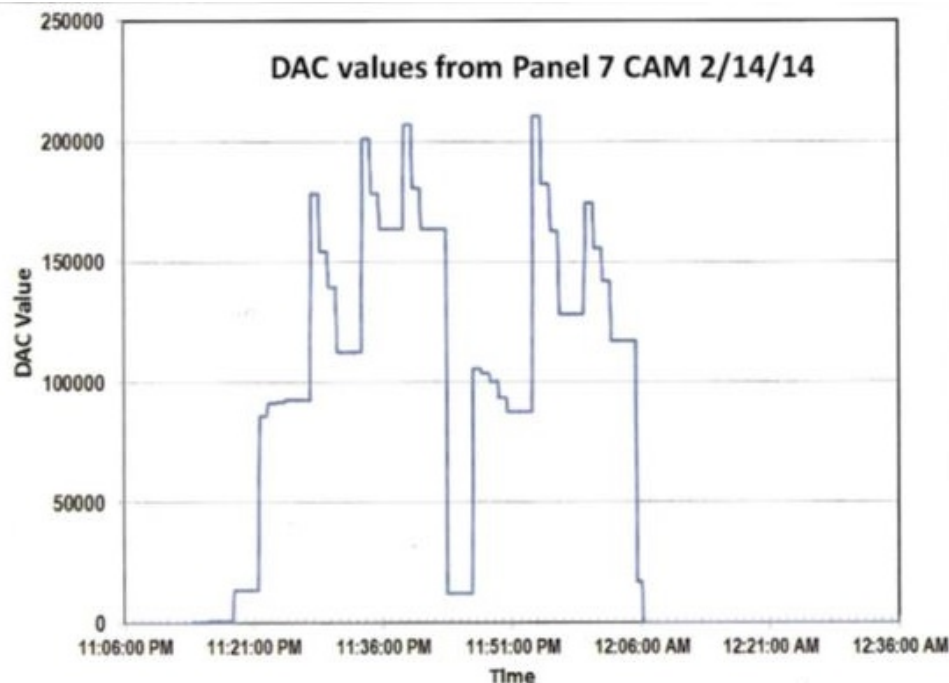
Figure 7: CAM-151 CMS

On February 14, 2014, at 2313, a “HI RAD” alarm from CAM-151 (U/G, monitoring the Panel 7 exhaust drift) was received on the CMS. The “HI RAD” setpoint for this CAM is 30 Derived Air Concentration (DAC) for alpha and beta contamination. Approximately one minute later, a “HI-HI RAD” alarm from CAM-151 was received on the CMS. The “HI-HI RAD” setpoint is 50 DAC. The CMS indicated that the CAM reading was 332 DAC. Figure 7 provides a graphical representation of CAM readings during the event.
