OFFICE OF  
ENVIRONMENTAL  
MANAGEMENT

# **WIPP Underground Radiological Event Investigation Summary February 14, 2014**

**Ted Wyka**  
**Chairman, Accident Investigation Board**  
**March 2014**

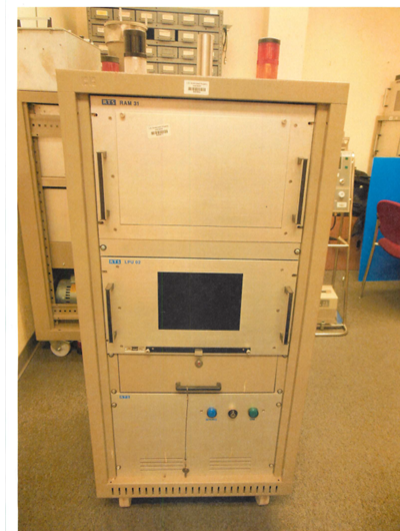
### **Continuous Air Monitor (CAM)**

The alarm was from a Continuous Air Monitor (CAM) in the underground that was monitoring an active transuranic (TRU) waste panel.
