U.S. Department of Energy Office of Environmental Management

Accident Investigation Report

Phase 2 Radiological Release Event at the Waste Isolation Pilot Plant, February 14, 2014

April 2015

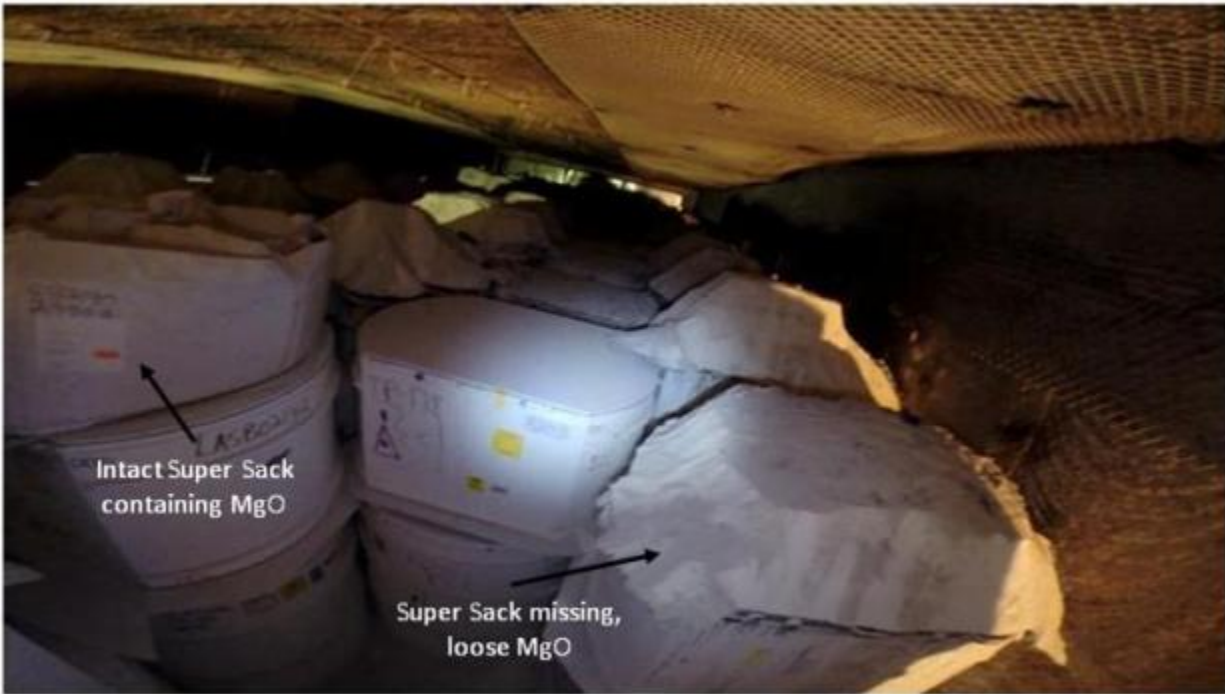
Photographic evidence of Panel 7 Room 7 from re-entries shows that 17 of the MgO super sacks were damaged. The super sack fabric and stiffener material (cardboard) was damaged or missing as illustrated in Figure 2-2, which allowed MgO to fall between waste stacks and left partial sloped piles of material on top of and between the waste stacks.

Figure 2-2: Missing Super Sacks Leaving Loose Piles of MgO on Waste Stacks

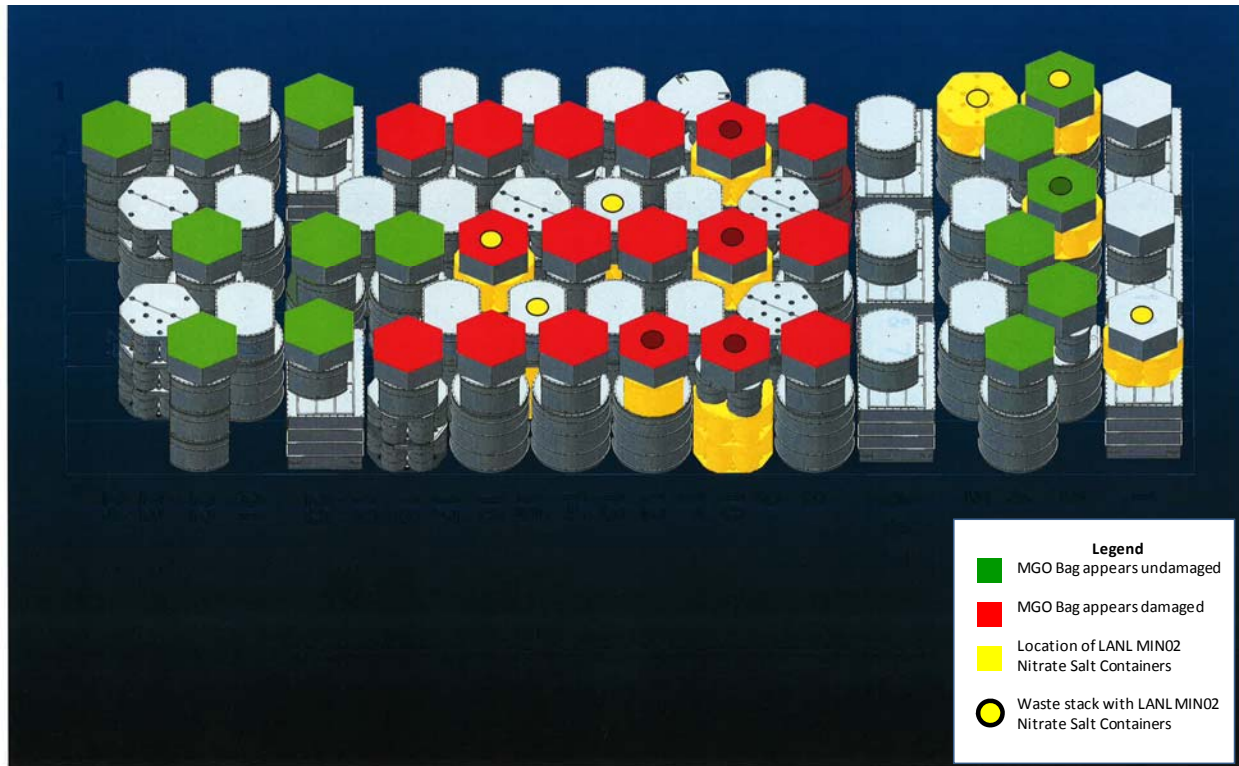
Figure 2-4: Panel 7, Room 7 Location of Damage from Event

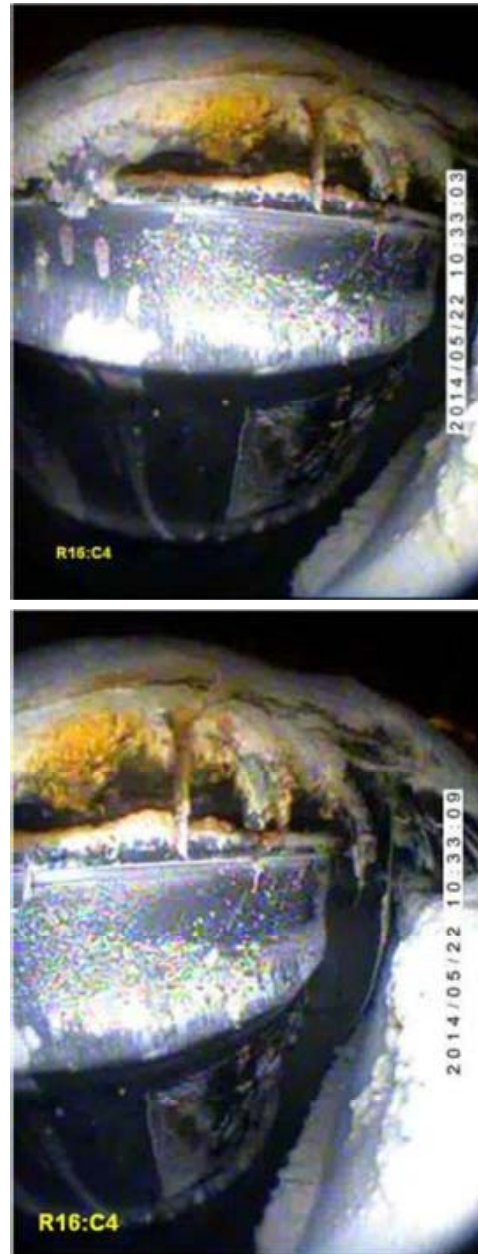
Figure 6-1: Drum 68660

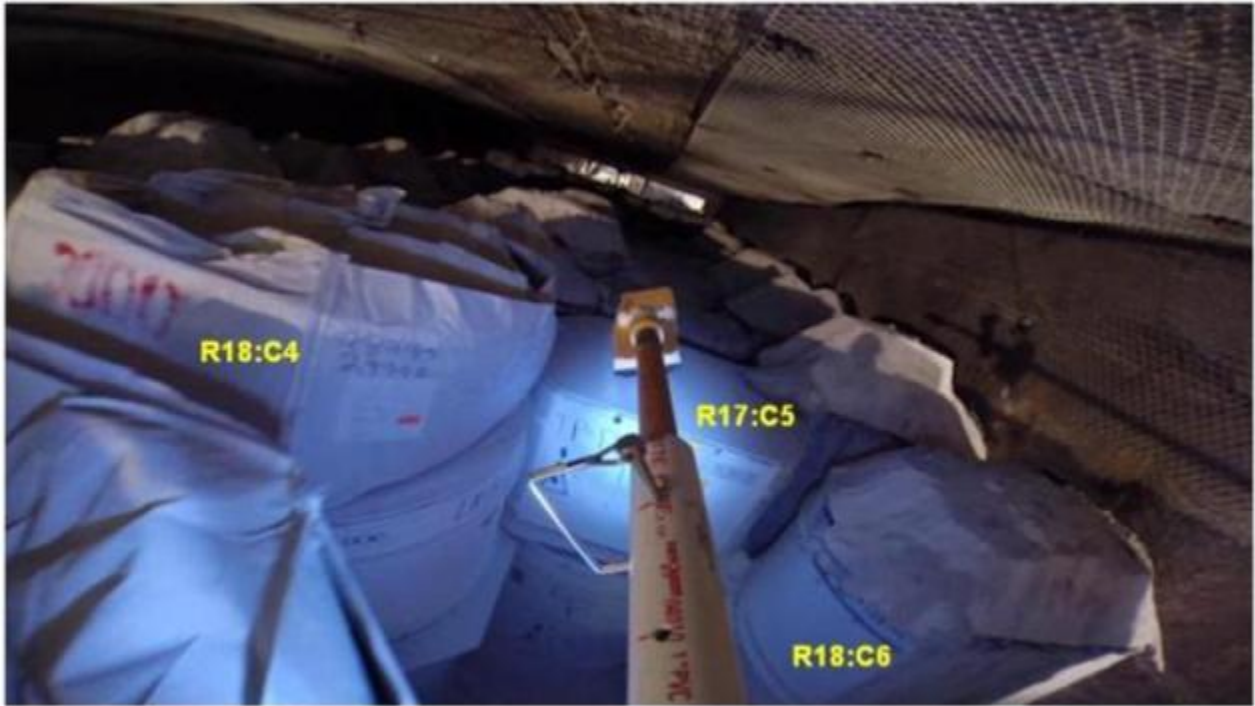
The MgO super sacks from Rows 8 through 18 were damaged. The polypropylene fabric that formed the sacks was severely damaged or missing from most of these locations. The fabric damage could have been caused by melting or ignition (Figure 6-4). Polypropylene is categorized as an easy-to-ignite material with a melting temperature in the range of 160°-176°C. Evidence of both mechanisms was identified during the array inspections. When the fabric was damaged, the cardboard stiffeners collapsed, the MgO flowed and formed piles of loose material at the damaged MgO super sack locations. At most of these locations the angle of repose (e.g., slope) was very steep, almost 60°, indicating gravity was the dominant force acting on the MgO after the super sacks were consumed by the fire.

Figure 6-4: Panel 7 Room 7 Array, Columns 4 through 6

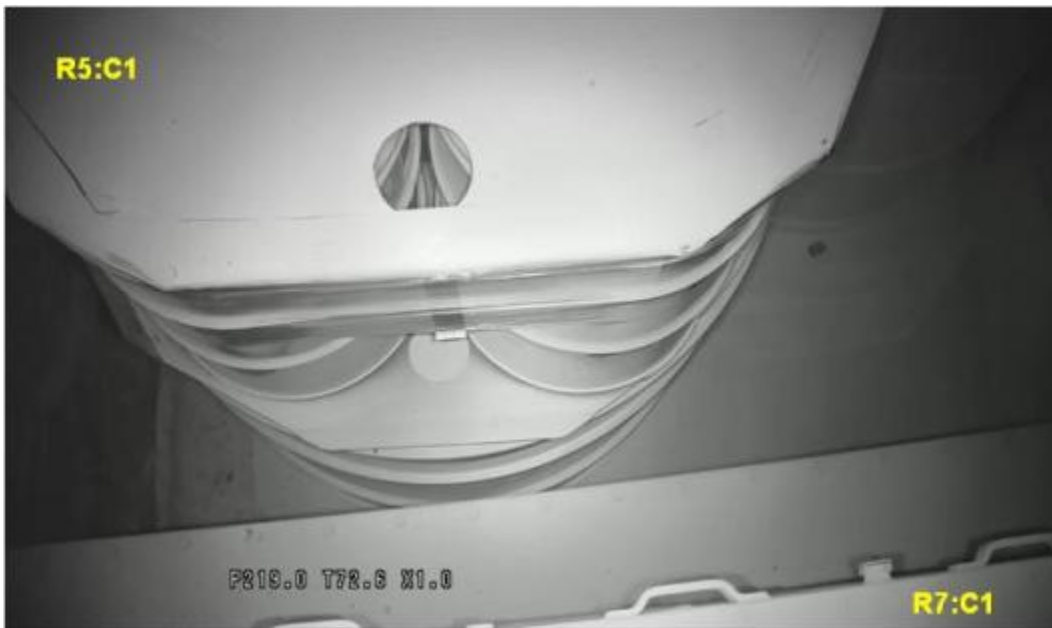
Rows 2 through 7 contained a mix of TDOPs, SWBs, 55GD assemblies, 100GD assemblies, and Standard Large Box Type 2s. These rows were closest to the bulkhead. The inspection identified no fire-related damage to the polyethylene stretch wrap or the polypropylene super sacks in these rows. The lack of damage to the polyethylene stretch wrap in these rows establishes that the bulk air temperature passing over the array was low, nominally below 135°C, which is the upper value of the melting temperature range of the polyethylene stretch wrap¹² (Figure 6-7, Figure 6-8 and Figure 6-9).

Figure 6-7: Undamaged Stretch Wrap at R5:C1

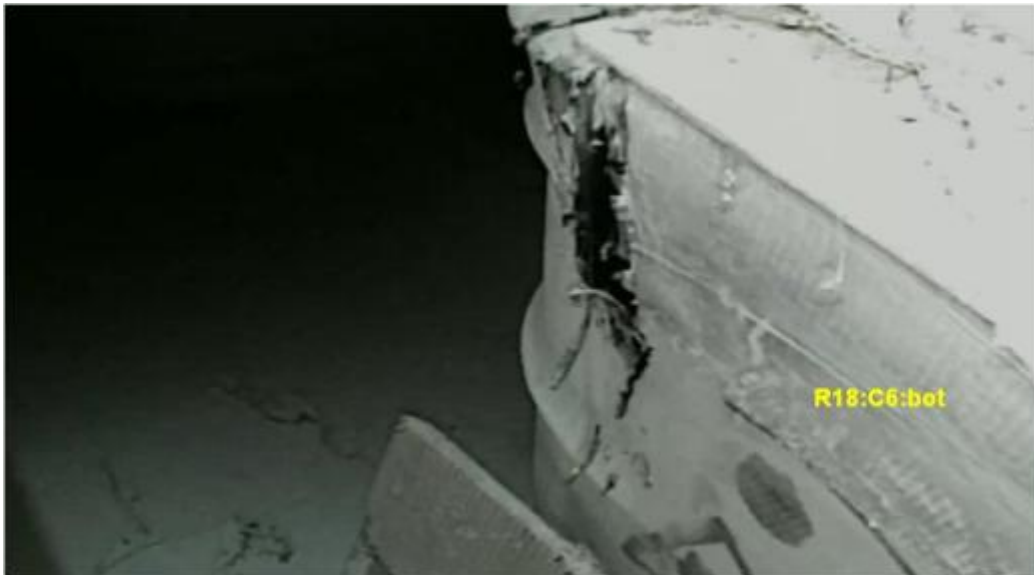
Figure 6-14: Face View (west) Stretch Wrap at Bottom Tier

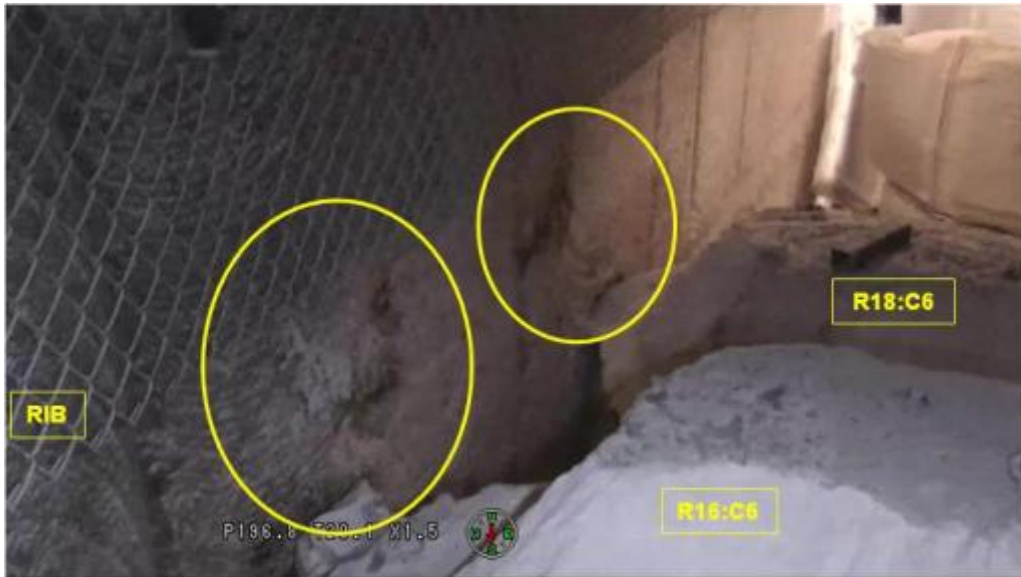
Figure 6-17: Rib Damage near Rows 16 and 18

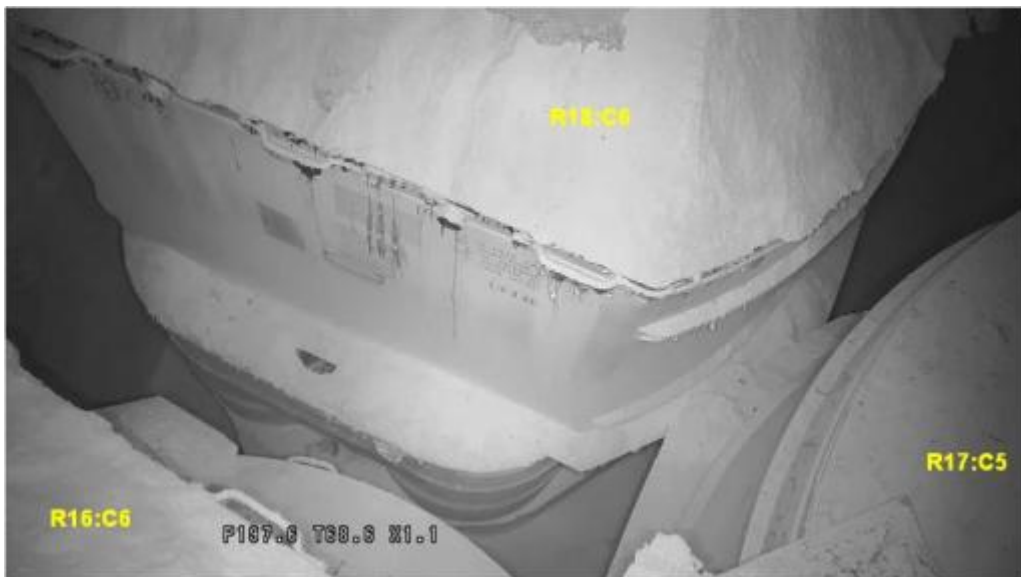
Figure 6-18: Bulkhead Side of R18:C6

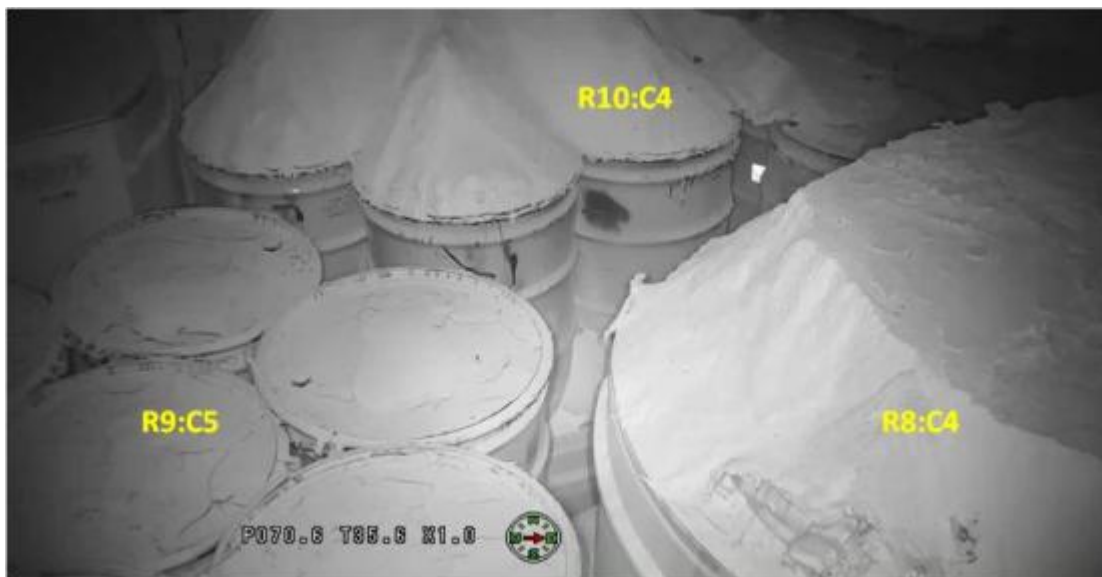
Figure 6-22: Damage at R9:C5 and R10:C4

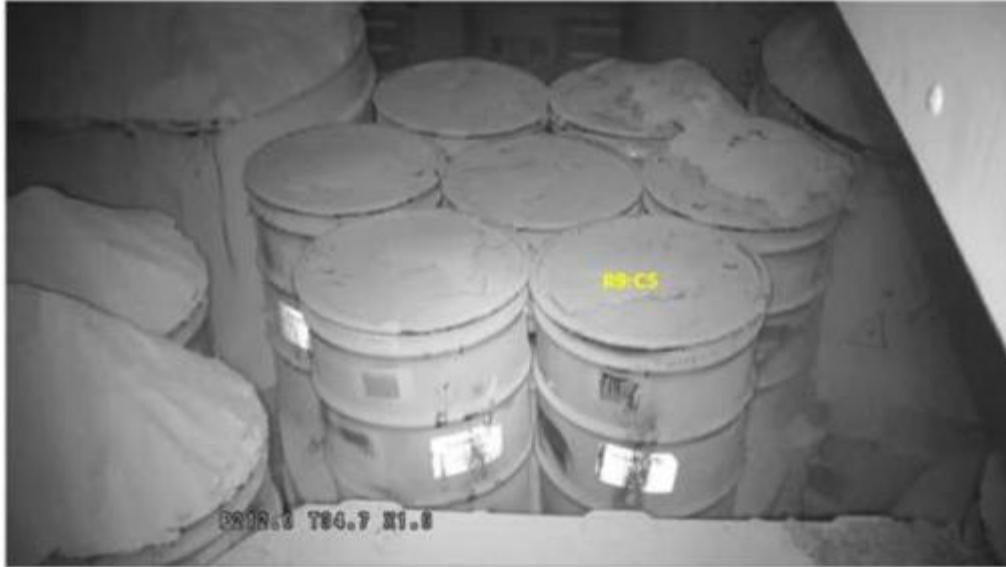
Figure 6-23: Damage at R9:C5

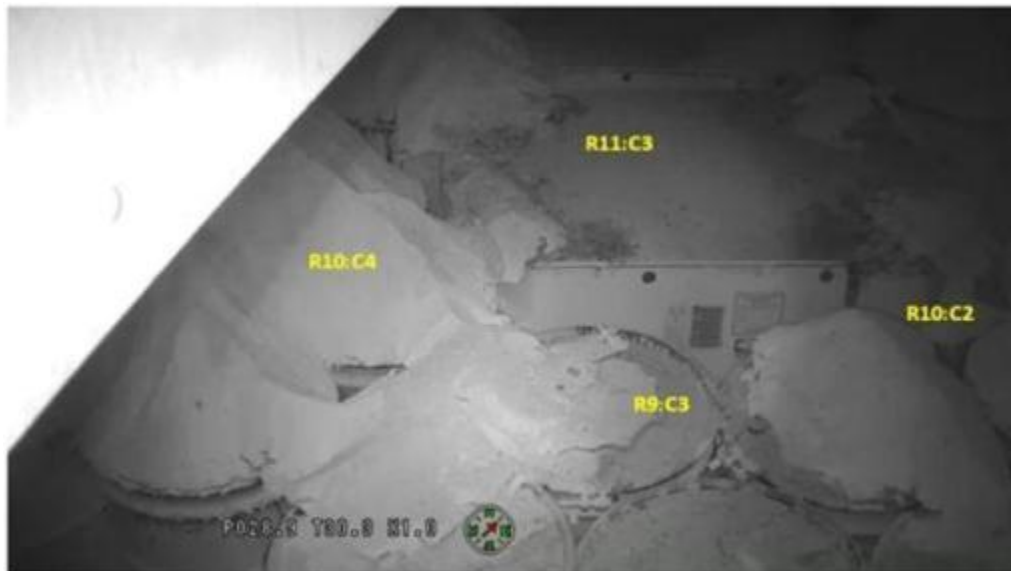
Figure 6-24: R10:C2, R9:C3 and R10:C4 East (Bulkhead) View

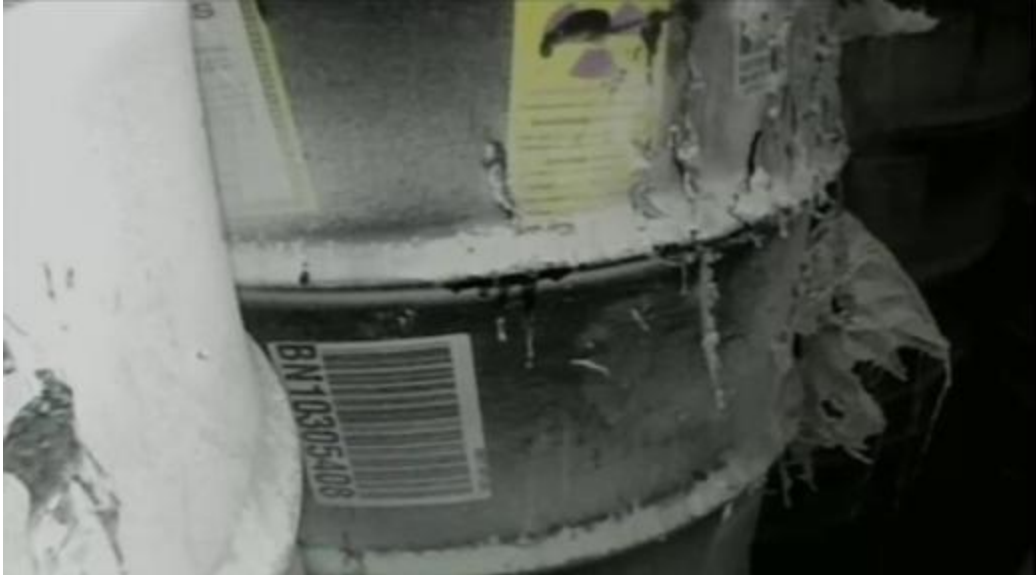
Figure 6-34: Drum in R15:C3 on Bulkhead Side Looking Southeast

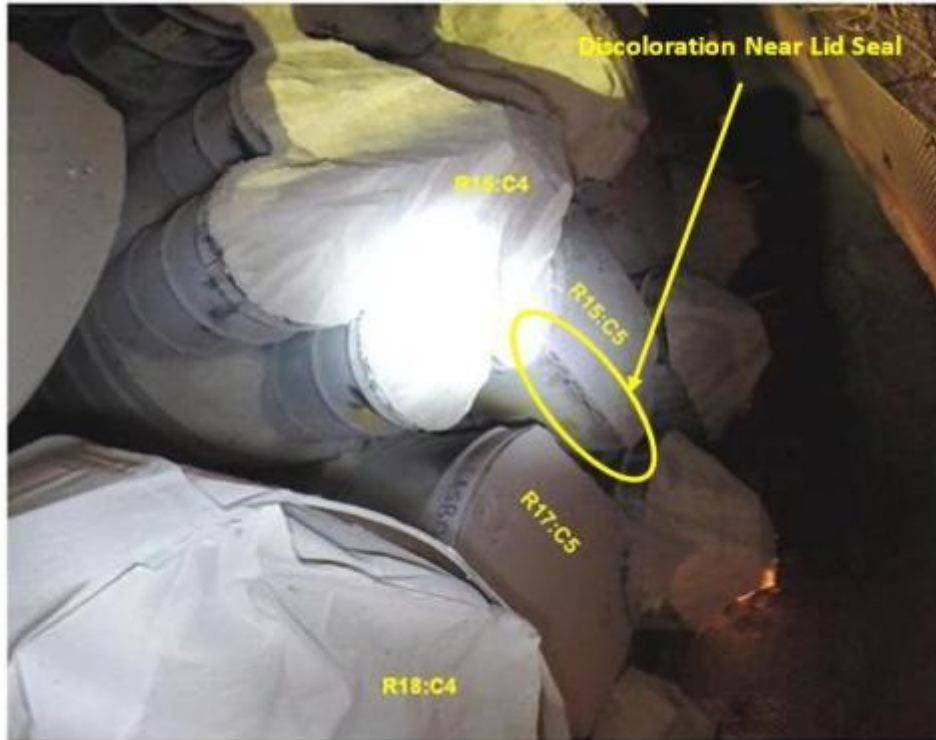
One 55GD on the middle tier of R15:C5 exhibited evidence of localized heat or flame exposure. Between the middle and upper rolling hoop there was one label that had charred, while a second label that showed no damage (Figure 6-39). In addition, there was a dark inverted-cone shaped pattern starting at the base of the drum that extended up the side of the drum about 12 inches. Around this region there was clumped MgO resting on the middle-tier slip sheet. While there was severe flame damage evidence on the west side of the SWB and the middle tier 55GD assembly, the lower tier stretch wrap appeared undamaged on the outer surface as viewed from the west side of the stack.

Figure 6-35: Discoloration of SWB at R15:C5

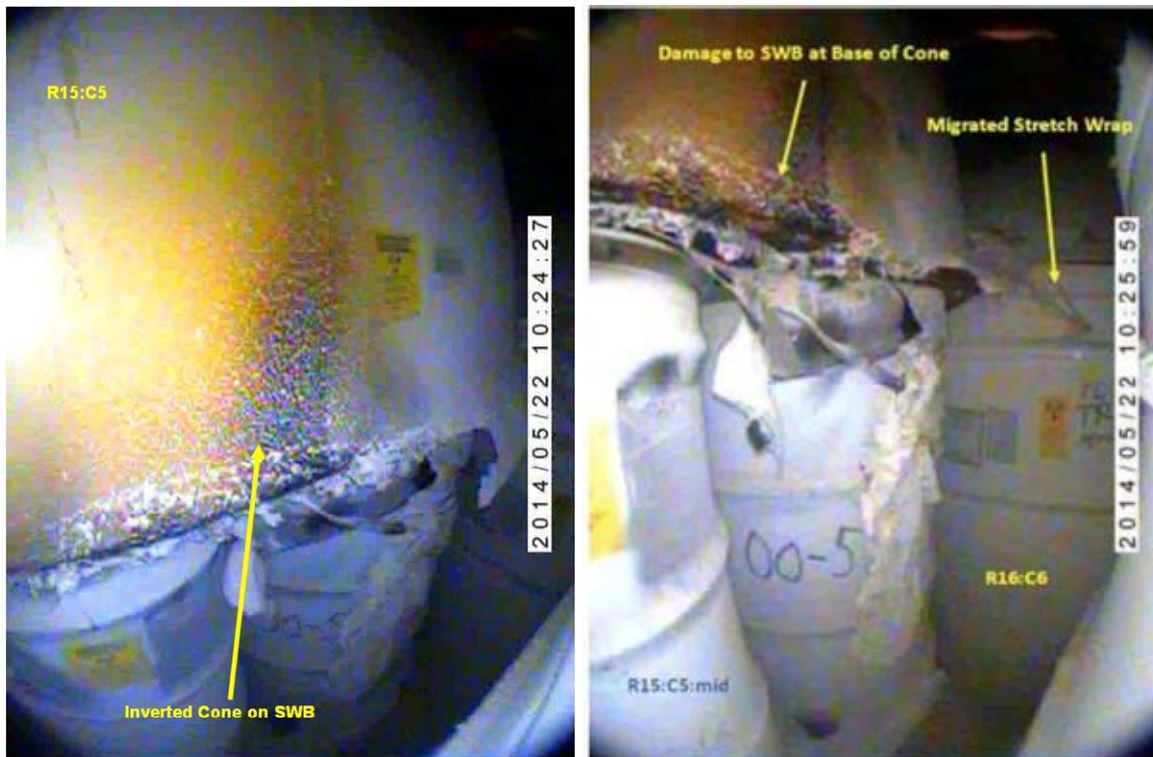
Figure 6-36: Side of SWB at R15:C5:top

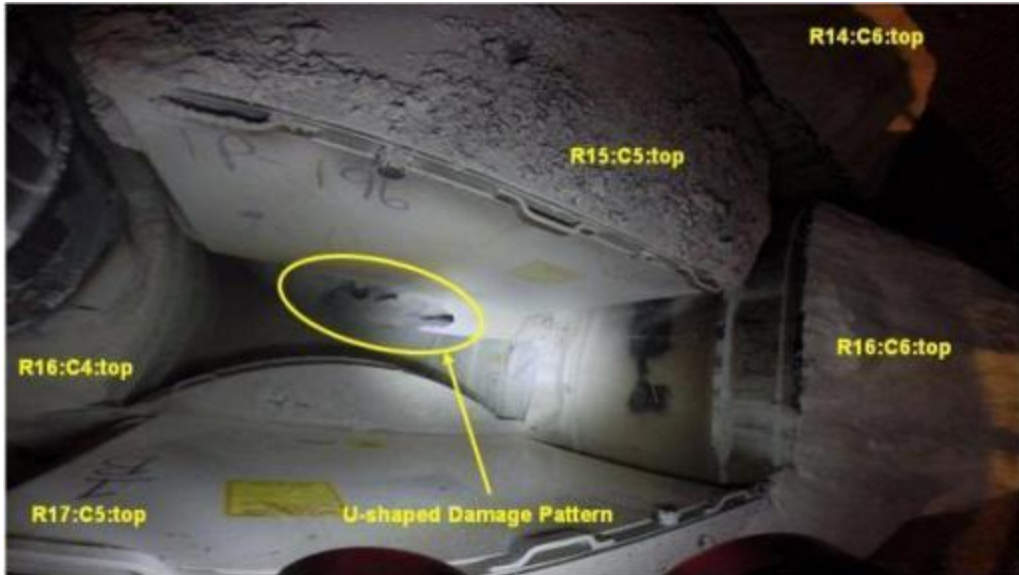
Figure 6-37: Damage to Slip Sheet at R15:C5

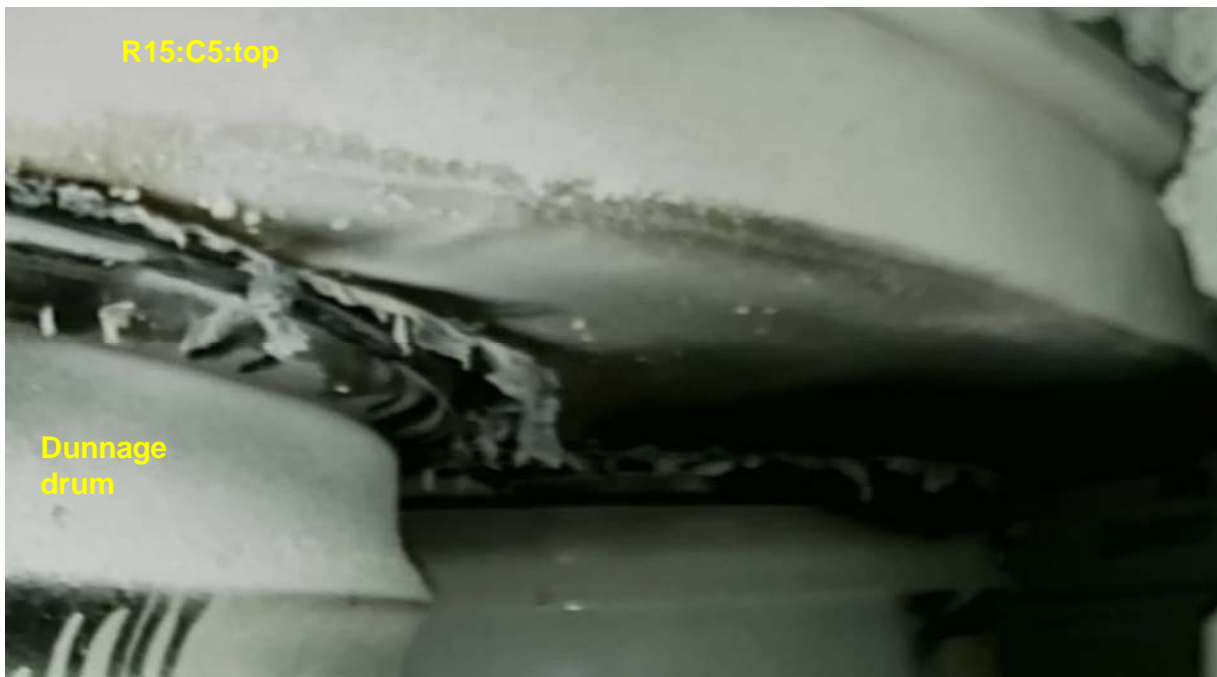
Figure 6-38: North View of R15:C5, Bottom of SWB on Top Tier

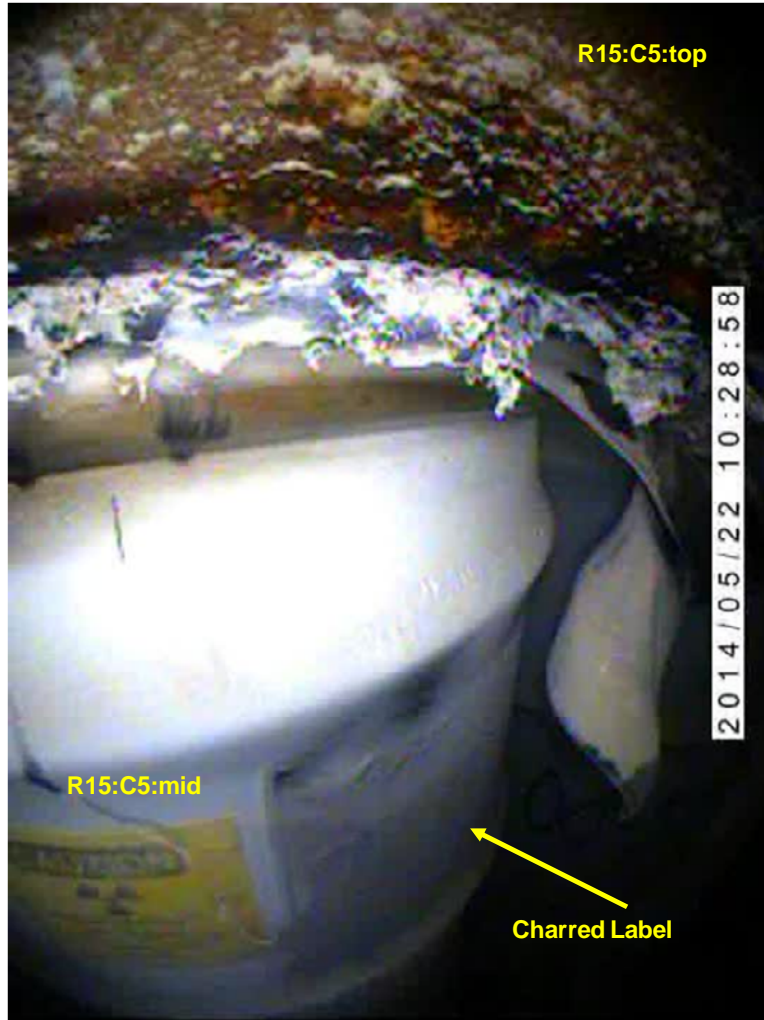
Figure 6-39: Charred Label at R15:C5

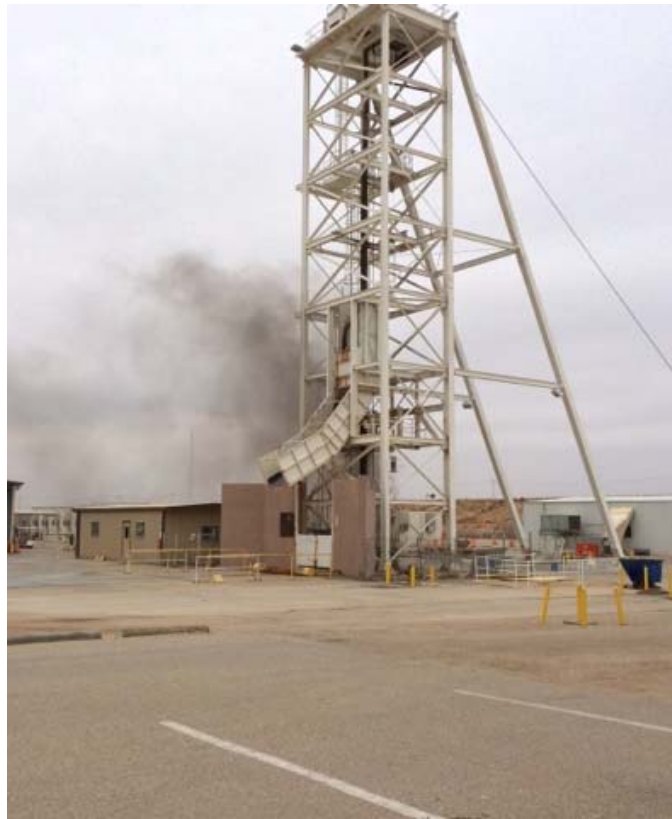
Upcasting in the Salt Handling Shaft did occur following the change to filtered mode (Figure 6-43). This upcasting increased the airflow moving past the salt haul truck fire. The flow behavior in the Salt Handling Shaft was modeled by a Bernoulli's fluid equation, recognizing that the volumetric flow up the shaft was induced by the thermal gradient, and would create a friction flow resistance. Simultaneous solution of the flow equation, and the energy balance equation, as discussed for the early portion of the fire, demonstrated that the temperature at the based of the Salt Handling Shaft was about 82°C when the energy release rate was 15 megawatts.

Figure 6-43: Upcasting Observed at the Salt Shaft on February 5, 2014
