Waste Isolation Pilot Plant

Geotechnical Analysis Report For July 2010 – June 2011

Geotechnical Analysis Report for July 2010 – June 2011
DOE/WIPP-12-3484, Vol. 1

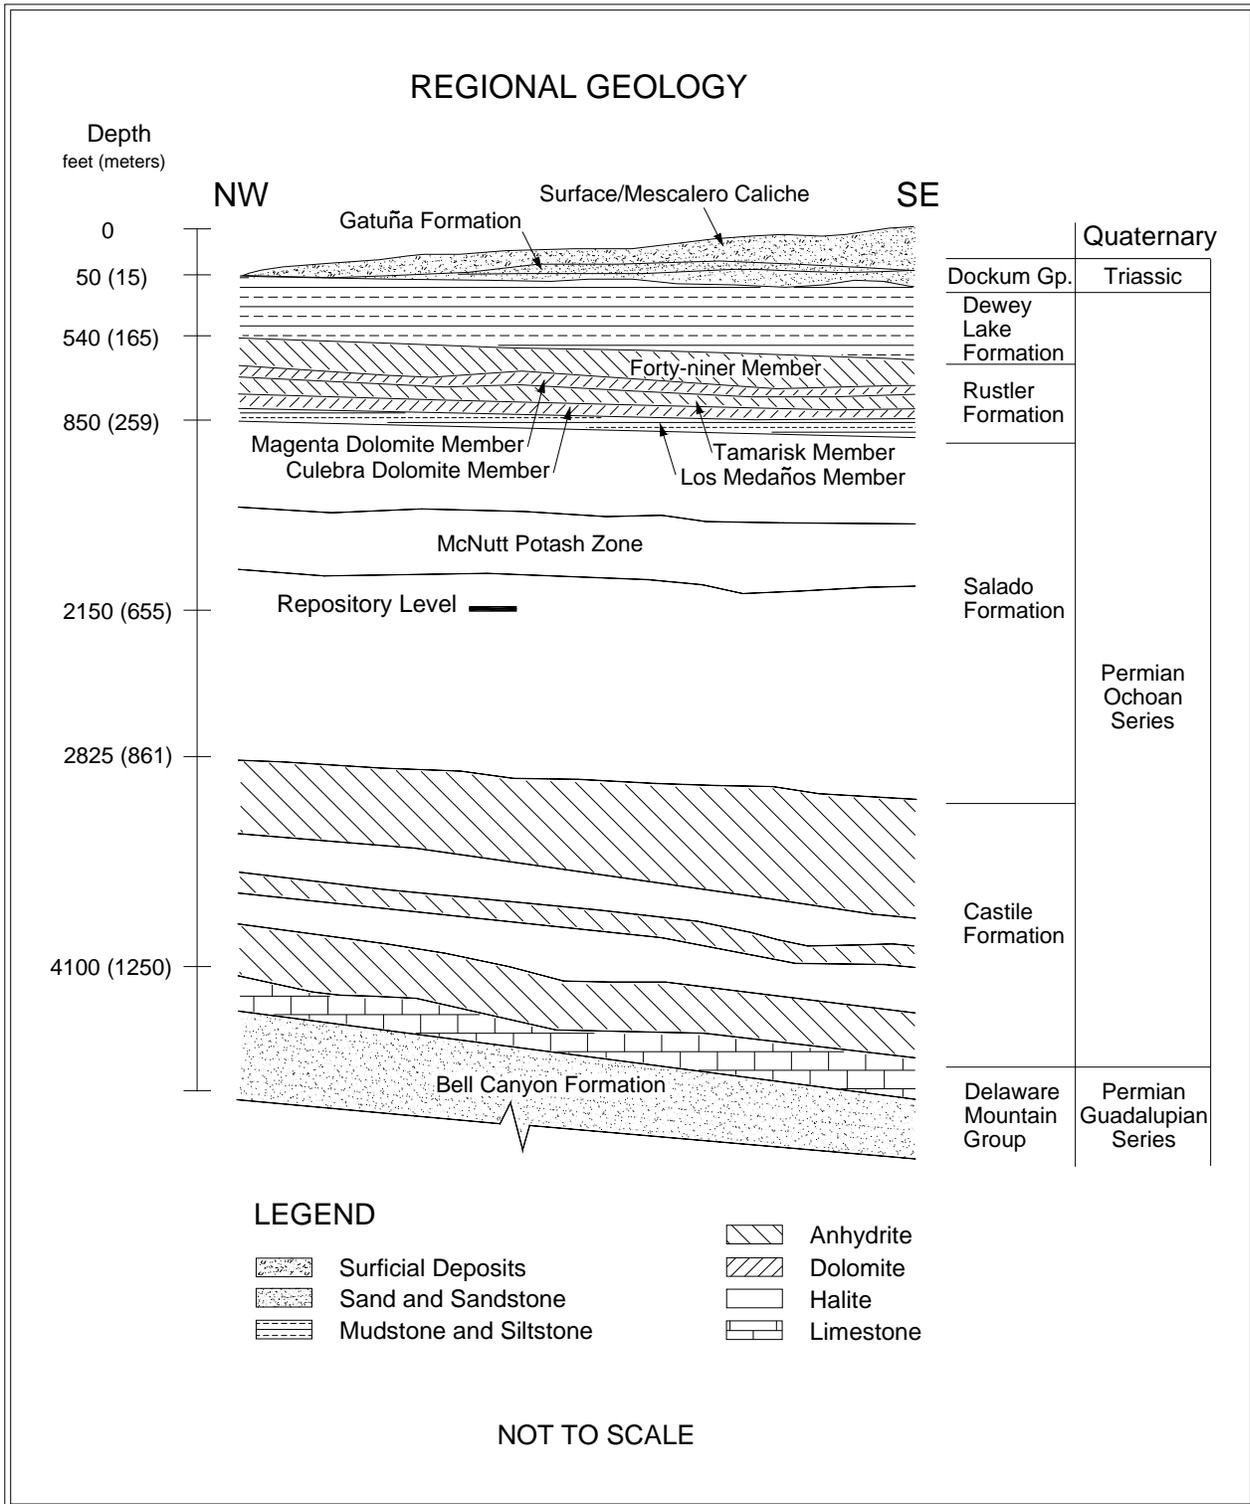
Figure 2-1 – Regional Geology

The stratigraphy in the vicinity of the WIPP site includes rocks of Permian (295 to 250 million years [Ma] before present [bp]), Triassic (250 to 203 Ma), and Quaternary (1.75 Ma to present) ages. The descriptions of formations provided in this section are given in order of deposition (oldest to youngest), beginning with the Castile Formation (Figure 2-1).

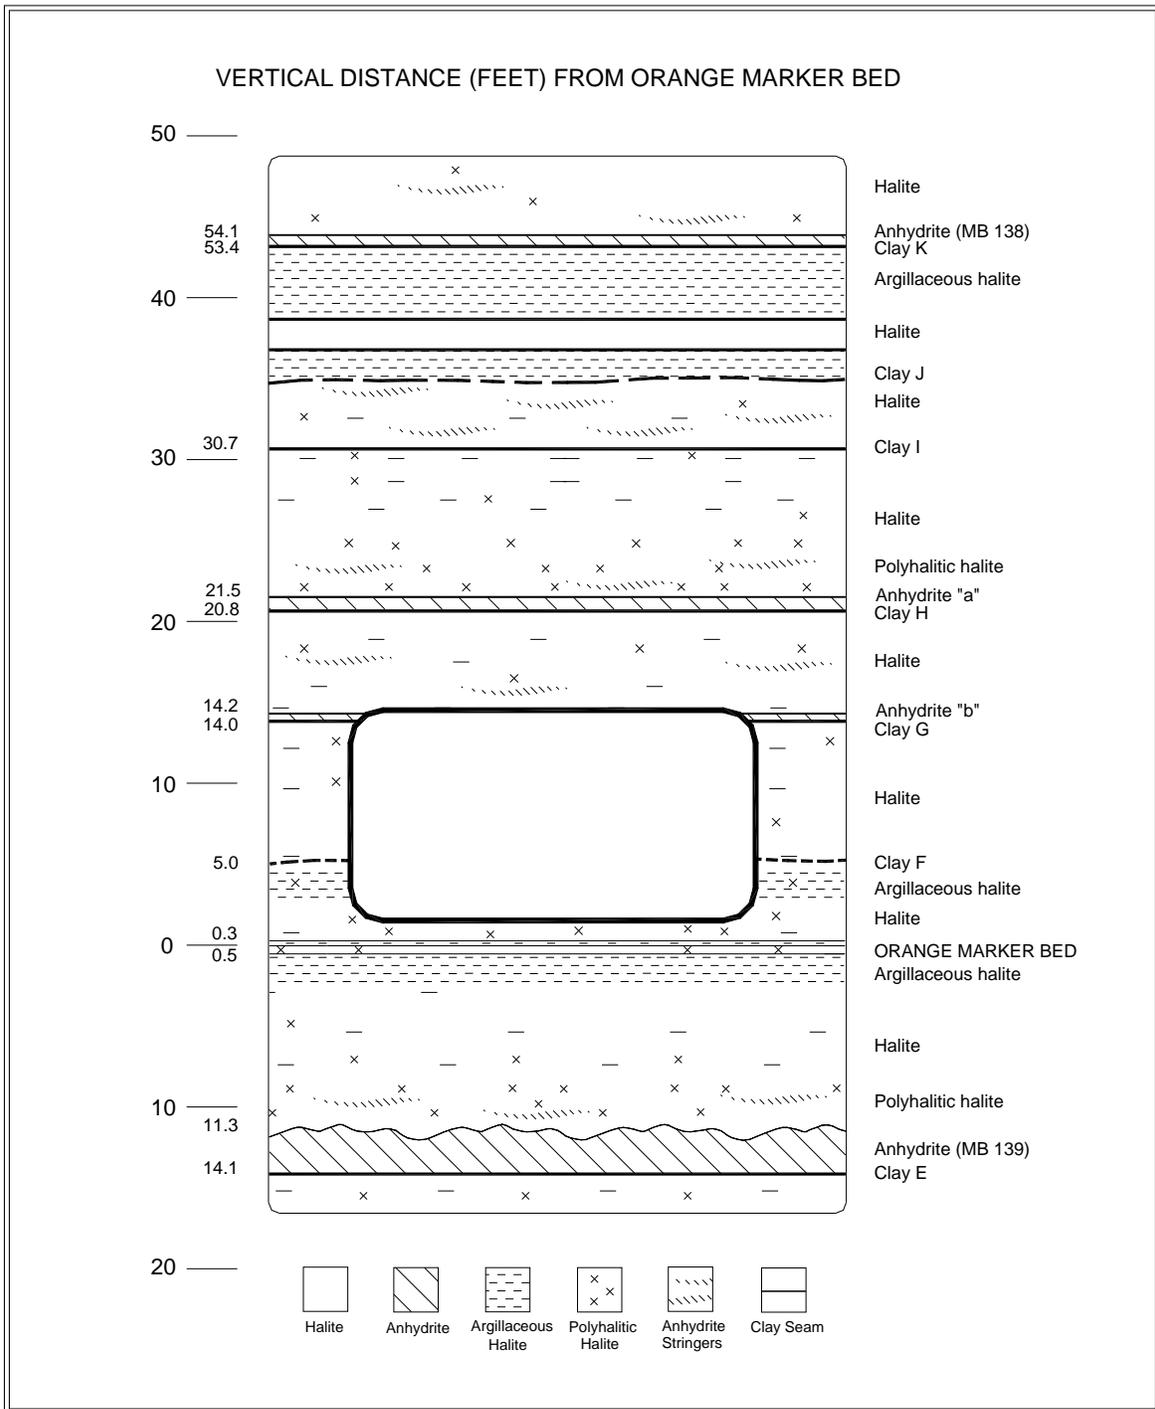
Figure 2-3 – Repository Level Stratigraphy of Panels 3, 4, 5, and 6

In this horizon (see Figure 2-3), the OMB lies at or below the floor. MB139 lies about 12 ft (3.7 m) below the floor. The roof lies at or slightly above Anhydrite "b." Clay G/ Anhydrite "b" is used as the mining reference during excavation of this disposal horizon.

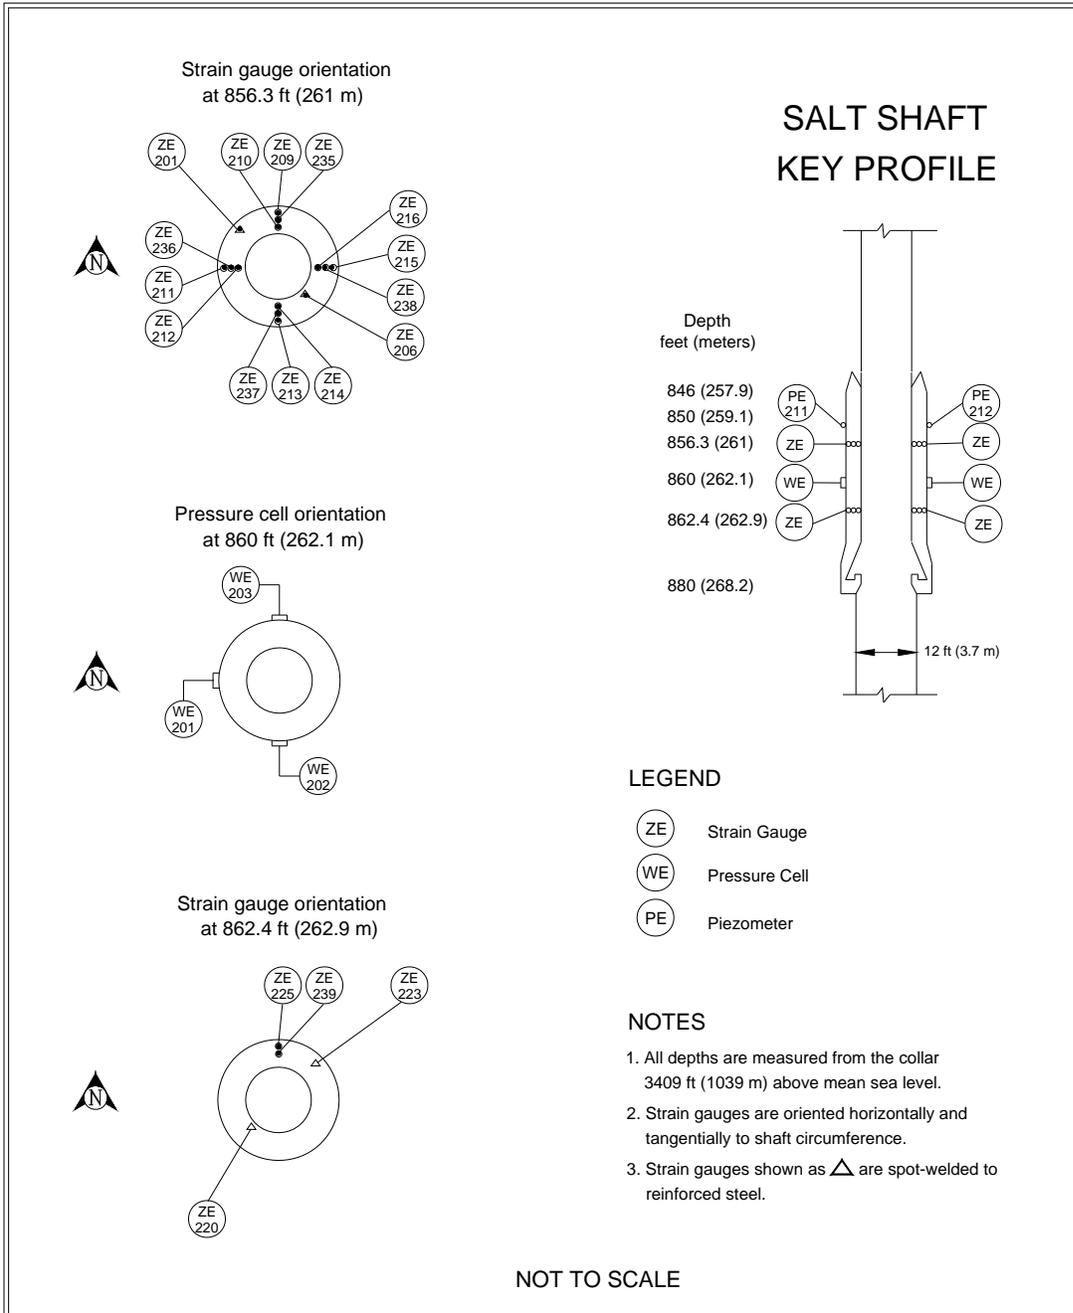
Figure 3-3 – Salt Shaft Key Instrumentation

Four earth pressure cells were installed in the key section during concrete emplacement at the 860-ft (262-m) level. These instruments measure the normal stress between the concrete key and the Salado Formation as salt creep loads up the key structure. Three of the four earth pressure cells continue to provide data. These instruments have indicated essentially no contact pressure since their installation (readings resemble instrument drift at a zero pressure). The maximum contact pressure recorded by the instruments for this reporting period is 7 psi (48 kPa).

Sixteen spot-welded and twenty-four embedment strain gauges were installed on and in the shaft key concrete at both the 856.3-ft (261-m) level and at the 862.4-ft (263-m) level. Four spot-welded strain gauges are still functioning at these levels. Strains at the 856.3-ft (261-m) level were 653 and 746 microstrain. Strains at the 862.4 ft (263 m) level were 705 and 906 microstrain. Fourteen embedment strain gauges are still functioning. The strains at the 856.3-ft (261-m) level ranged from -891 to 998 microstrain. The strains from the two embedment strain gauges at the 862.4 ft (263-m) level were 271 to 391 microstrain. The strains recorded by the spot-welded strain gauges and the embedment strain gauges during this reporting period are very similar to the strains recorded by these instruments at the end of the previous reporting period.

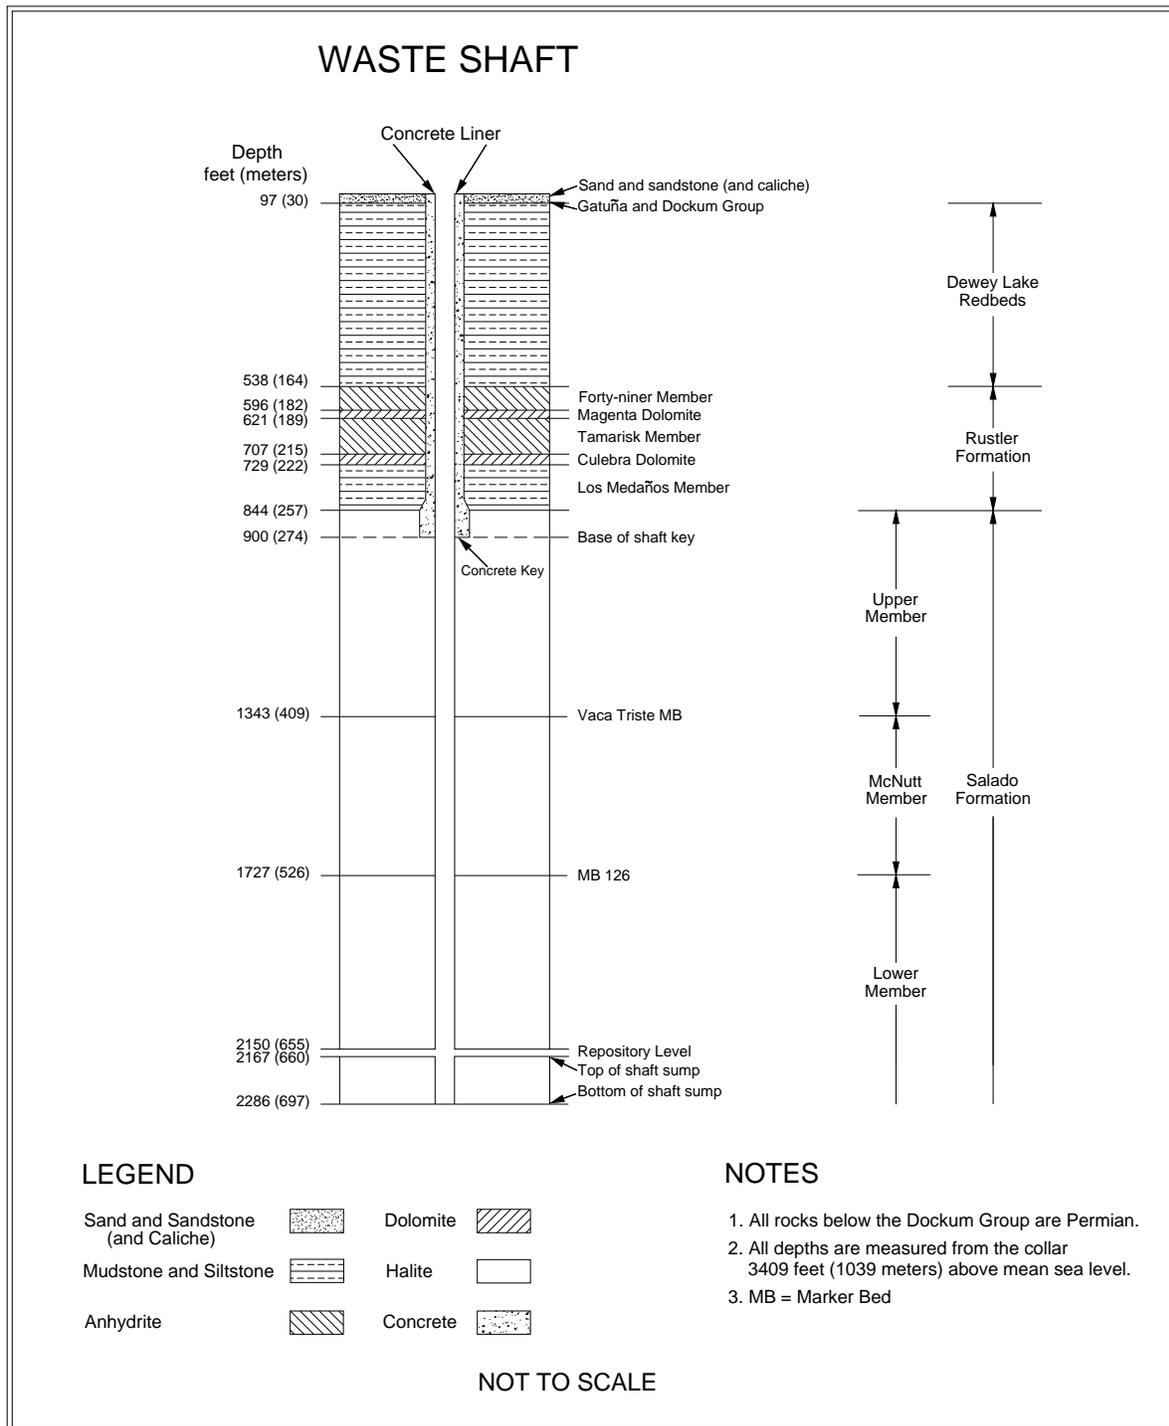
Figure 3-4 – Waste Shaft Stratigraphy

The Waste Shaft is lined with non-reinforced concrete having a 19 ft (6 m) inside diameter from the surface to the top of the key at 837 ft (255 m). Liner thickness increases from 10 in (25 cm) at the surface to 20 in (51 cm) at the key. The key is 63 ft (19 m) long and 4.25 ft (1.3 m) thick and is constructed of reinforced concrete. The bottom of the key is 900 ft (274 m) below the surface. The diameter of the shaft is 20 ft (6 m) at the bottom of the key and increases to 23 ft (7 m) just above the shaft station. The shaft below the key is lined with wire mesh anchored by rock bolts. The diameter of 23 ft (7 m) extends to a depth of approximately 2,286 ft (697 m), with the shaft sump comprising the lower 119 ft (36 m) of that interval.

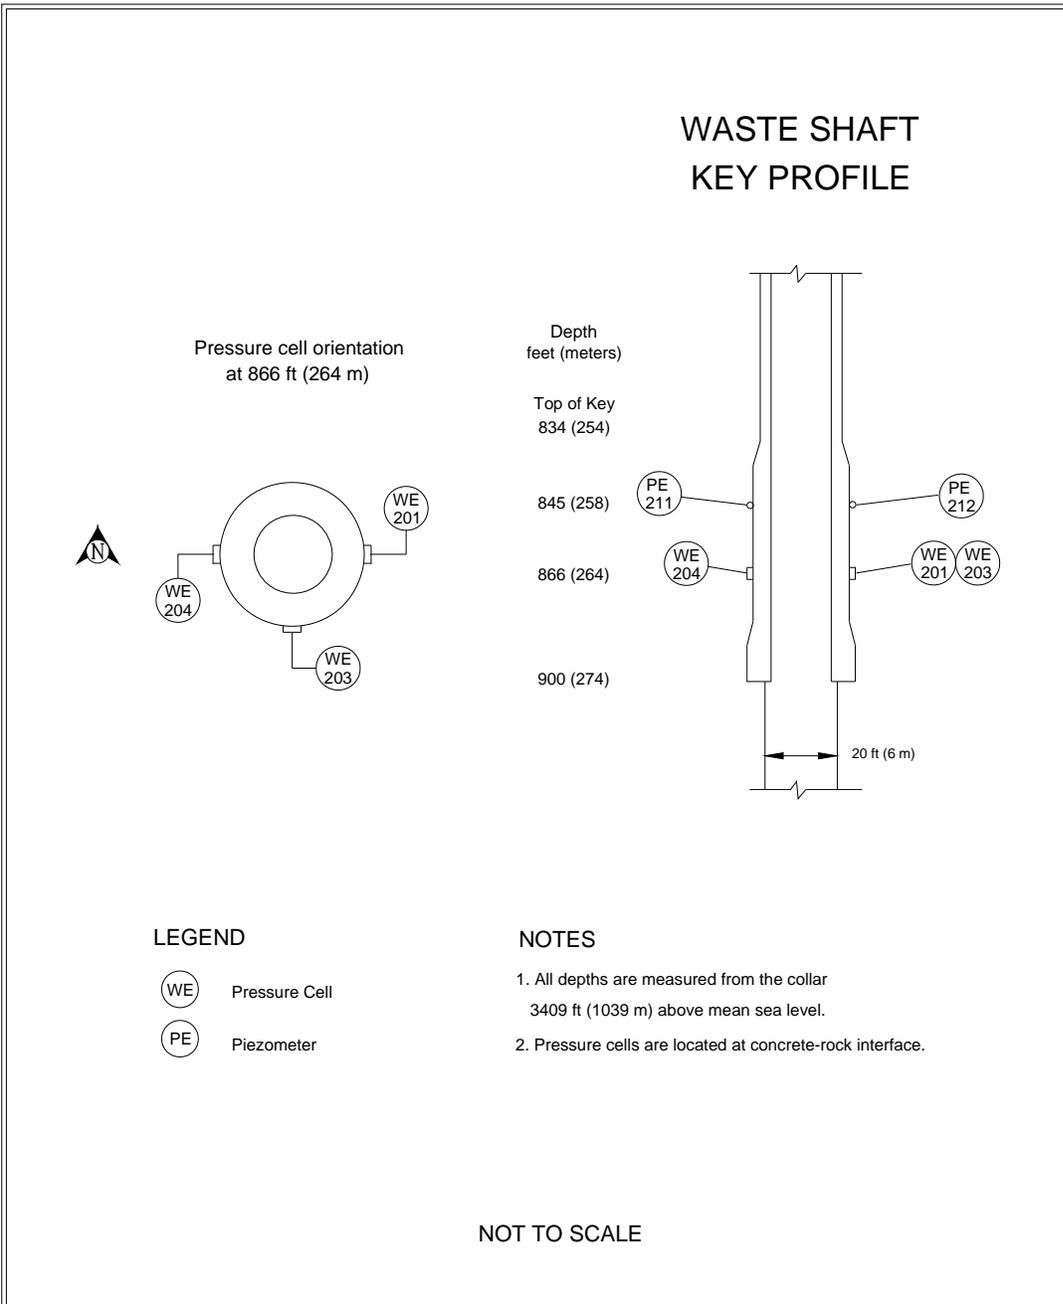
Figure 3-6 – Waste Shaft Key Instrumentation

Four earth pressure cells were installed in the key section of the Waste Shaft during concrete emplacement between March 23 and April 3, 1984. One is still working. Earth pressure cells measure the normal stress between the concrete key and the Salado Formation as salt creep loads the key structure. The contact pressure recorded by the instrument during this reporting period was 118 psi (814 kPa) at the 866 ft (264 m) level.

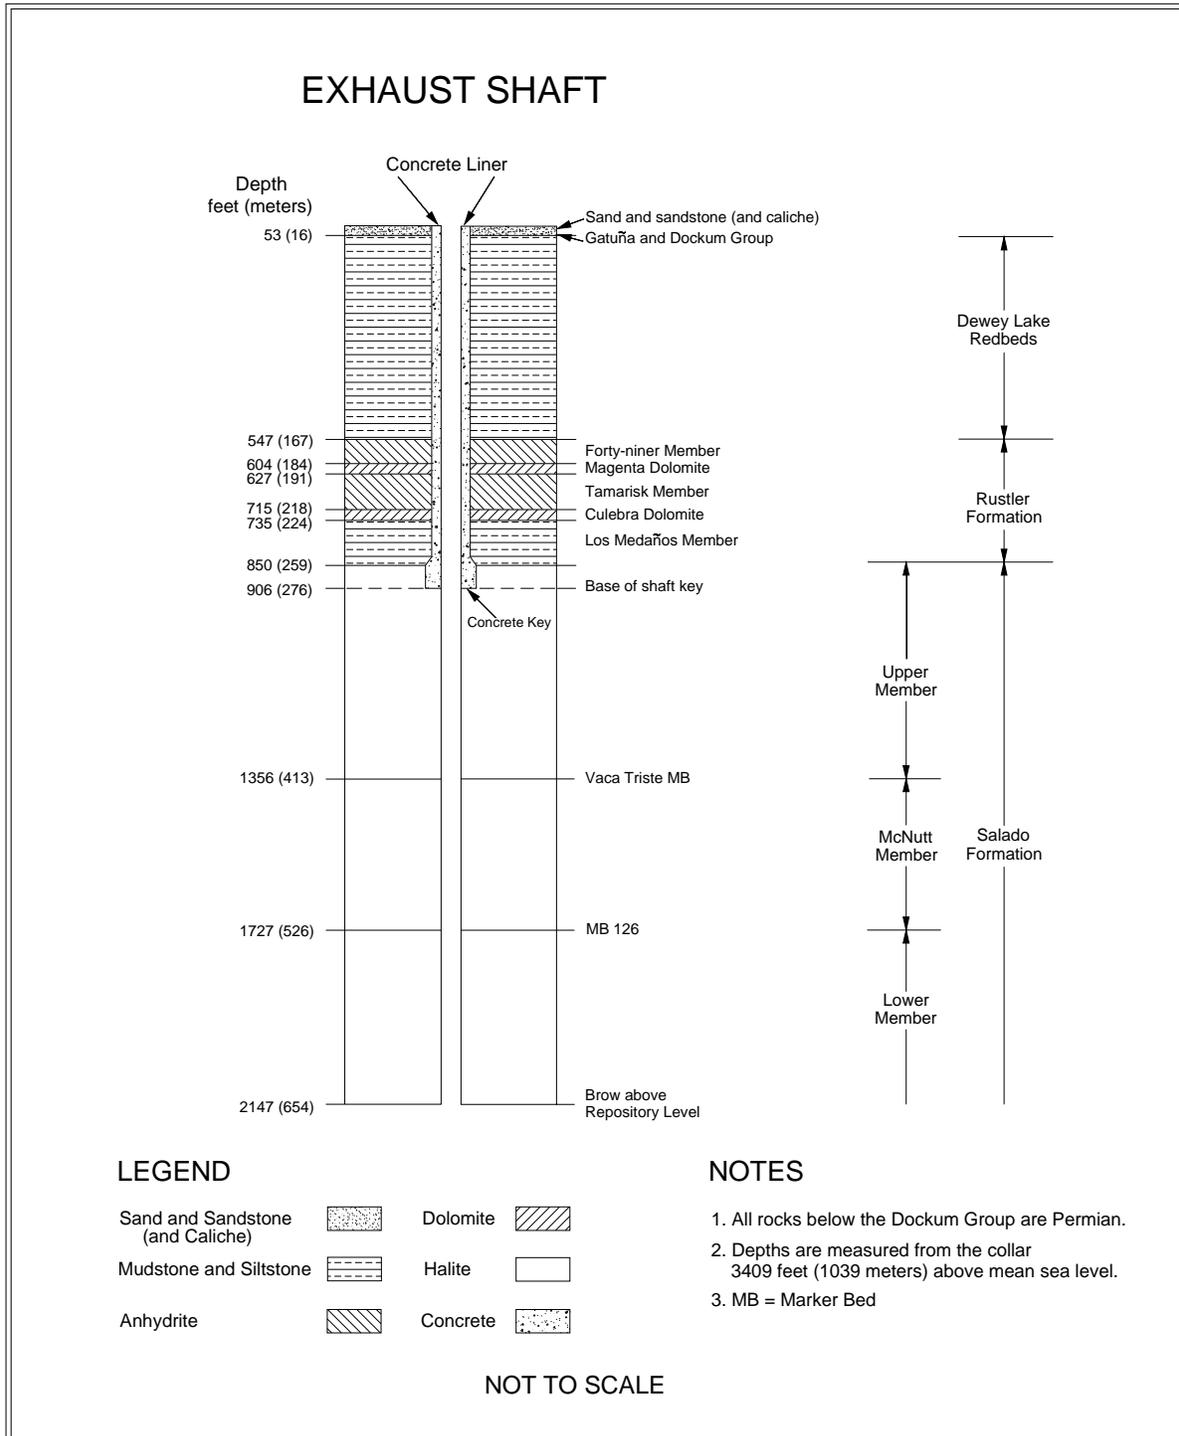
Figure 3-7 – Exhaust Shaft Stratigraphy

The Exhaust Shaft was drilled from September 22, 1983, to November 29, 1984, to establish a route from the underground to the surface for exhaust air (Figure 1-2). Stratigraphic mapping was conducted from July 16, 1984, to January 18, 1985 (DOE, 1986c). Figure 3-7 illustrates the shaft stratigraphy.

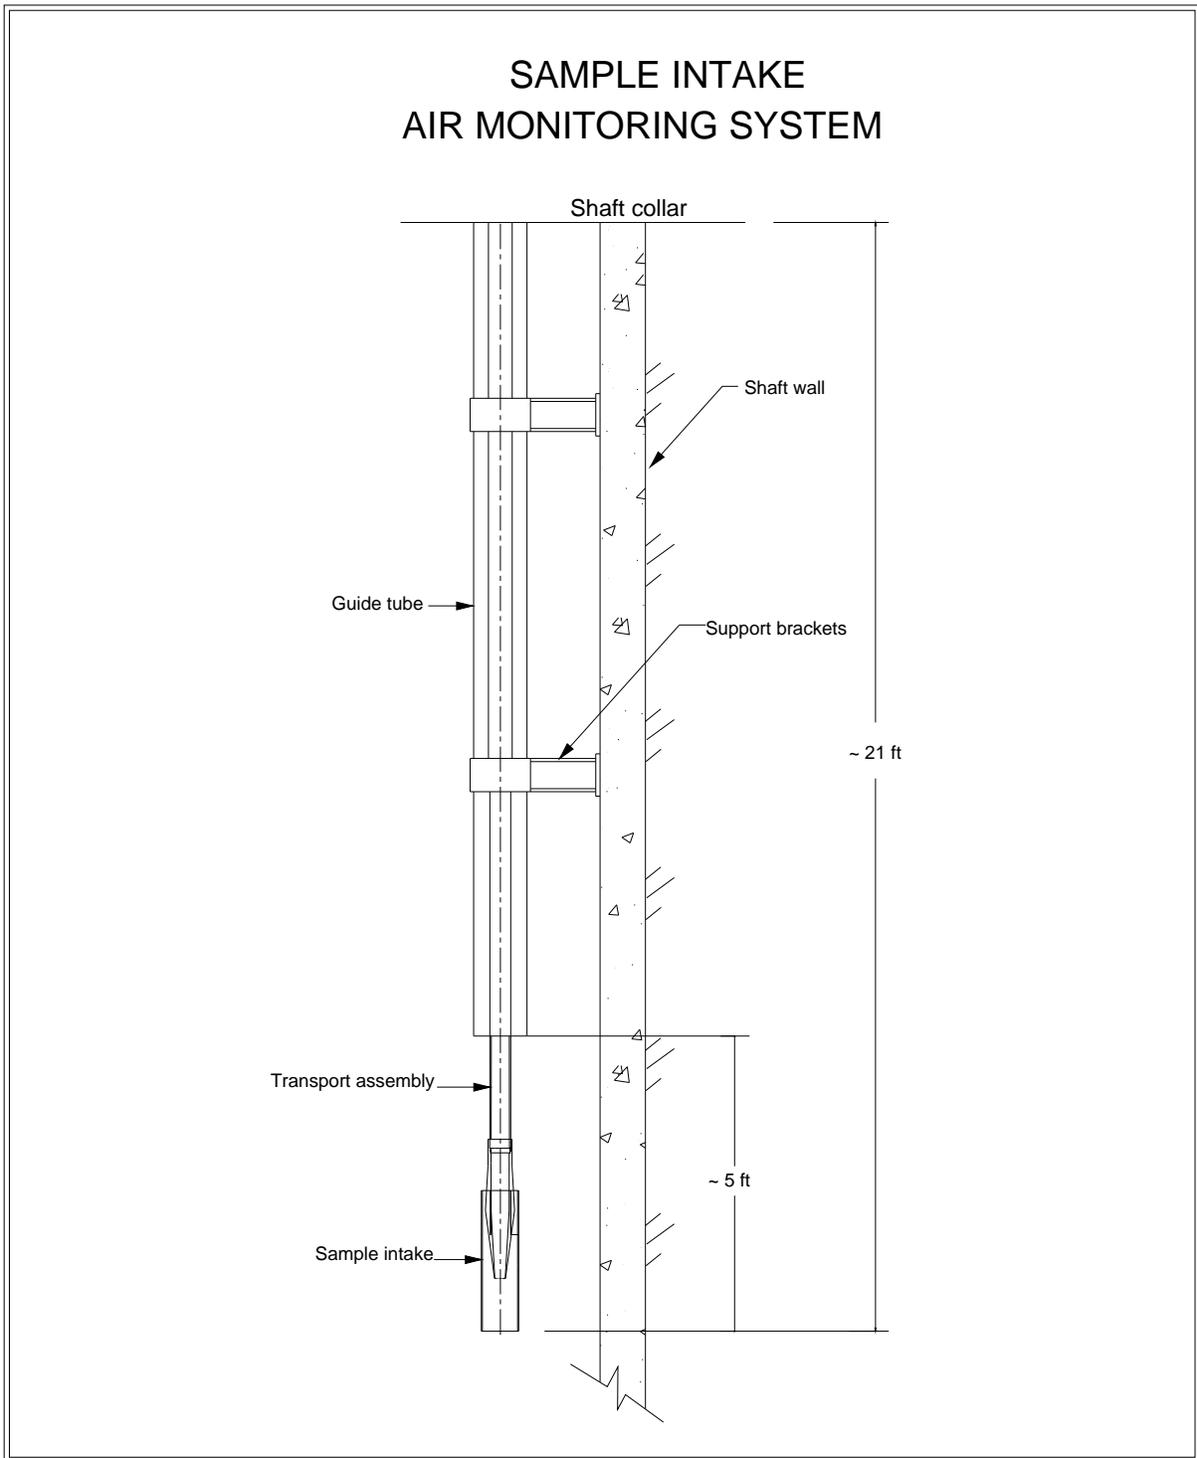
Figure 3-8 – Sample Intake of Exhaust Shaft Air Monitoring System

Quarterly video inspection observations concentrate on four major areas: air monitoring components, shaft liner, shaft walls, and equipment support and cabling. The air monitoring components consist of one air-velocity and three air-monitoring devices as shown in Figure 3-8. The video inspection includes examination of each device, including the transport assembly, guide tubes, the sample intake, and the support brackets that extend from Station "A" above the shaft to the shaft collar. Air monitoring components extend from the collar 21 ft into the shaft. Video inspections indicate that the air-sampling components can accumulate salt buildup of up to several inches thick.

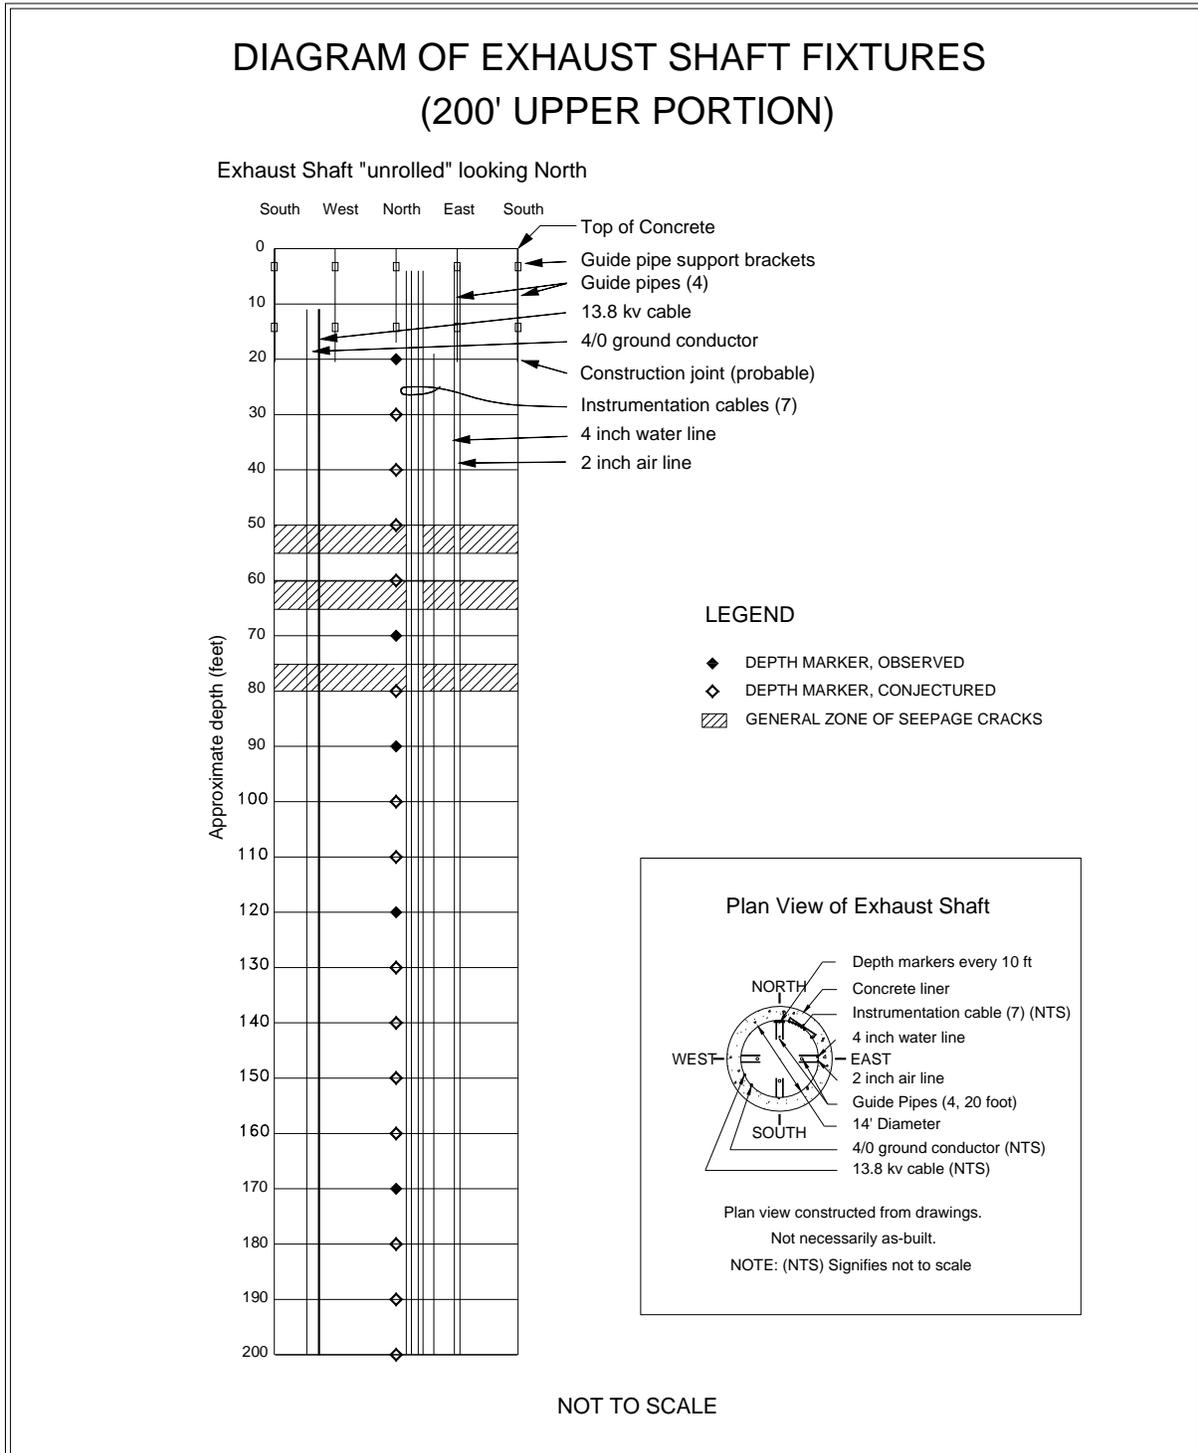
Figure 3-9 – Diagram of Exhaust Shaft Fixtures and Seepage Zones (Upper 200 ft)

The Exhaust Shaft liner is examined for cracks, seepage, and general shaft stability. Currently, there are three principal zones of seepage in the shaft. The first is about 50 to 55 ft below the shaft collar (bsc). The second is about 60 to 65 ft bsc. The third is

about 75 to 80 ft bsc, as shown in Figure 3-9. Monitoring of seepage horizons started before 1995. Water entering the shaft through these cracks is believed to originate from a perched aquifer at the base of the Santa Rosa Formation that is being recharged as the result of surface modifications at the site. The fluid level in the Santa Rosa near the shaft is about 46 to 47 ft below the surface. Based on examination of inspection videos, the flow rate into the shaft during this reporting period is estimated at about 1 to 1 1/2 gallons per minute, most of which is carried out of the shaft by the exhaust air. Seepage cracks are confined primarily to the eastern side of the shaft wall.

Though the Magenta and Culebra water rings are encrusted with salt buildup, no water appears to originate from the liner or water rings. Most of the seepage was observed along the east face of the shaft wall near the instrumentation cables and the air lines and water-lines in the upper section of the shaft. Though the presence of water is an inconvenience requiring periodic disposal, at this time it does not appear to have created any hazard or affected the structural integrity of the shaft. However, brine increases the probability of corrosion and deterioration of utility hangers and brackets. There are no visible signs of dissolution of the salt below the key.

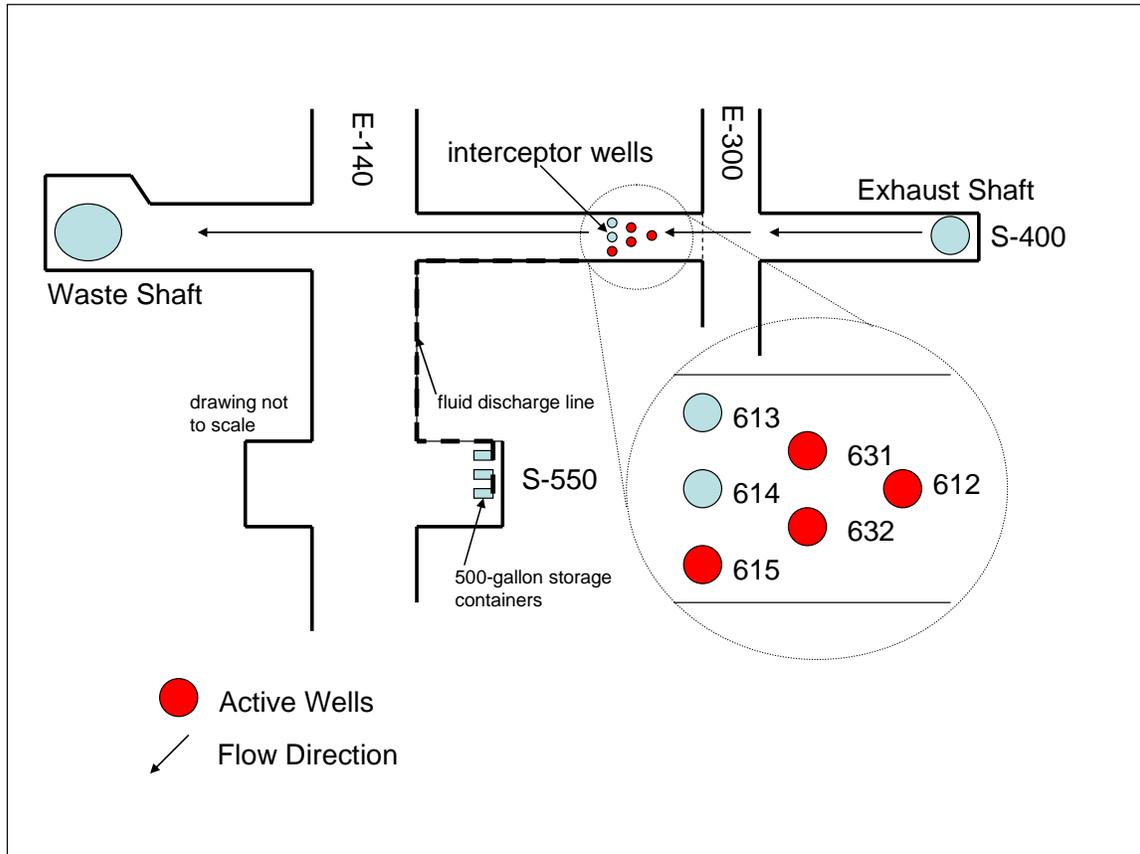
Figure 3-10 – Location of Interception Wells and Storage Containers

Between February 2 and 6, 2008, two additional fluid collection holes, OH631 and OH632, were drilled in S-400 to improve the total volume of fluid recovered by the interception well system. They replaced OH613 and OH614 which generated little fluid. As with the previous four holes, the additional holes were drilled at 9-7/8-inch diameter to a total depth of 30 feet. Pumps were pulled from OH613 and OH614 and installed in OH631 and OH632. Figure 3-10 shows the location of the interception wells system and the 500-gallons storage containers.

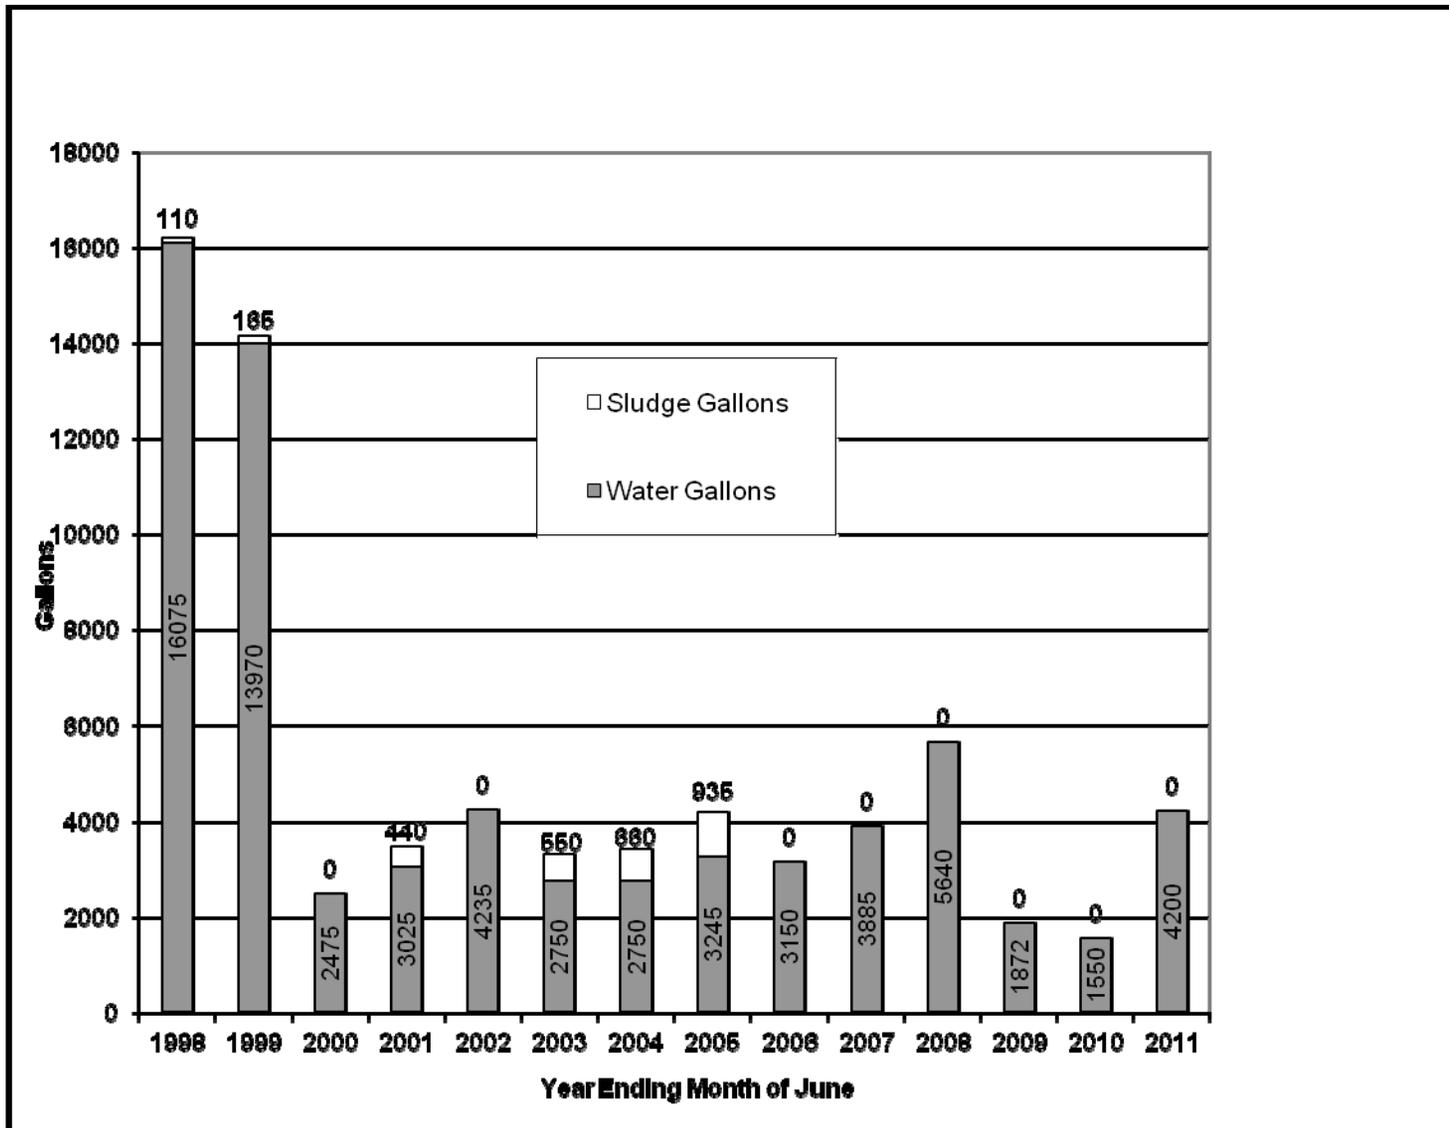
Figure 3-11 – Water Removed from the Exhaust Shaft Catch Basin and the Interception Well System

Table 3-1 and Figure 3-11 present the volume of fluid removed from the catch basin from July 1997 through June 2006, and by the interception well system from July 2006 through June 2011. The largest reported volumes are typically associated with periods of reduced ventilation and increased humidity. For a discussion of the factors affecting the quantity of fluid produced in the Exhaust Shaft, refer to DOE/WIPP 00-2000, *Brine Generation Study*.

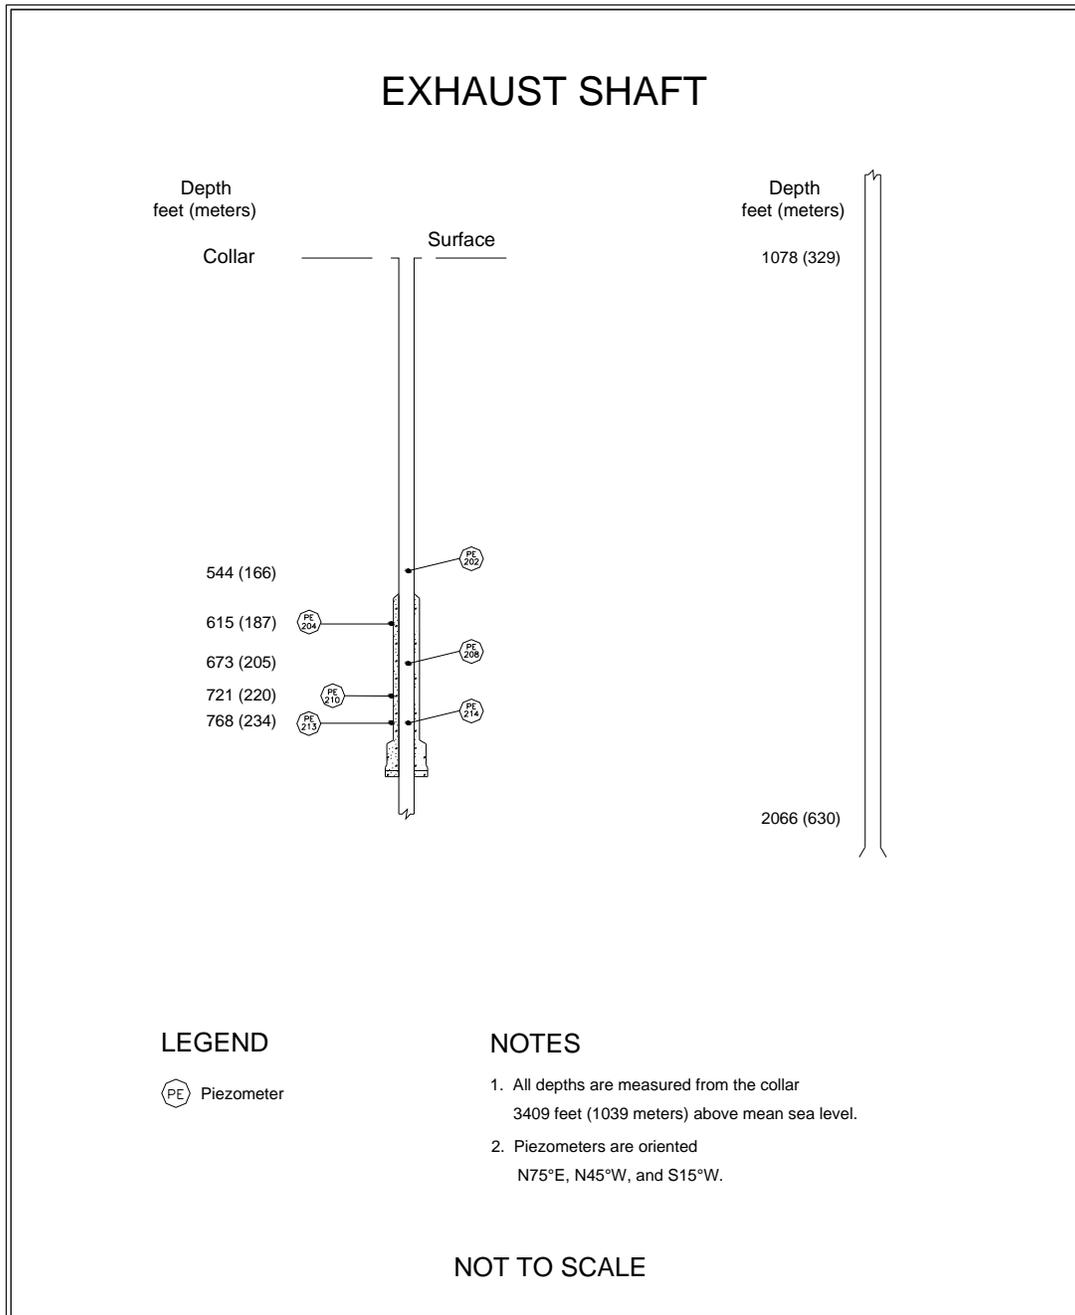
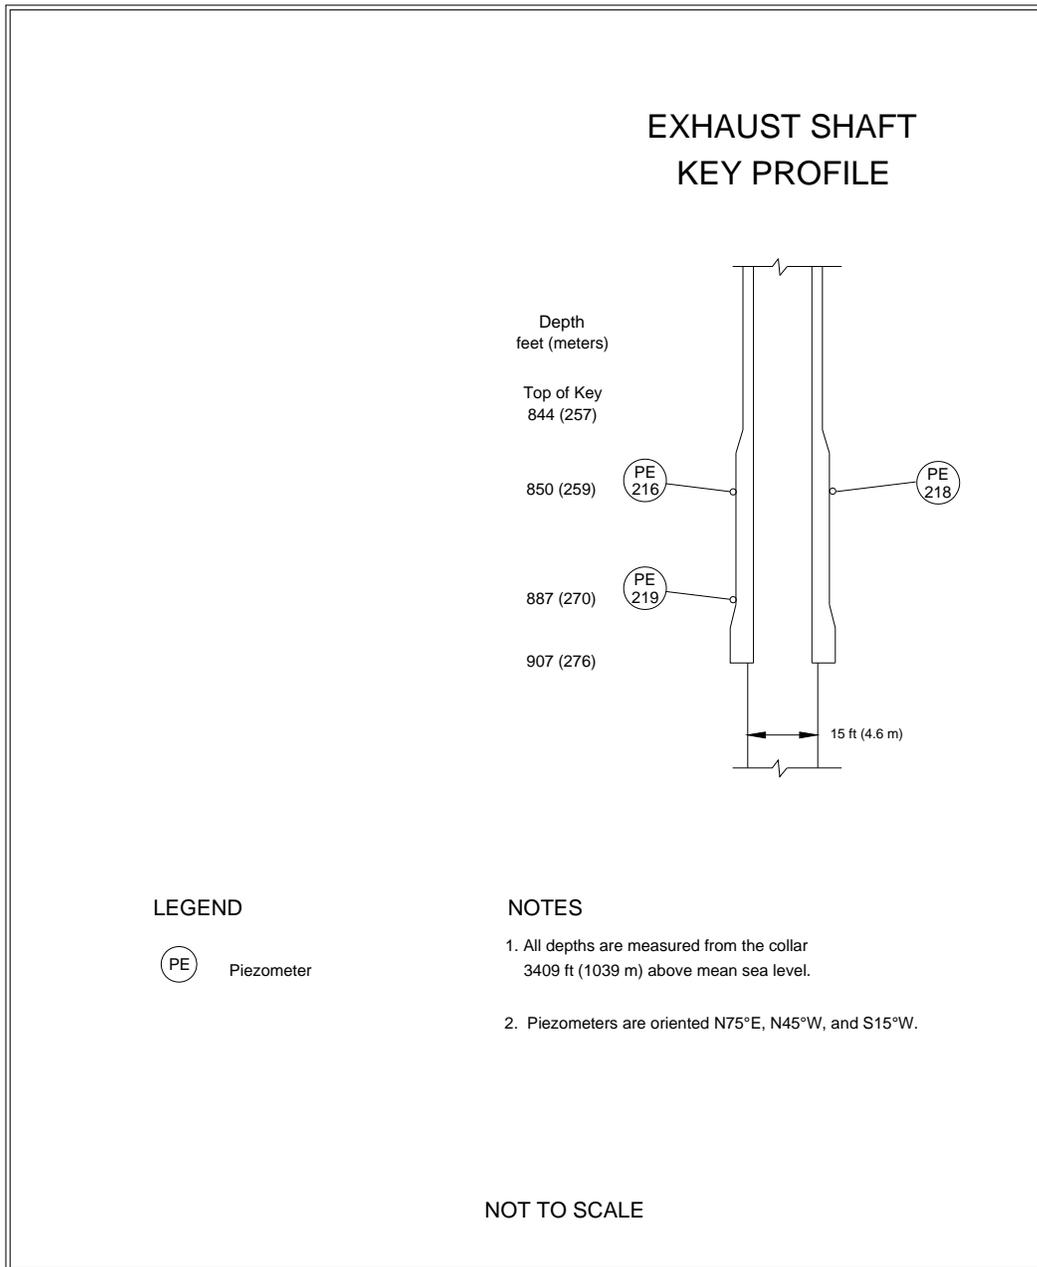
The Exhaust Shaft was equipped with geomechanical instrumentation in two stages. Earth pressure cells were installed behind the liner key in November 1984. Piezometers and nine multi-position extensometers were installed during November and December 1985. Figure 3-12 and Figure 3-13 show the instrument locations.

Eight piezometers remain in working condition. The fluid pressure readings from the working piezometers at the end of the reporting period range from -3 psi (-21 kPa) at 544 ft (166 m) to 141 psi (972 kPa) at 721 ft (220 m). Maximum pressure readings from the working piezometers during this reporting period were consistent with maximum readings from the previous reporting period.

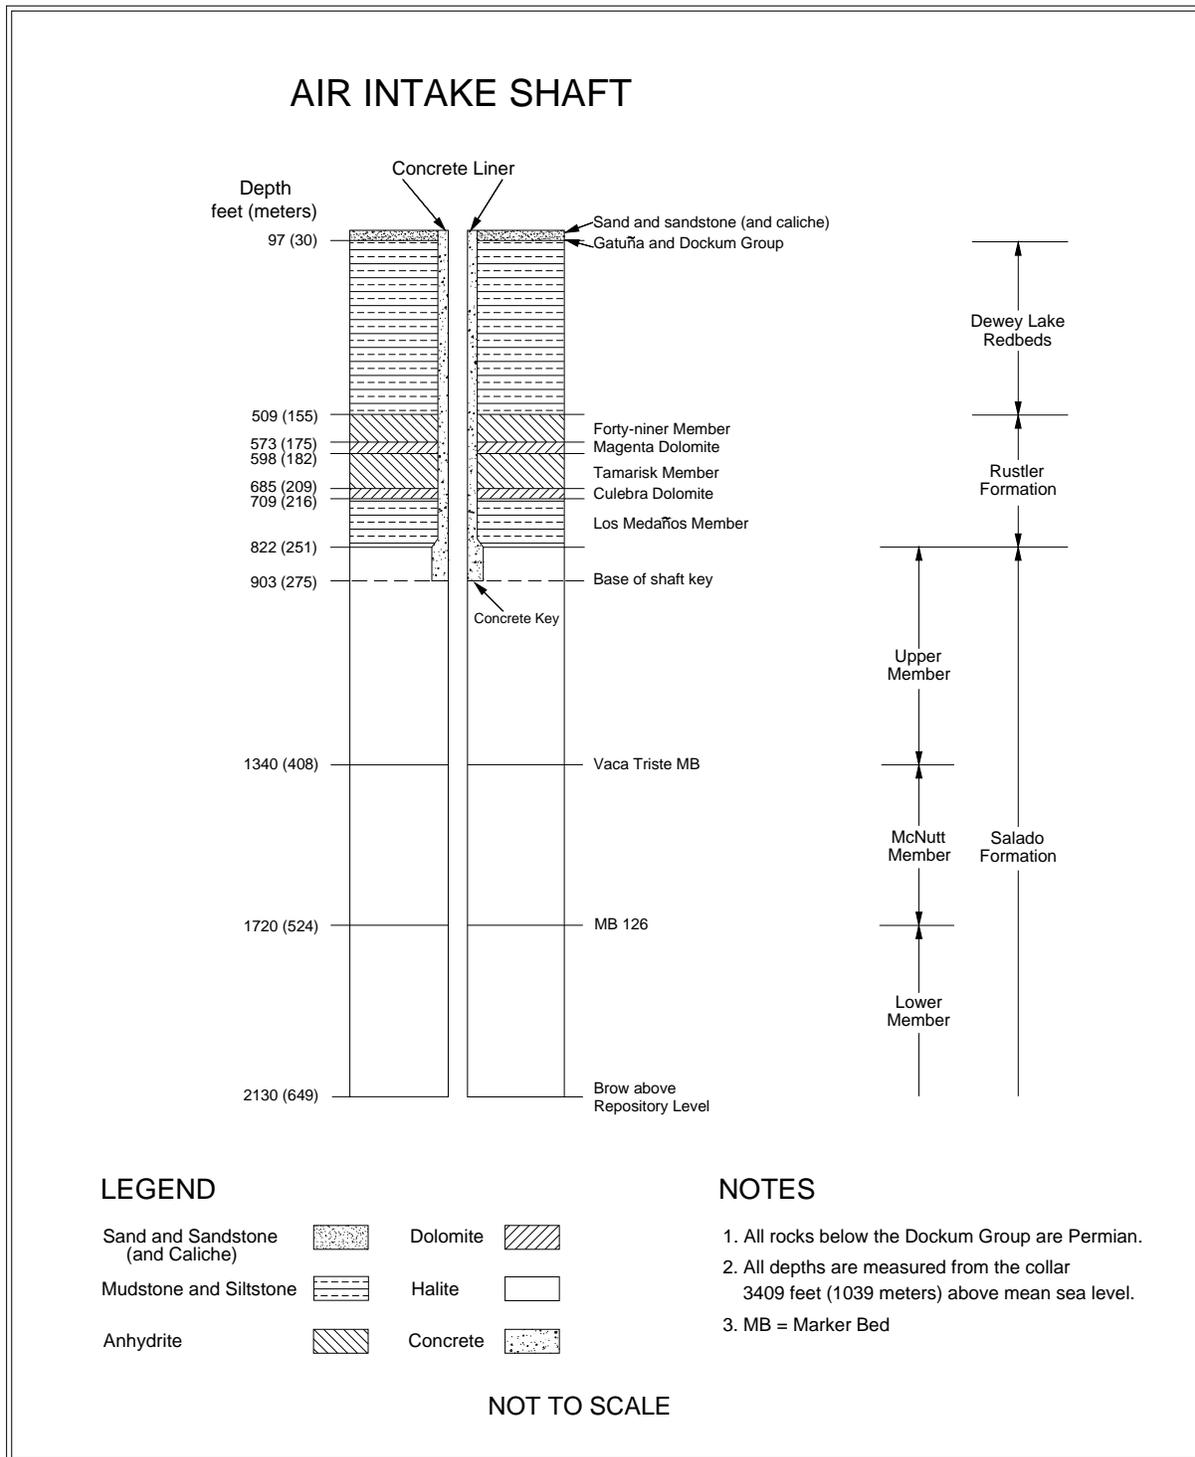
Figure 3-14 – Air Intake Shaft Stratigraphy

The Air Intake Shaft was drilled from December 4, 1987, to August 31, 1988, to establish a primary route for surface air to enter the repository (see Figure 1-2). The stratigraphy was mapped from September 14, 1988, to November 14, 1989 (Holt and Powers, 1990). Figure 3-14 summarizes the shaft stratigraphy.
