Waste Isolation Pilot Plant

Geotechnical Analysis Report For July 2010 – June 2011

Geotechnical Analysis Report for July 2010 – June 2011
DOE/WIPP-12-3484, Vol. 1

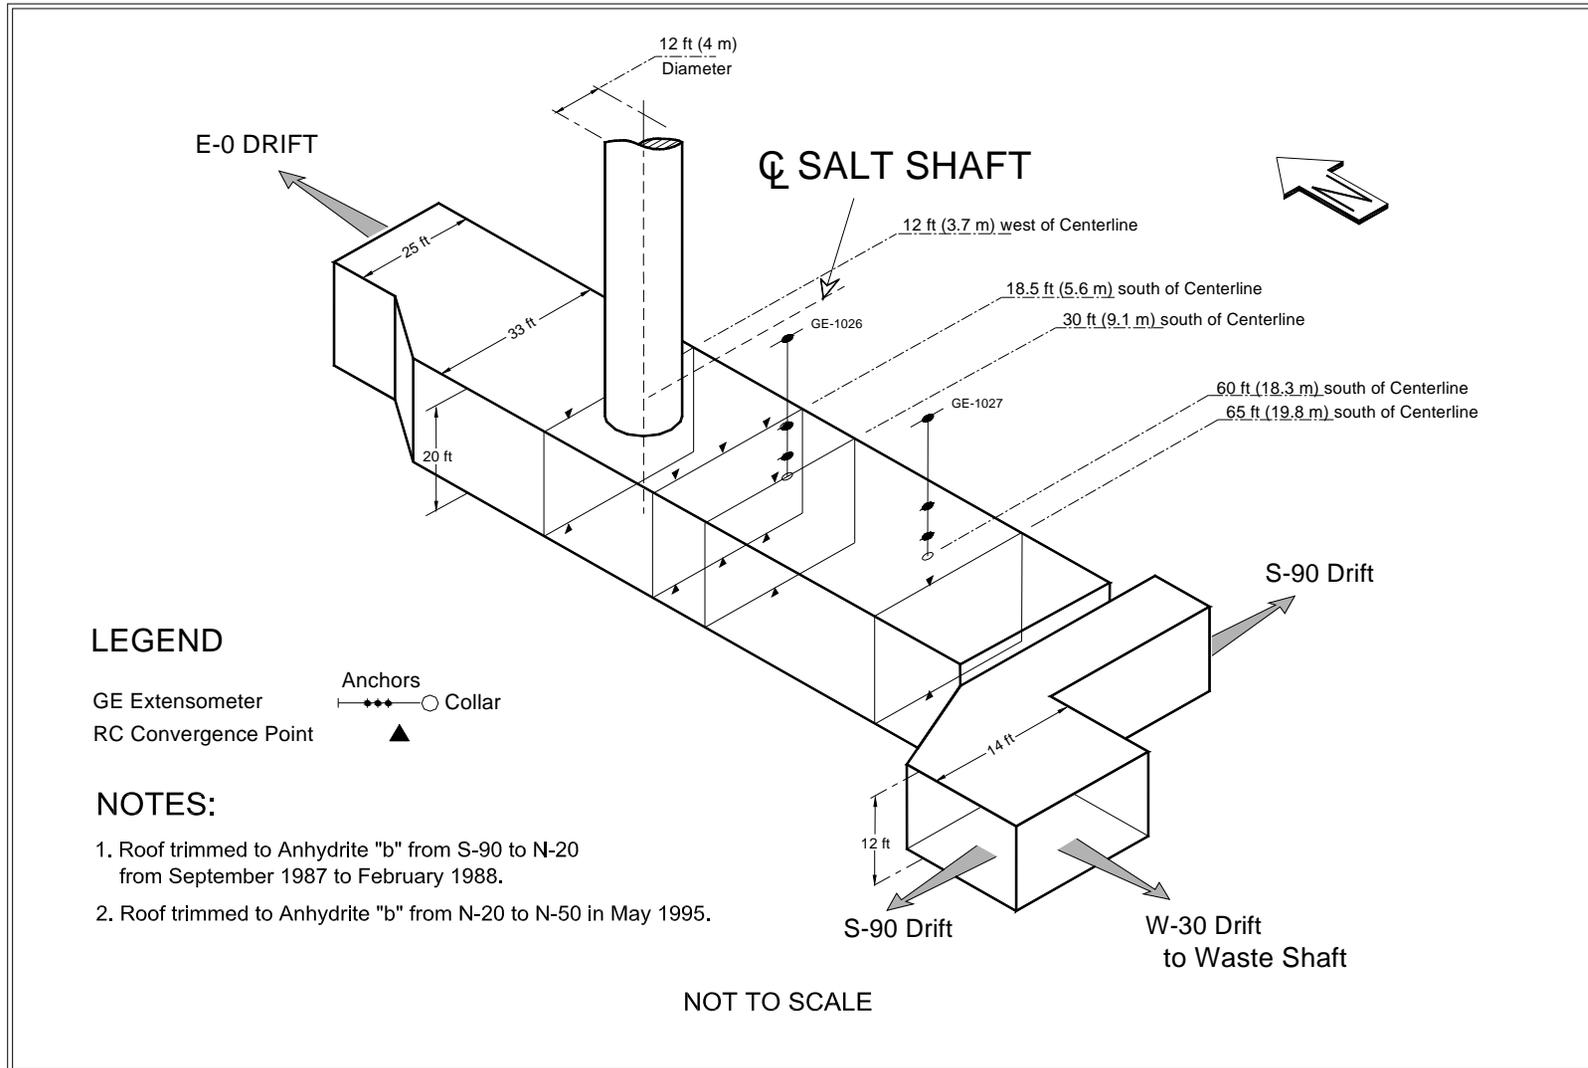
Figure 4-2 – Salt Shaft Station Instrumentation after Roof Beam Excavation

Geomechanical instrumentation was installed in the Salt Shaft Station between June 1982 and February 1983, with subsequent re-installation of extensometers and convergence points as necessary. Figure 4-2 shows the instrument locations after the roof beam was taken down.

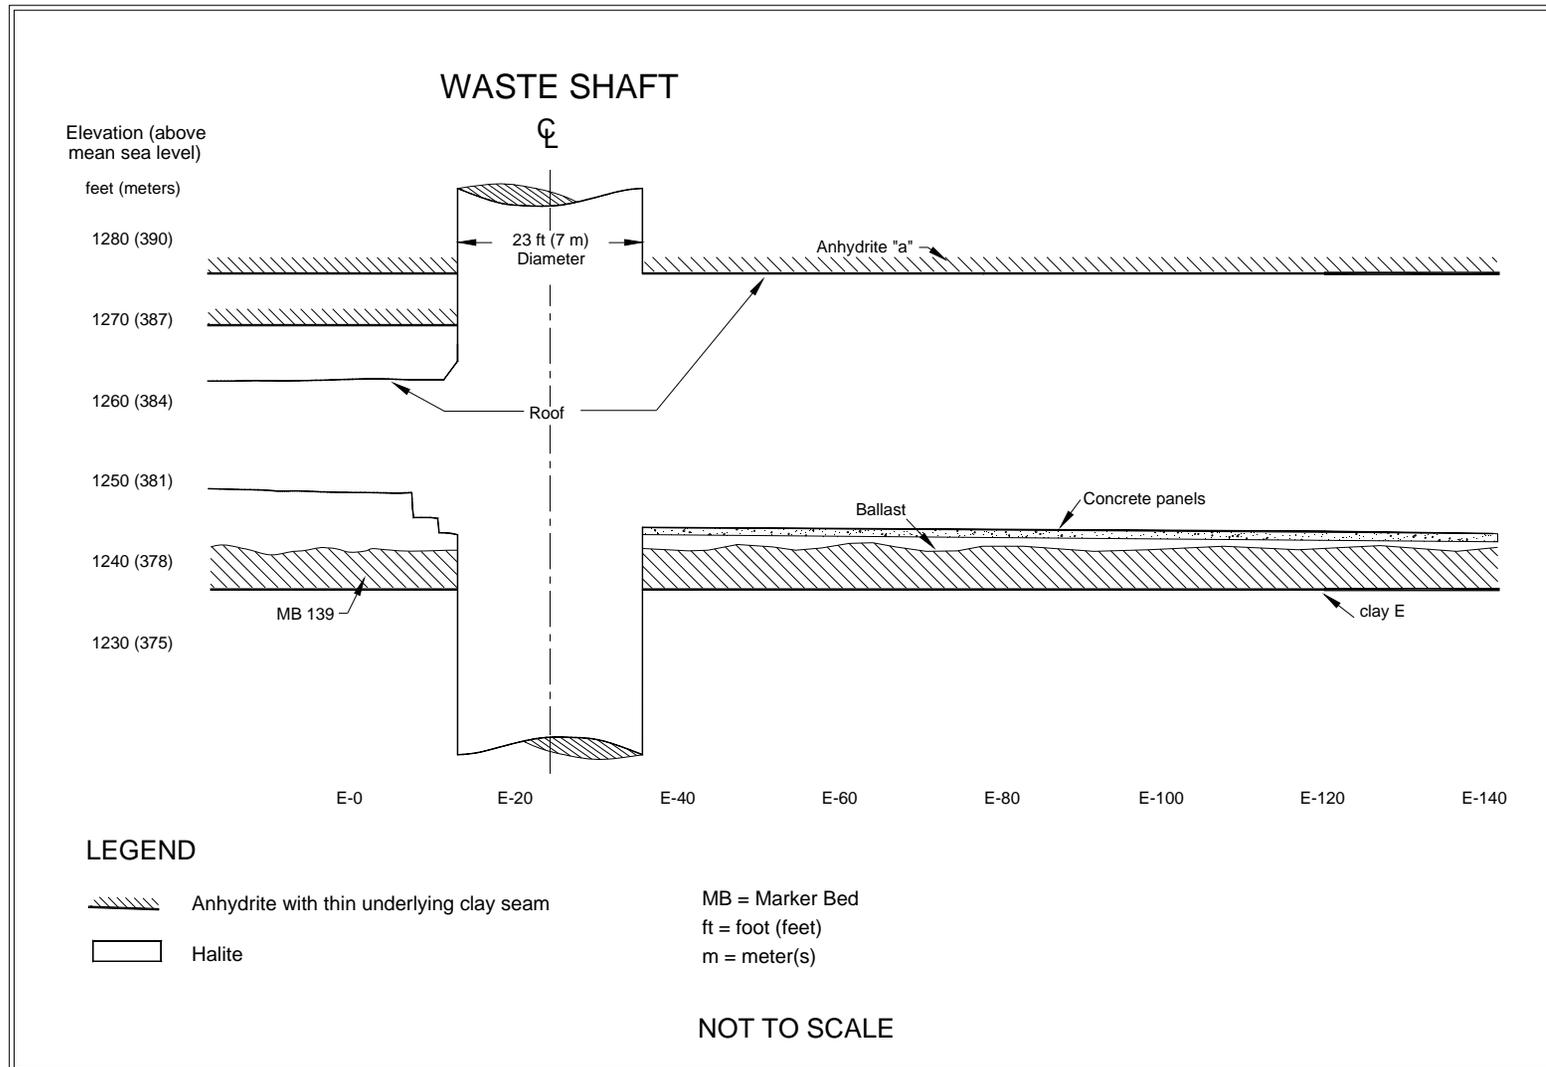
Figure 4-3 – Waste Shaft Station Stratigraphy

The Waste Shaft Station was initially excavated with a continuous miner as a ventilation connection to a 6-ft (2-m) diameter exhaust shaft in November 1982. In 1984, the station was enlarged to a height of 15 to 20 ft (4.5 to 6 m) and a width of 20 to 30 ft (6 to 9 m). The station is approximately 150 ft (46 m) long. In 1988, the station walls were trimmed, and concrete was placed on the floor. Since 1988, the Waste Shaft Station has undergone five major floor renovations. A 53-ft (16-m)-long section of the reinforced concrete was removed in February 1991, in 1995 an additional 30-ft (9-m) section was removed, and in 2000 floor maintenance included trimming of the floor and reinstallation of the rails supported by segmented concrete panels on a crushed rock backfill. The roof of the Waste Shaft station was mined up to Clay G in December 2008 to assure adequate operational clearance. 12-ft resin-anchored roof bolts and chain link were installed for ground support. Figure 4-3 shows a cross-section of the Waste Shaft Station.

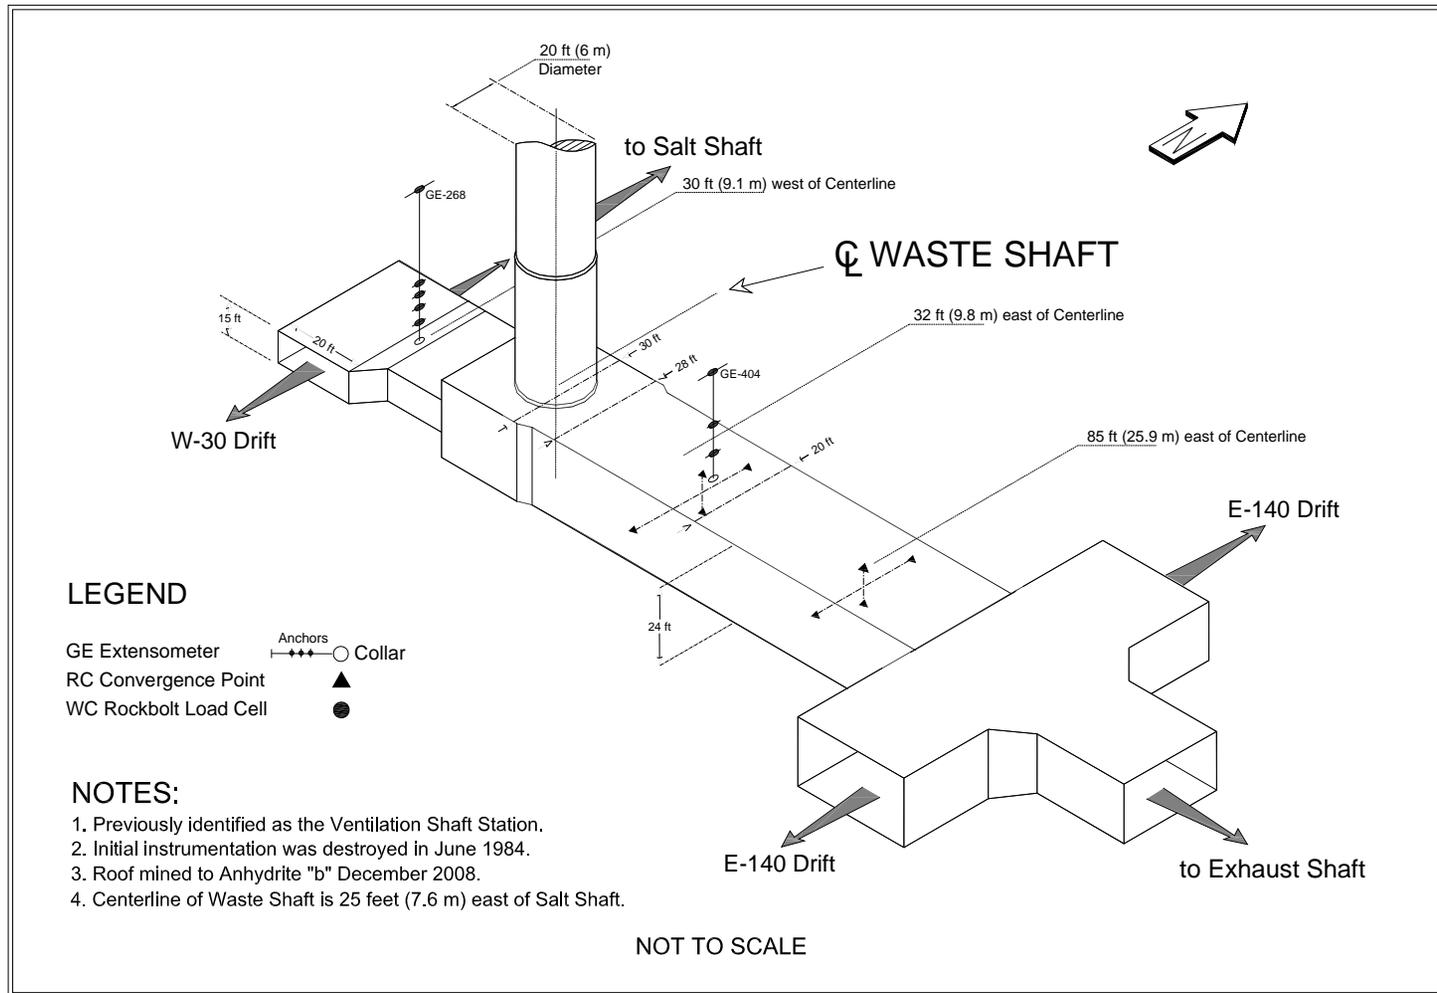
Figure 4-4 – Waste Shaft Station Instrumentation after Raising the Roof

Instruments were initially installed in the Waste Shaft Station between November 12 and December 2, 1982. Figure 4-4 illustrates the locations after enlargement. Two extensometers in the Waste Shaft Station are currently being monitored. In addition, horizontal convergence is being monitored at E-32 and E-85.

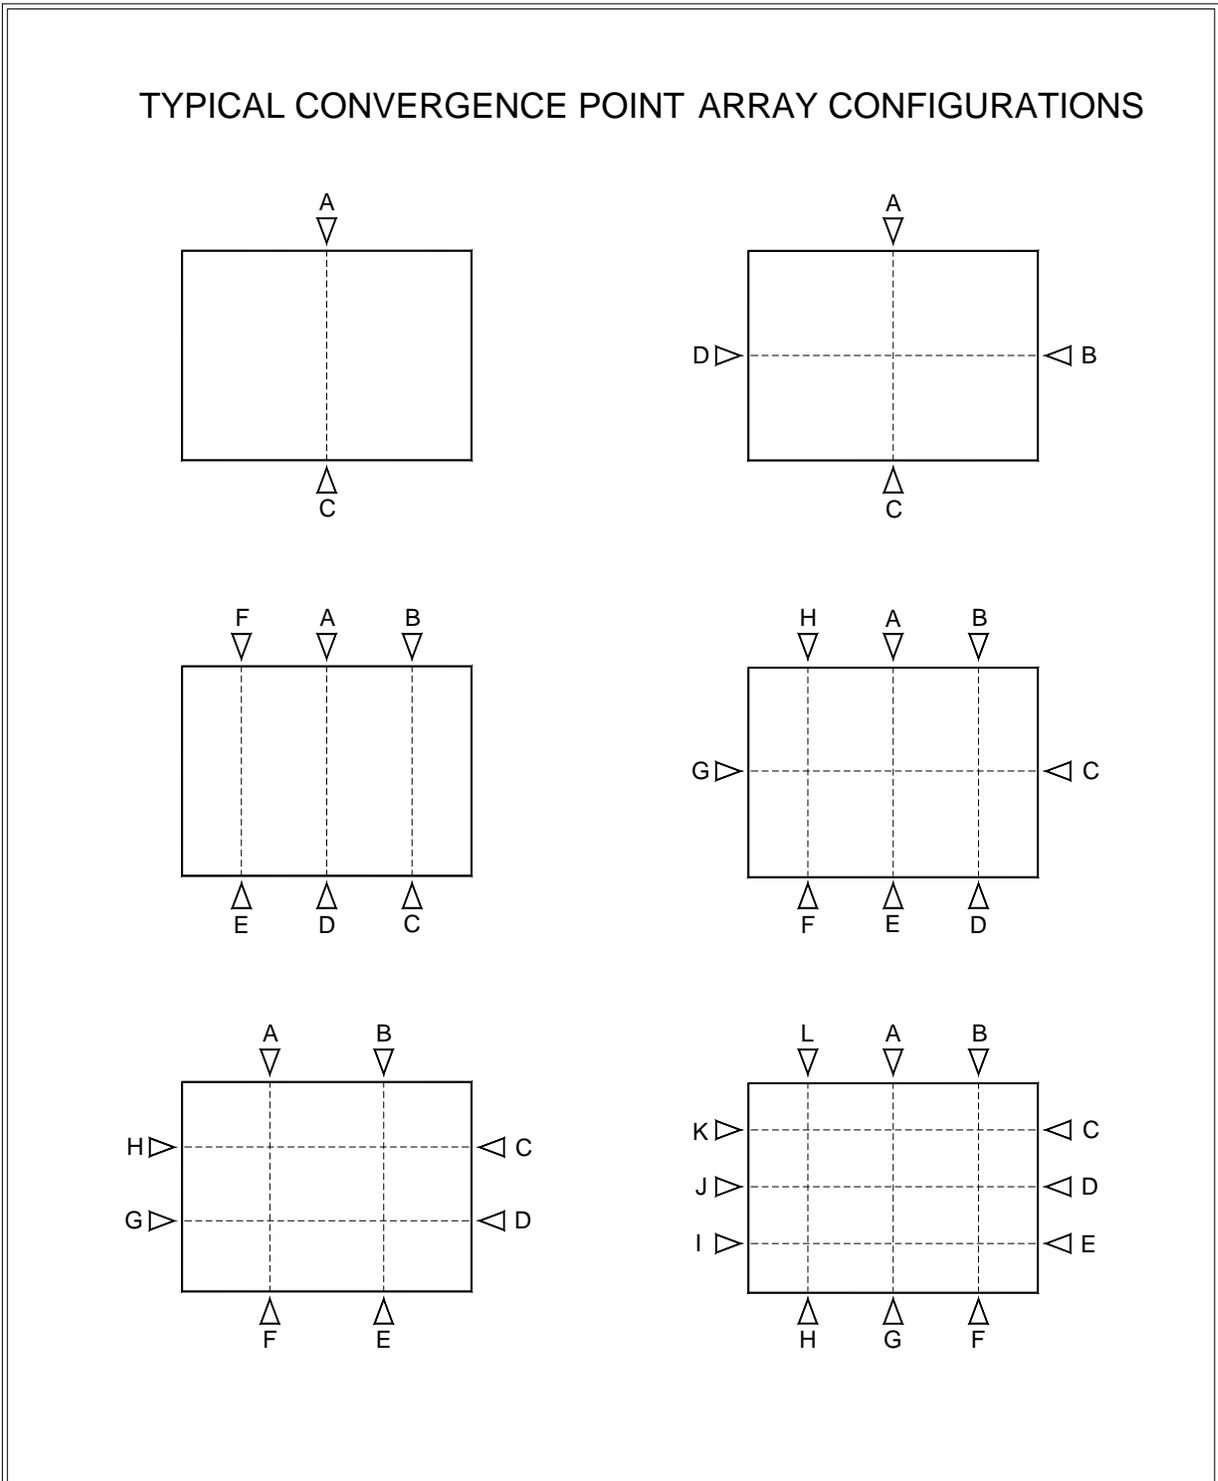
Figure 5-1 – Typical Convergence Point Array Configurations Showing Anchor Designations

Where possible, annual closure rates were calculated from convergence point array data gathered in the access drifts. A complete tabulation of these convergence point data and calculated closure rates is presented in the supporting data document for this report. Locations with increases in annual vertical closure rates of greater than 10 percent are shown in Table 5-3.

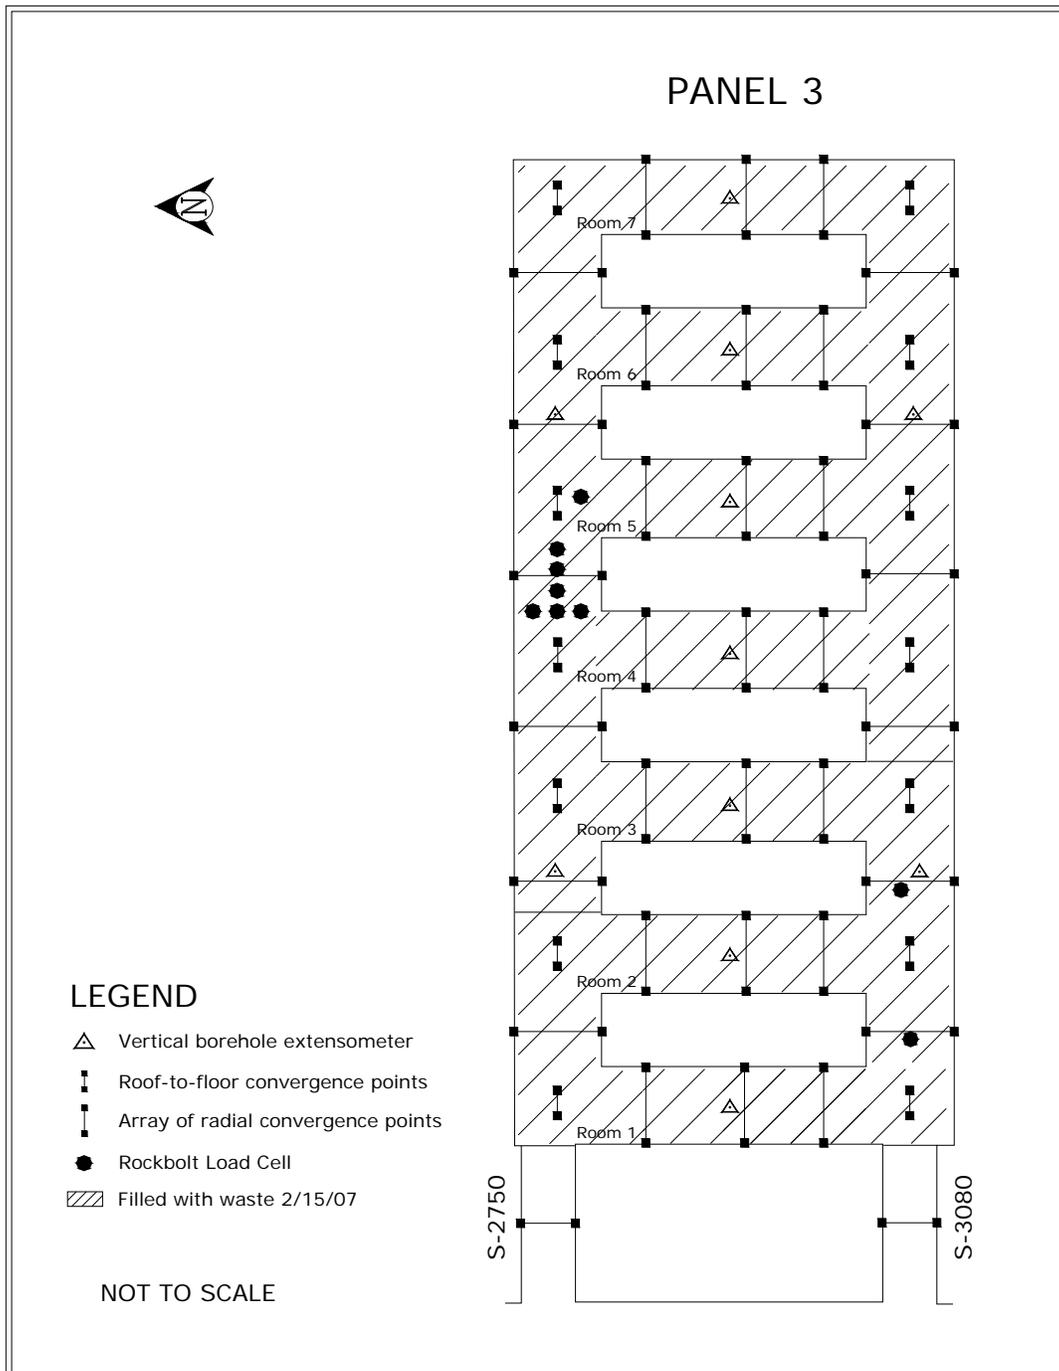
Figure 6-1 – Location of Panel 3 Geotechnical Instruments

Schematics of the geotechnical instrumentation layout in Panels 3, 4, 5, and 6 are shown in Figure 6-1 through Figure 6-3.

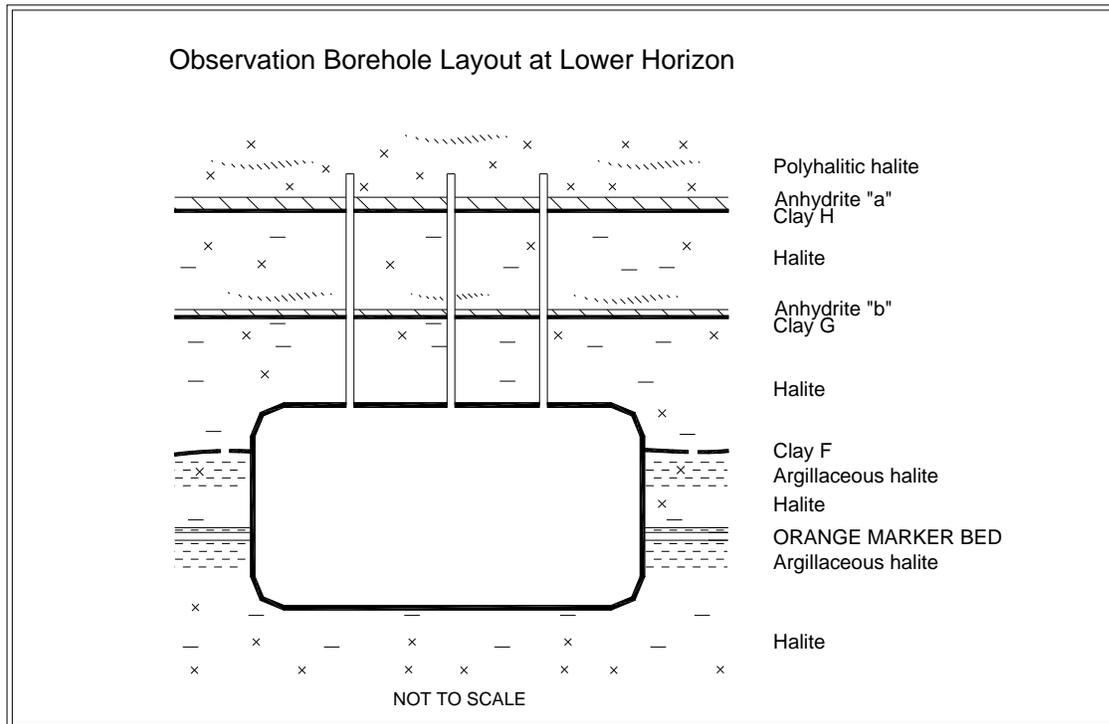
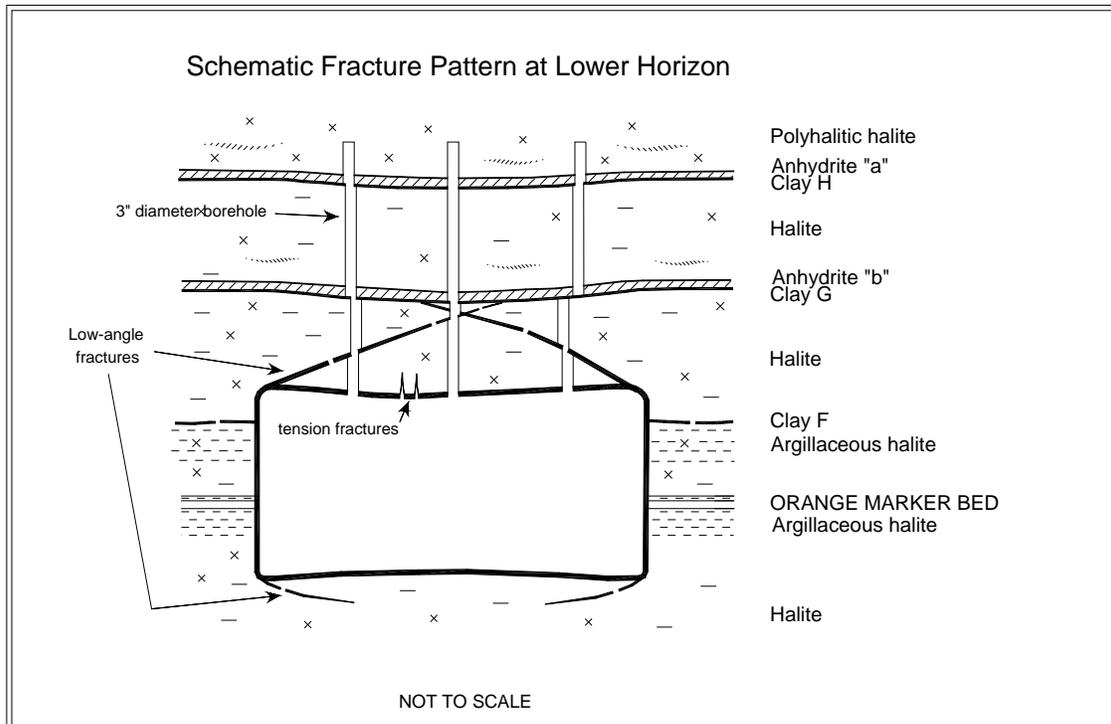
Observation holes are inspected for fractures, using an aluminum rod with a flattened steel wire probe attached to one end perpendicular to the rod (referred to as a "scratch rod"). Fractures and clay seams are located by moving the probe along the inside of the hole until it is snagged in one of these features. Depth to each feature is recorded, as is the magnitude of separations encountered. A fiber scope camera is occasionally used in addition to the scratch rod to visually document features of interest in a hole.

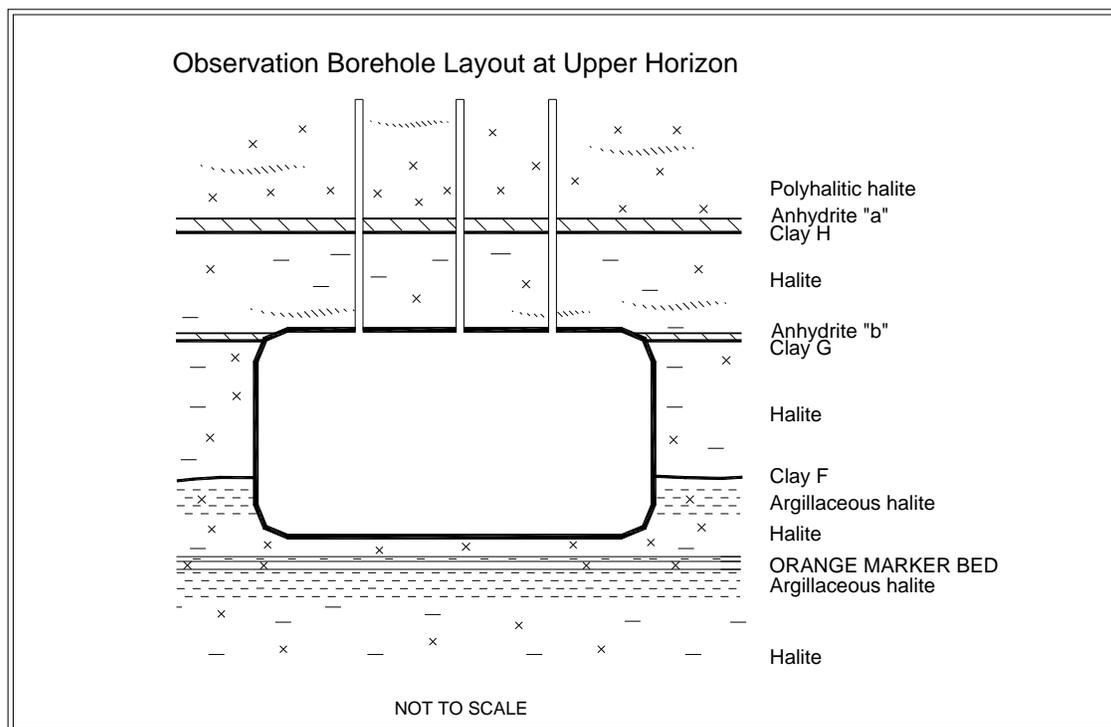
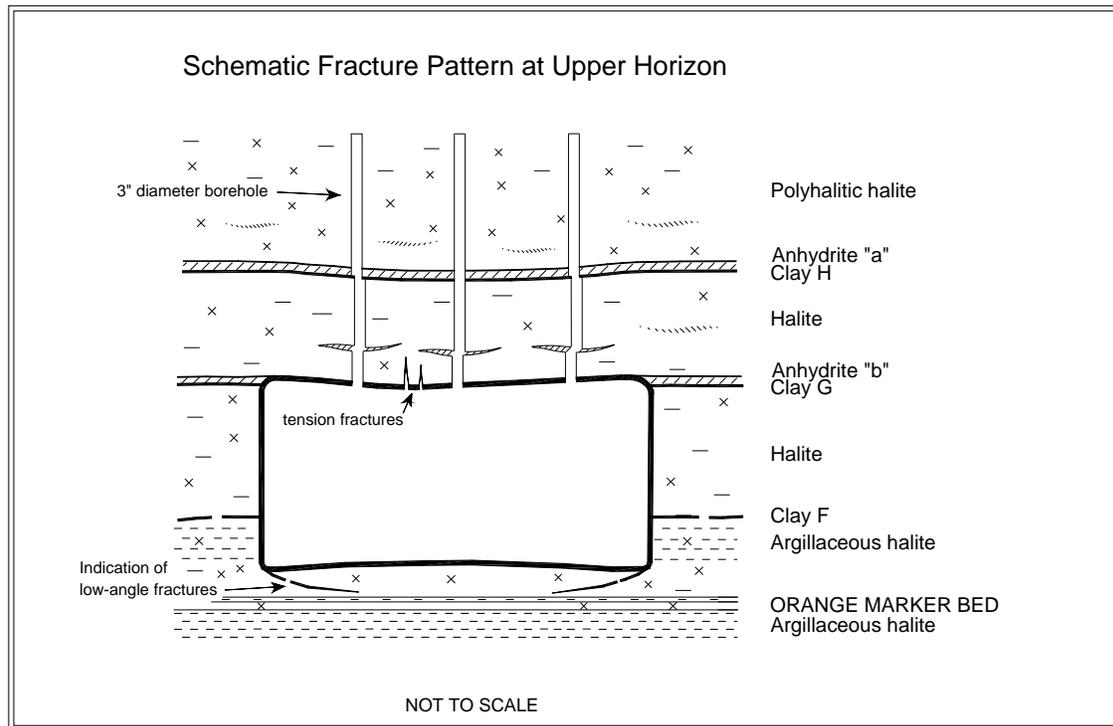
holes located near ribs than in those located along excavation centerlines. Offsetting along the clay layers is observable until total offset is reached or visibility is obstructed by intervening offsets at other clay seams or fractures.

The separation and offset data observed in accessible observation holes in the back are presented in the supporting data document for this report. Forty-seven accessible holes were monitored in Panel 5, and 47 in Panel 6. In Panel 6, the greatest separations were associated with Clay H and Anhydrite "a." Nineteen holes in Panel 6 had fractures associated with anhydrite stringers in the lower portion (first 3 feet) of the roof beam. Thirty-eight of 47 holes in Panel 6 and sixteen of the 47 holes in Panel 7 showed some offset.
