Waste Isolation Pilot Plant

Geotechnical Analysis Report For July 2012 – June 2013

U.S. Department of Energy

June 2014

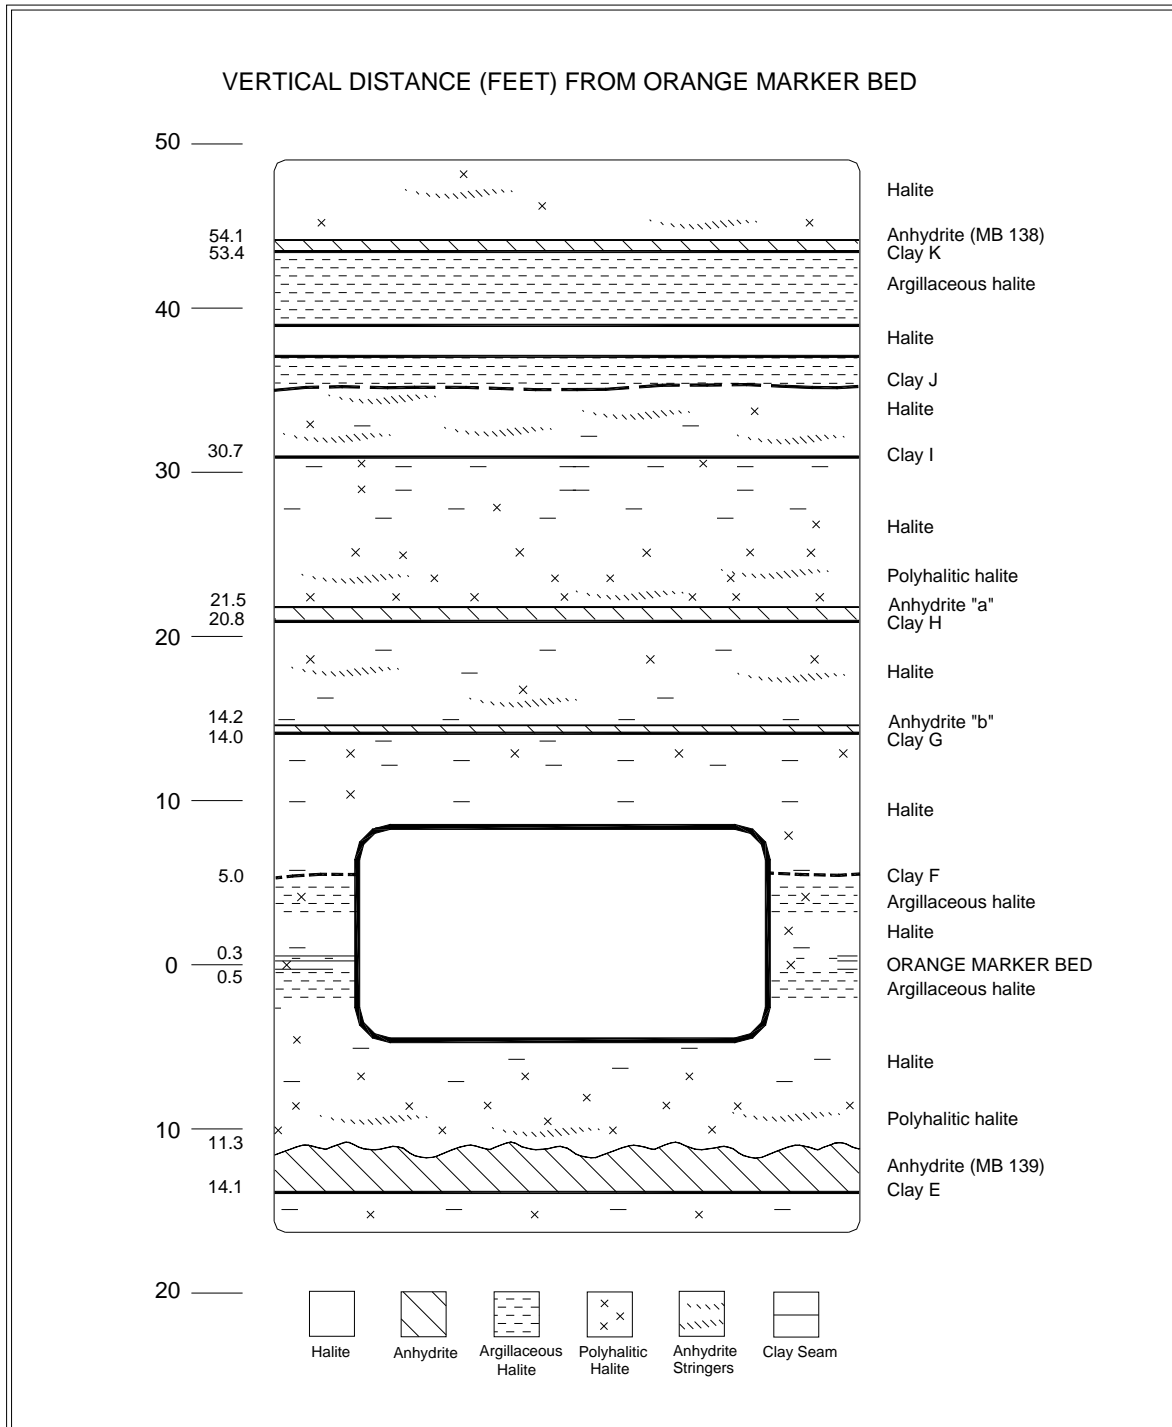
Figure 2 - 2 Repository Level Stratigraphy of Panels 1, 2, 7, and 8

The roof of some disposal horizon excavations (e.g., the E-140 drift between S-1000 and S-1950), has been excavated to the upper contact of Anhydrite "b." In this case, a roof beam is formed by the next depositional sequence beginning with Anhydrite "b" and progressing upward to the Clay H/Anhydrite "a" interface, approximately 6.5 ft (2 m) above the upper contact of Anhydrite "b."

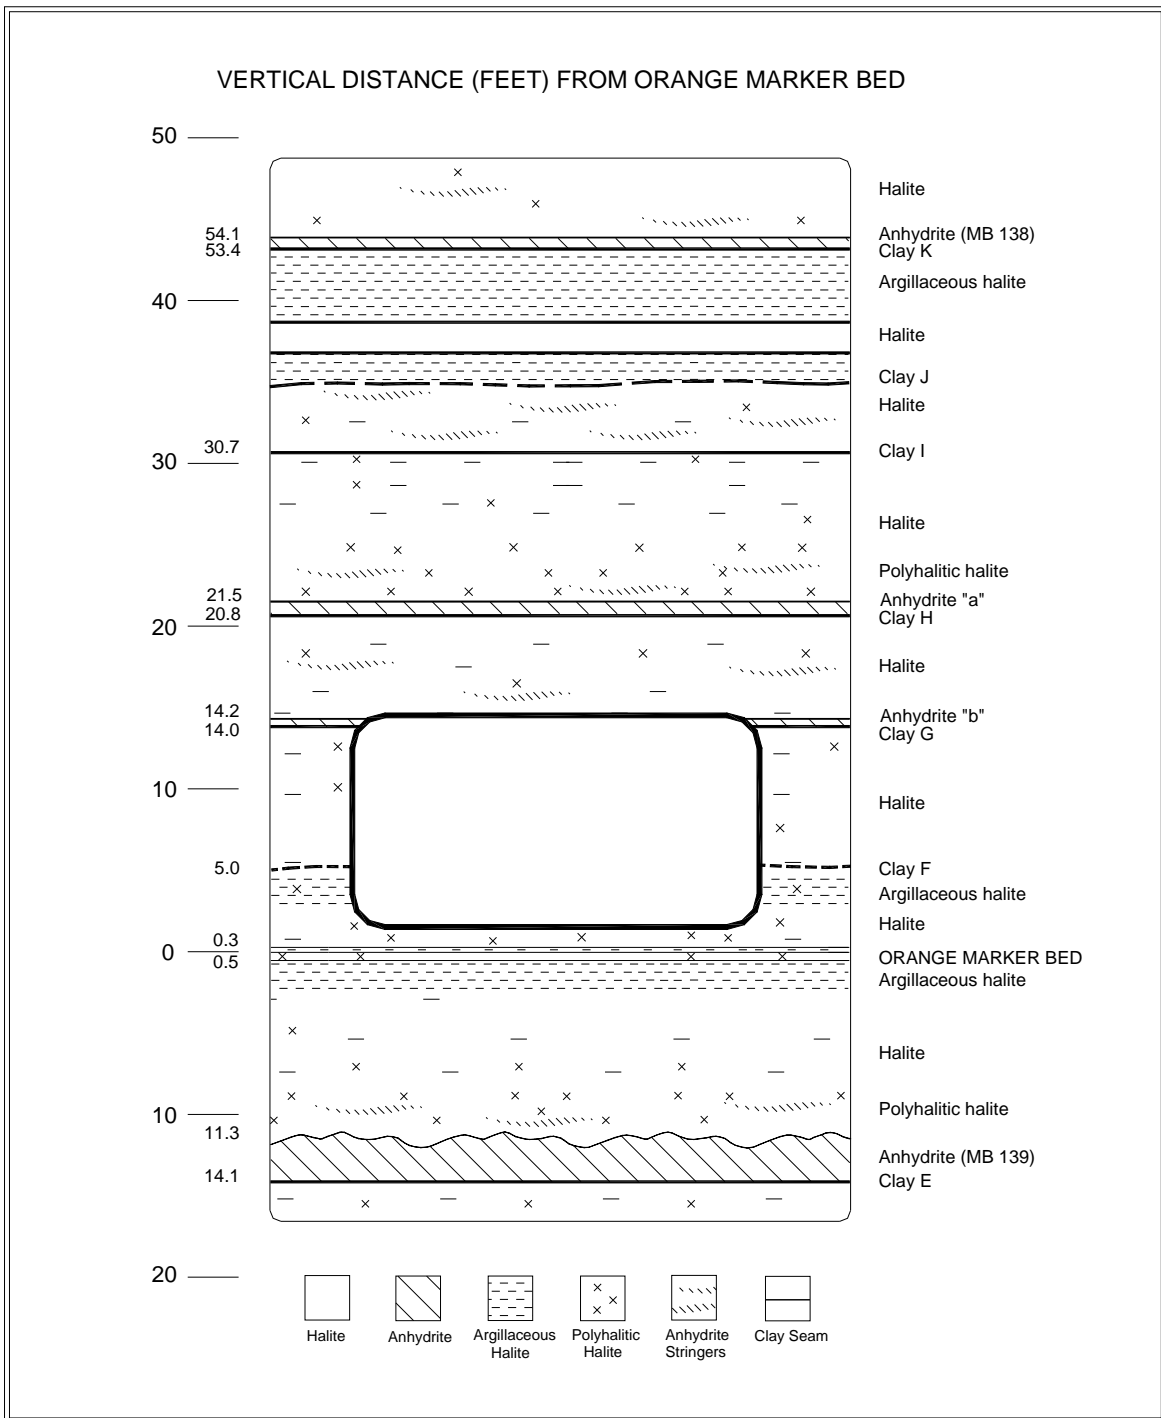
Figure 2 - 3 Repository Level Stratigraphy of Panels 3, 4, 5, and 6

Field observations and computer modeling indicated that moving the disposal horizon stratigraphically upward (so that the roof was located at Clay G) would improve long term ground conditions and provide a more stable roof configuration without significantly impacting repository performance. In 2000, the decision was made to implement this change by moving the mining horizon up approximately six feet. Subsequently, in 2000 and 2001, ramps were mined in the W-170, W-30, E-140, and E 300 drifts between S-2620 and S-2750 (Figure 1-2). As a result, the disposal horizon for Panels 3, 4, 5, and 6, and the associated connecting drifts lies above the horizon for the other panels (Figure 2-3).

In this horizon, the OMB lies at or below the floor. MB139 lies about 12 ft (3.7 m) below the floor. The roof lies at or slightly above Anhydrite "b." Clay G/ Anhydrite "b" is used as the mining reference during excavation of this disposal horizon. Locally continuous anhydrite stringers are found within this beam, generally concentrated in the lower portion toward Anhydrite "b". These effectively divide the roof beam itself into a series of thinner, independent beams.

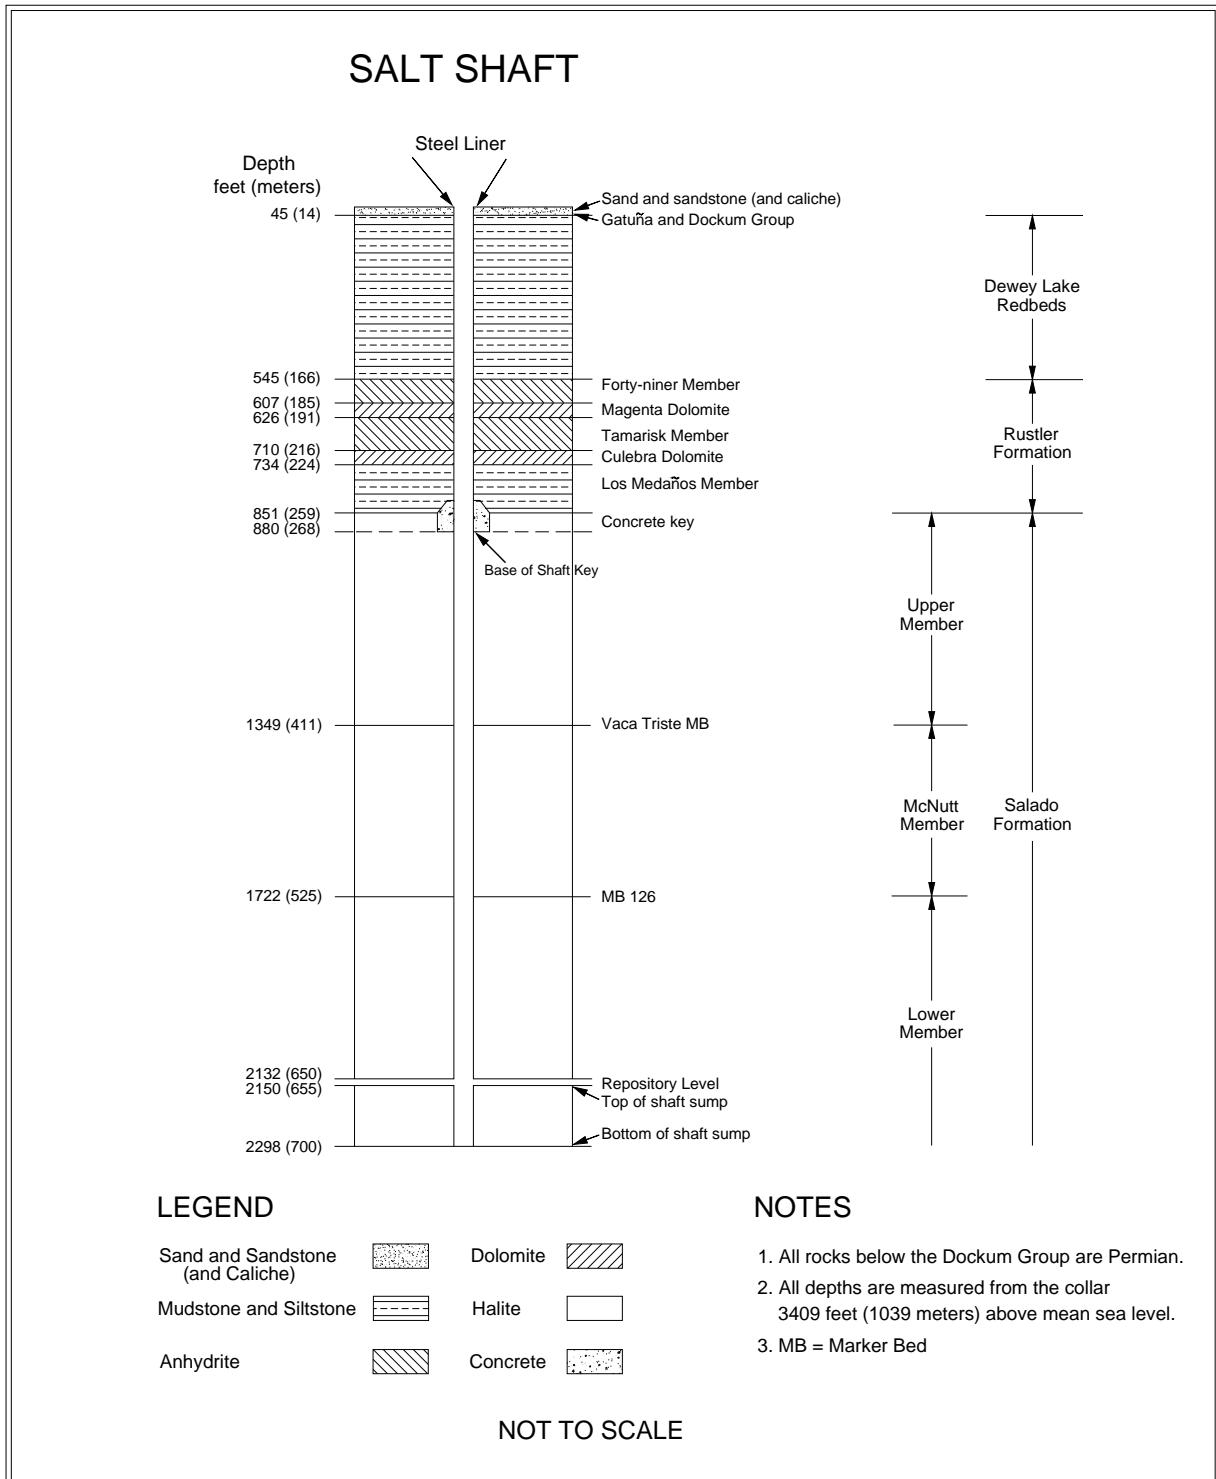
Figure 3 - 1 Salt Shaft Stratigraphy

Wire mesh anchored by rock bolts is installed in sections of the lower shaft as a safety screen to contain rock fragments that may become detached. The shaft extends approximately 140 ft (43 m) below the repository horizon in order to accommodate the skip loading equipment and a sump.

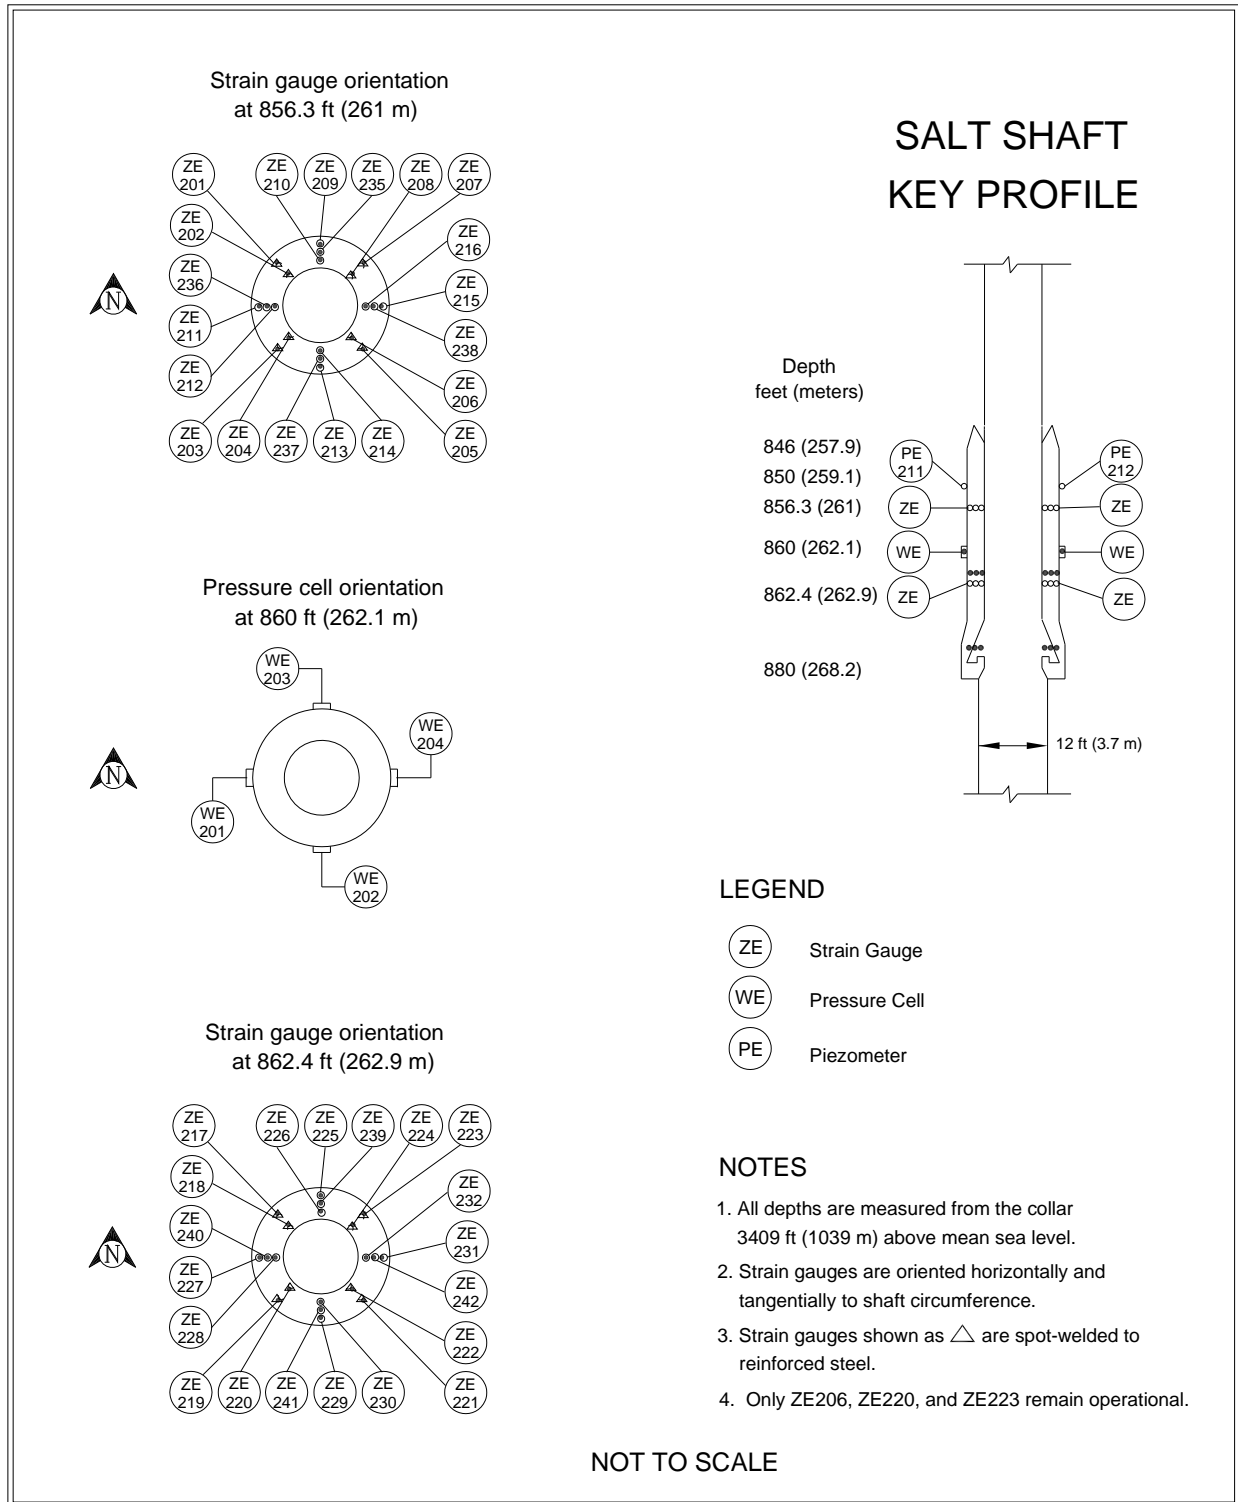
Figure 3 - 3 Salt Shaft Key Instrumentation

Sixteen spot-welded and twenty-four embedment strain gauges were installed on and in the shaft key concrete at both the 856.3-ft (261-m) level and at the 862.4-ft (263-m) level. Three spot-welded strain gauges are still functioning at these levels. Strain at the 856.3-ft (261-m) level recorded a maximum strain of 686 microstrain. Strains at the 862.4 ft (263 m) level were 714 and 956 microstrain.

Fourteen embedment strain gauges are still functioning. The strains at the 856.3-ft (261-m) level ranged from -858 to 1030 microstrain. The strains from the two embedment strain gauges at the 862.4 ft (263-m) level were 575 to 429 microstrain. The strains recorded by the spot-welded strain gauges and the embedment strain gauges during this reporting period are largely similar to the strains recorded by these instruments at the end of the previous reporting period.

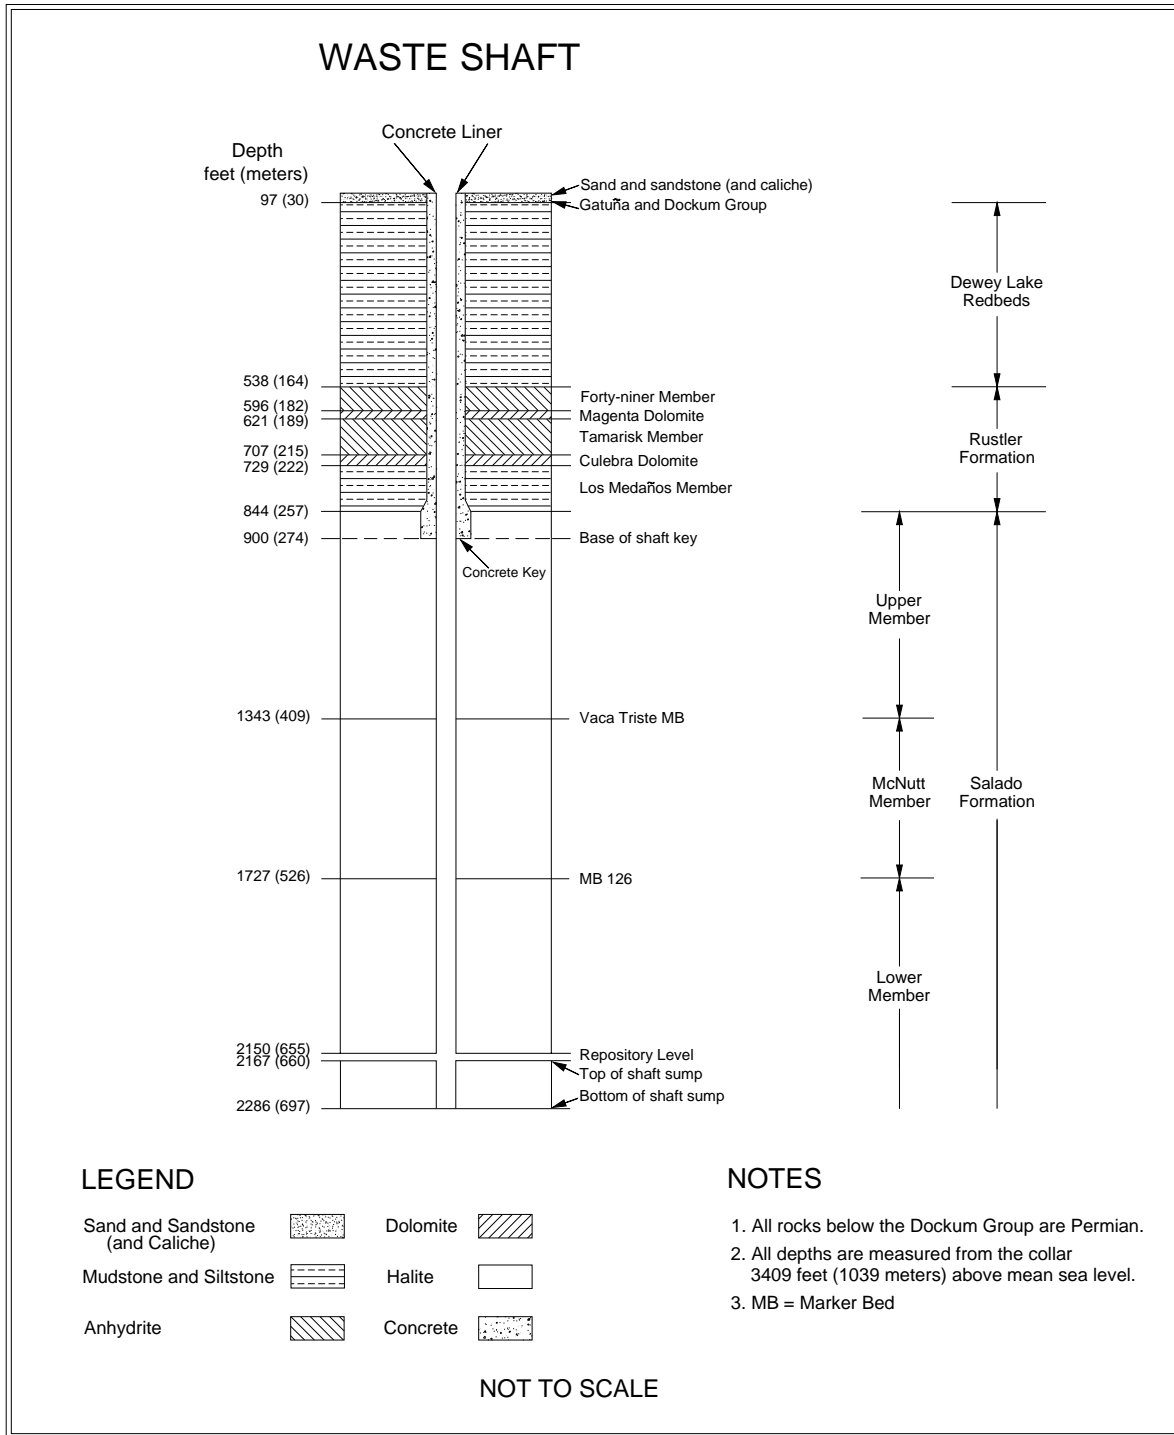
Figure 3 - 4 Waste Shaft Stratigraphy

The Waste Shaft is lined with non-reinforced concrete having a 19 ft (6 m) inside diameter from the surface to the top of the key at 837 ft (255 m). Liner thickness increases from 10 in (25 cm) at the surface to 20 in (51 cm) at the key. The key is 63 ft (19 m) long and 4.25 ft (1.3 m) thick and is constructed of reinforced concrete. The bottom of the key is 900 ft (274 m) below the surface. The diameter of the shaft is 20 ft (6 m) at the bottom of the key and increases to 23 ft (7 m) just above the shaft station. The shaft below the key is lined with wire mesh anchored by rock bolts. The diameter of 23 ft (7 m) extends to a depth of approximately 2,286 ft (697 m), with the shaft sump comprising the lower 119 ft (36 m) of that interval.

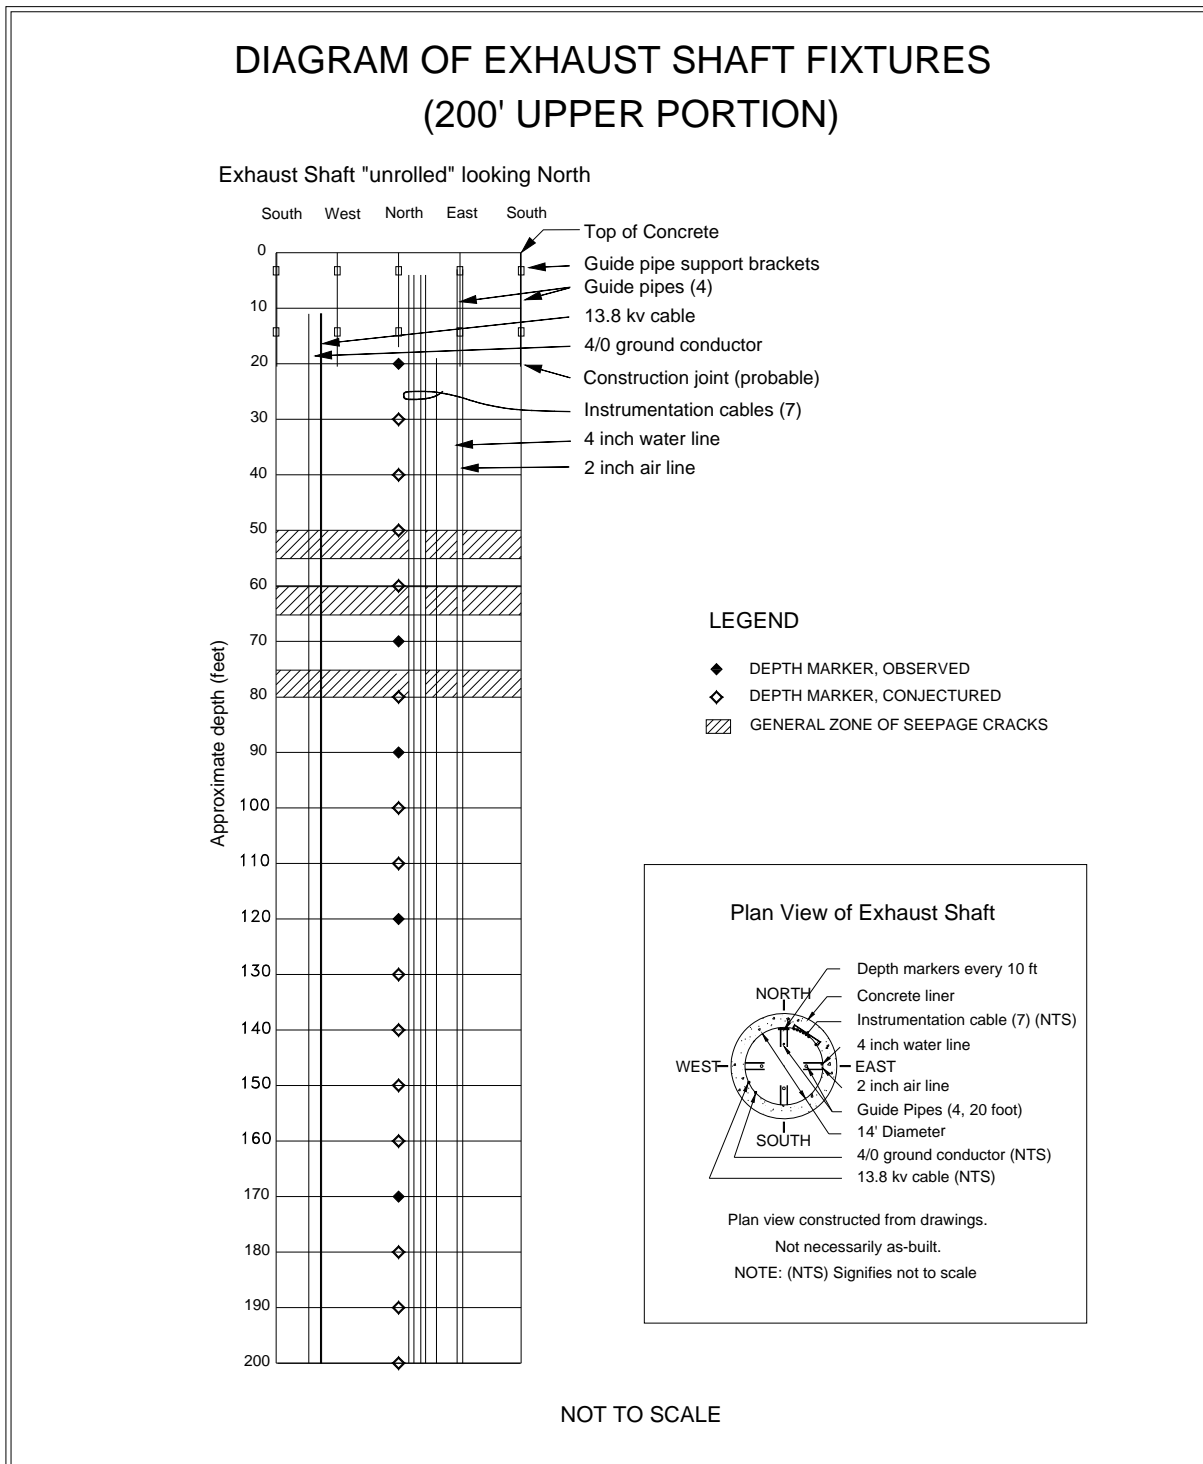
Figure 3 - 9 Diagram of Exhaust Shaft Fixtures and Seepage Zones (Upper 200 ft)

The Exhaust Shaft liner is examined for cracks, seepage, and general shaft stability. Currently, there are three principal zones of seepage in the shaft. The first is about 50 to 55 ft below the shaft collar (bsc). The second is about 60 to 65 ft bsc. The third is about 75 to 80 ft bsc, as shown in Figure 3-9. Monitoring of seepage horizons started before 1995. Water entering the shaft through these cracks is believed to originate from a perched aquifer at the base of the Santa Rosa Formation that is being recharged as the result of surface modifications at the site. The fluid level in the Santa Rosa near the shaft is about 46 to 47 ft below the surface. Based on examination of inspection videos, the flow rate into the shaft during this reporting period is estimated at about 1 to

1 ½ gallons per minute, most of which is carried out of the shaft by the exhaust air. Seepage cracks are confined primarily to the eastern side of the shaft wall.

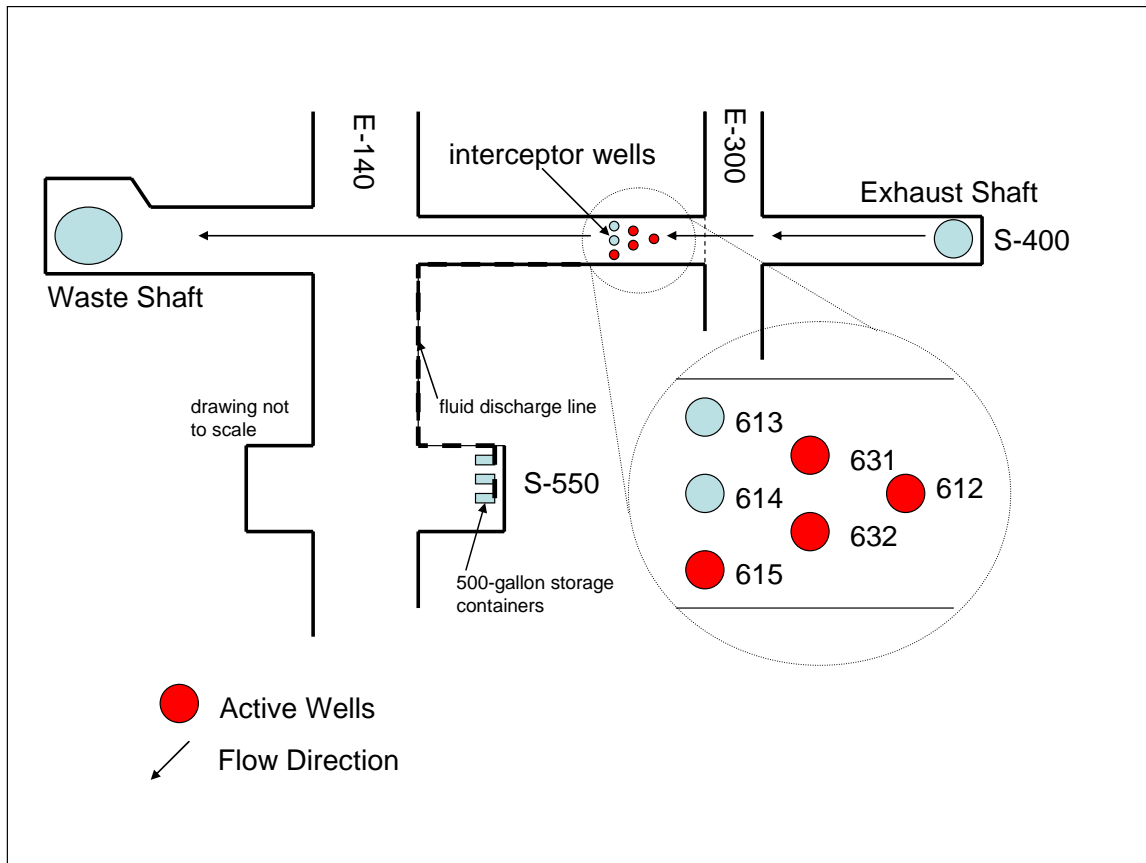
Figure 3 - 1 Location of Interception Wells and Storage Containers

When fluid was detected seeping into the shaft, a catch basin was designed and installed at the base of the Exhaust Shaft to intercept water and prevent it from draining into the Waste Shaft Sump. Fluid was removed from the catch basin from March 1996 through October 2005 as needed. The catch basin was damaged in 2004 by fallen debris, either salt or instrumentation cables or both. A new catch basin was fabricated and installed in December 2004. This basin was damaged in August 2005, most likely the result of fallen debris. An interception well system was installed between November 2005 and March 2006 to replace the catch basin. Interception wells were drilled down gradient in S-400 between E-140 and E 300 (Figure 3-10). The interception well system initially consisted of four 30-ft deep 9-7/8-in diameter fluid collection holes with a submersible pump and pressure transducer in each. Fluid is pumped from each hole to a series of storage containers in S-550. A data-acquisition system monitors the fluid level in each hole, turning the pump on and off between set limits as needed.

Between February 2 and 6, 2008, two additional fluid collection holes, OH631 and OH632, were drilled in S-400 to improve the total volume of fluid recovered by the interception well system. They replaced OH613 and OH614 which generated little fluid. As with the previous four holes, the additional holes were drilled at 9-7/8-inch diameter to a total depth of 30 feet. Pumps were pulled from OH613 and OH614 and installed in OH631 and OH632. Figure 3-10 shows the location of the interception wells system and the 500-gallons storage containers.

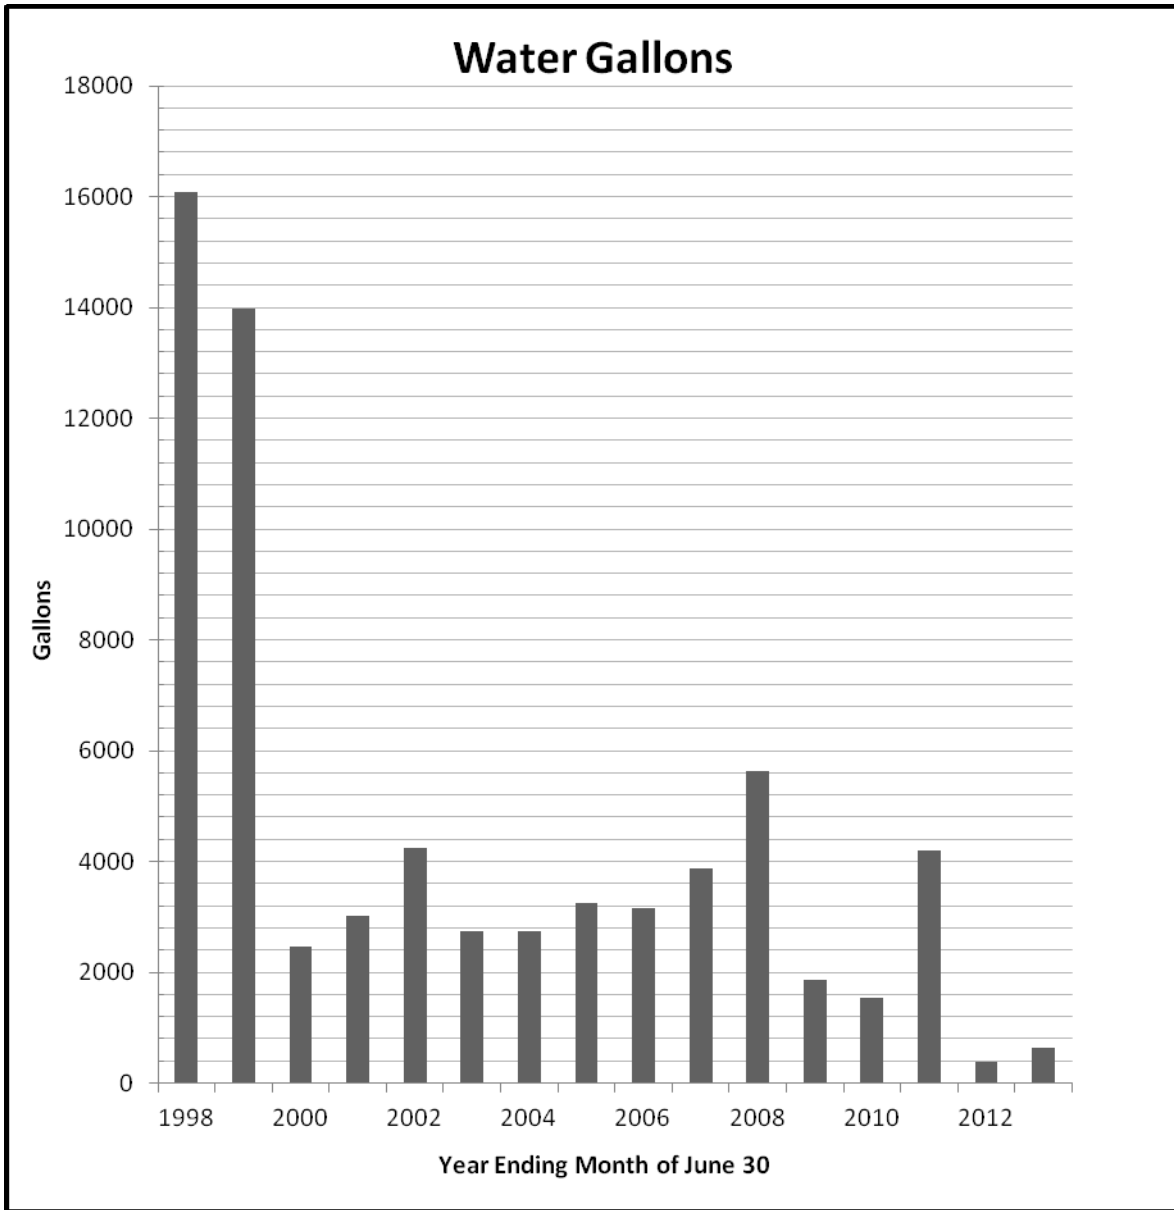
Figure 3 - 11 Water Removed from the Exhaust Shaft Catch Basin and the Interception Well System

Figure 3-11 presents the volume of fluid removed from the catch basin from July 1997 through June 2006, and by the interception well system from July 2006 through June 2013. The largest reported volumes are typically associated with periods of reduced ventilation and increased humidity. For a discussion of the factors affecting the quantity of fluid produced in the Exhaust Shaft, refer to DOE/WIPP-00-2000, *Brine Generation Study*.

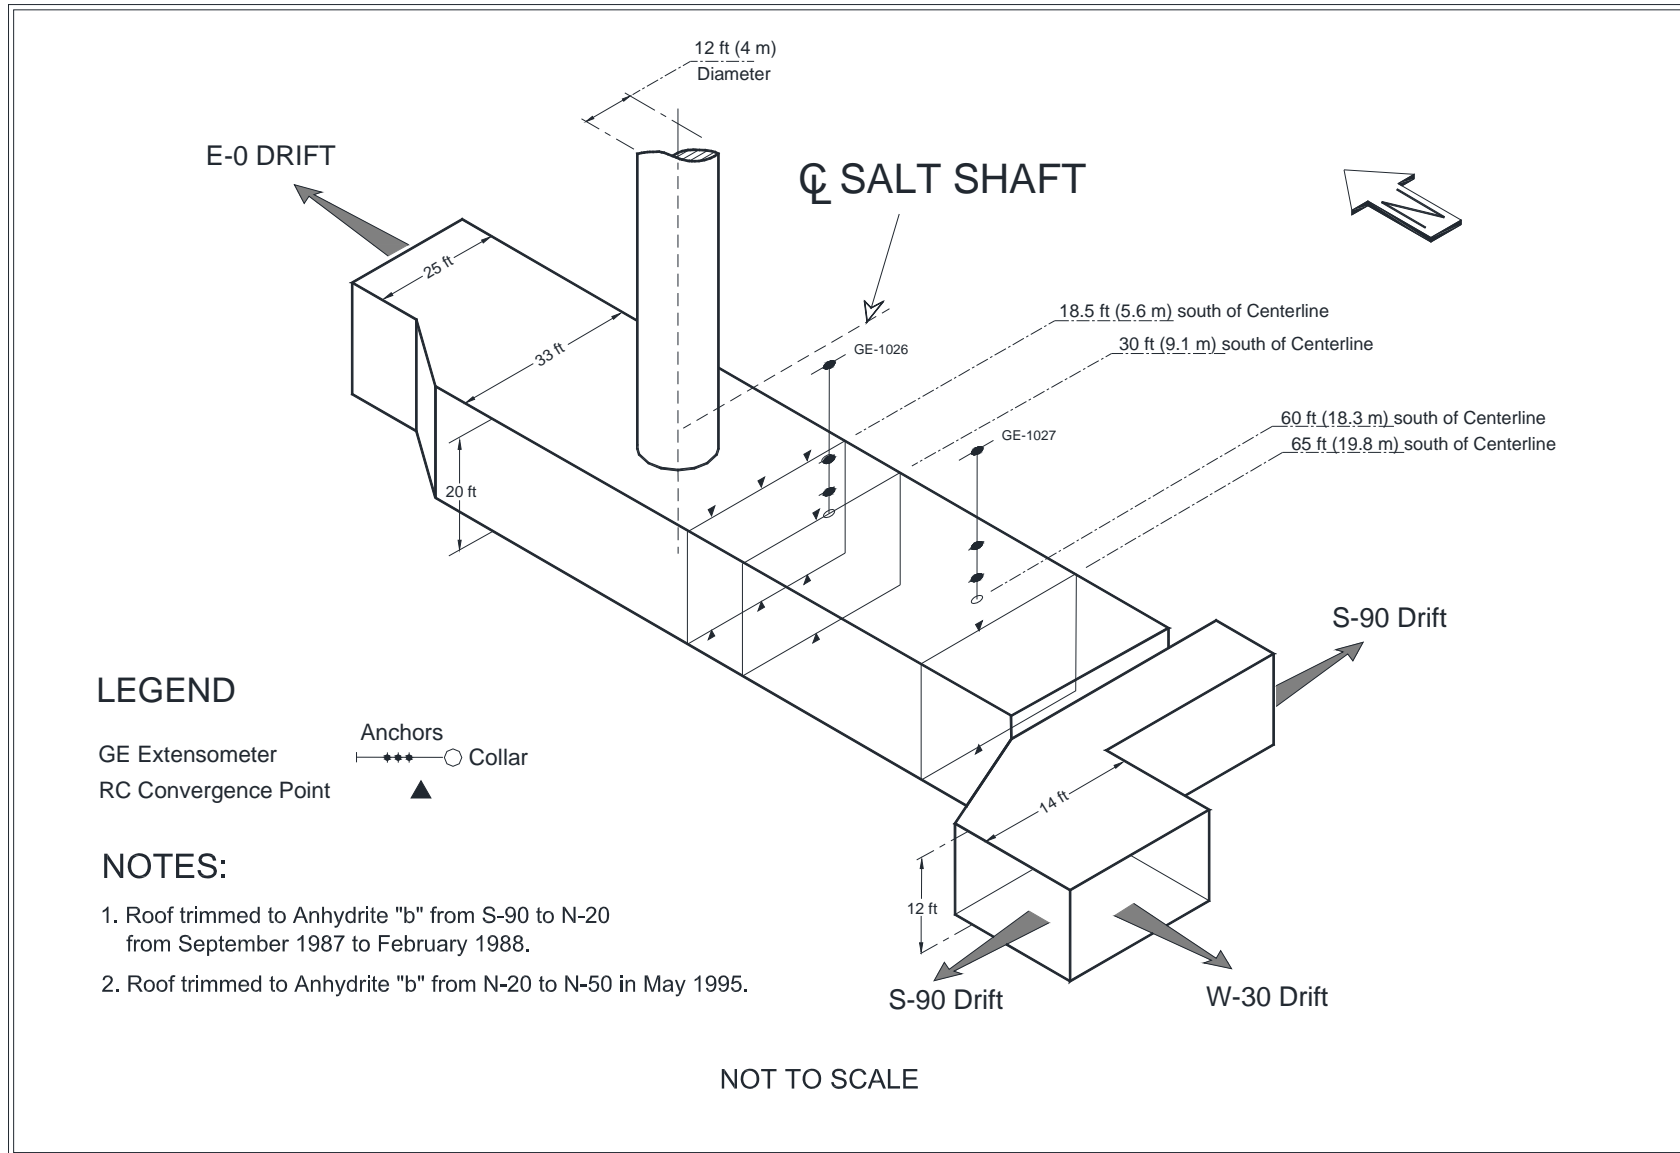
Figure 4 - 2 Salt Shaft Station Instrumentation after Roof Beam Excavation

Table 4-2 summarizes the recent history of the roof extensometers in the Salt Shaft Station. Extensometers 51X-GE-01026-2 (S-30) and 51X-GE-01027-2 (S60) are located in the roof of the station.

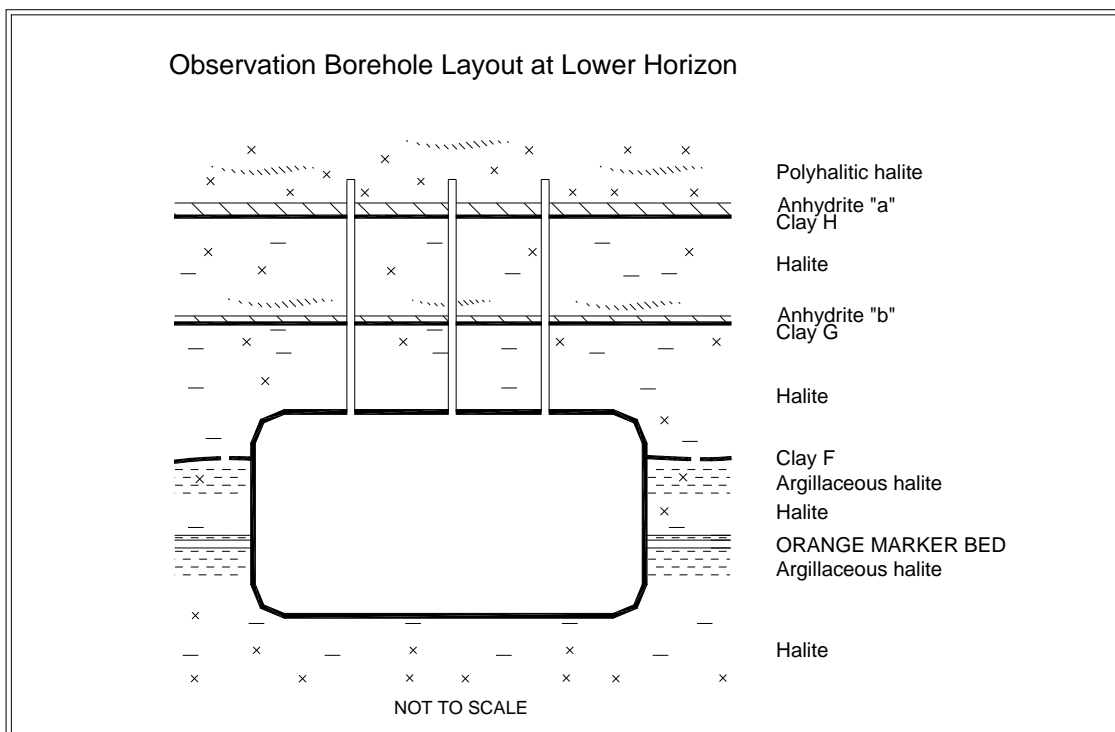
Figure 8 - 1 Example of Observation Hole Layout at Lower Horizon

The offset in an observation hole is determined by visually estimating the degree of occlusion. The direction of offset along clay seams is observed as the movement of the strata nearer to the observer relative to the strata farther away. Typically, the nearer strata move toward the center of the excavation (Figure 8-3 and Figure 8-4). Based on previous observations in the underground, the magnitude of offset is usually greater in holes located near ribs than in those located along excavation centerlines. Offsetting along the clay layers is observable until total offset is reached or visibility is obstructed by intervening offsets at other clay seams or fractures.

Observation holes are inspected for fractures, using an aluminum rod with a flattened steel wire probe attached to one end perpendicular to the rod (referred to as a "scratch rod"). Fractures and clay seams are located by moving the probe along the inside of the hole until it is snagged in one of these features. Depth to each feature is recorded, as is the magnitude of separations encountered. A fiber scope camera is available for use in addition to the scratch rod to visually document features of interest in a hole.

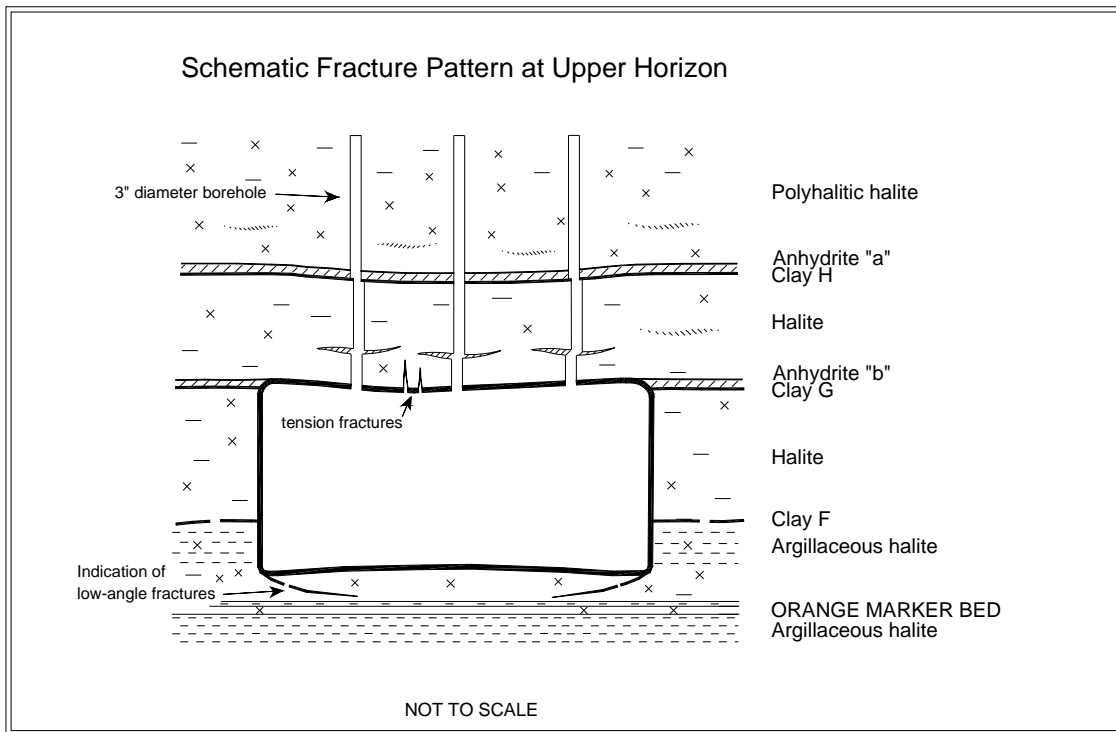
Figure 8 - 4 Typical Fracture Patterns at Upper Horizon

The separation and offset data observed in accessible observation holes in the back are presented in the supporting data document for this report. Nine accessible holes were monitored in Panel 6, forty-seven in Panel 7, and twenty-one in the E140 transport route between S400 and S2750. In Panel 6 and in E140, the greatest separations were associated with Clay H and Anhydrite "a". In addition, eight holes in Panel 6 and ten holes in E140 had separations associated with anhydrite stringers in the lower portion (first three feet) of the roof beam. Nine of nine holes in Panel 6 and thirty-three of the forty-seven holes in Panel 7, and sixteen of twenty-one holes in E140 showed some horizontal offset. In Panel 7, forty of forty-seven holes had separations associated with Clay G and Anhydrite "b".
