DOE/WIPP-16-3559  
Volume 1

# Waste Isolation Pilot Plant

## Geotechnical Analysis Report For July 2014 – June 2015

October 2016

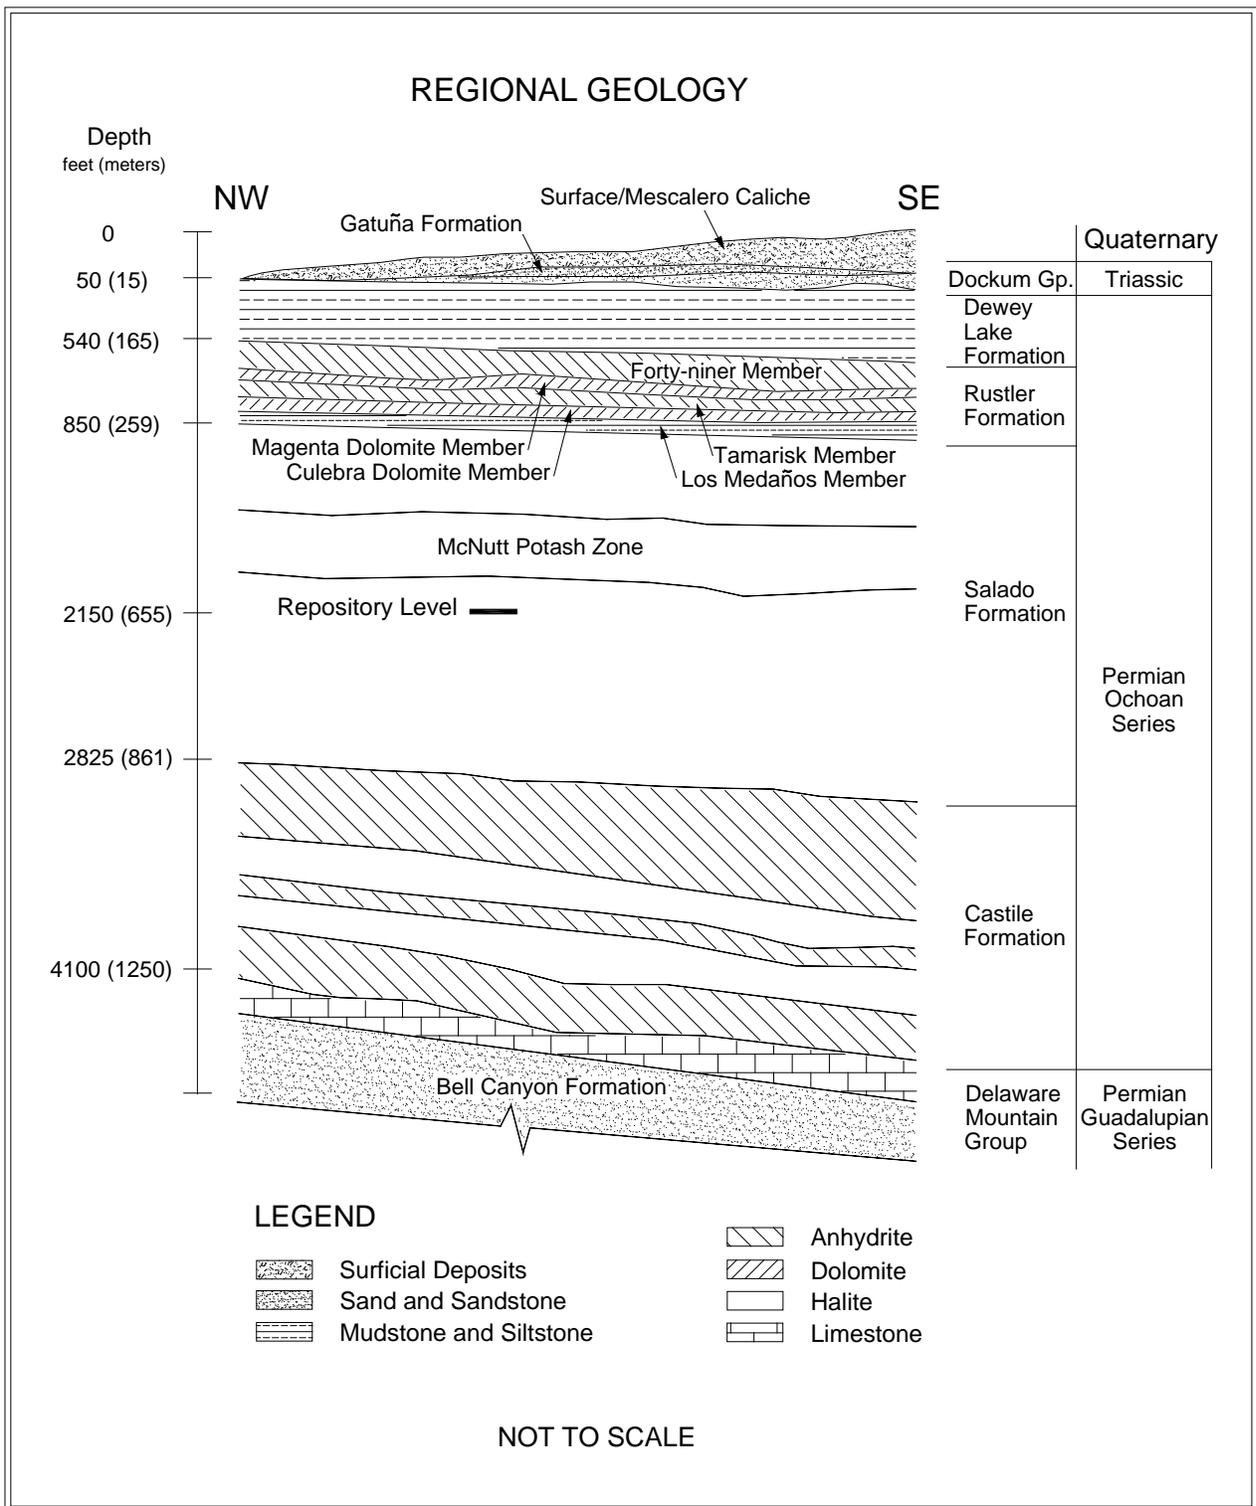
**Figure 2-1 Regional Geology**

The Ochoan Series is of mostly marine origin and consists of four formations: three evaporite formations (the Castile, the Salado, and the Rustler) and one redbeds formation (the Dewey Lake). The Ochoan evaporites overlie marine limestones and sandstones of the Guadalupian Series (Delaware Mountain Group). The younger redbeds represent a transition from the lower evaporite deposition to fluvial deposition on a broad, low-relief, fluvial plain. The Permian rocks are overlain by fluvial deposits of the Triassic and Quaternary periods.

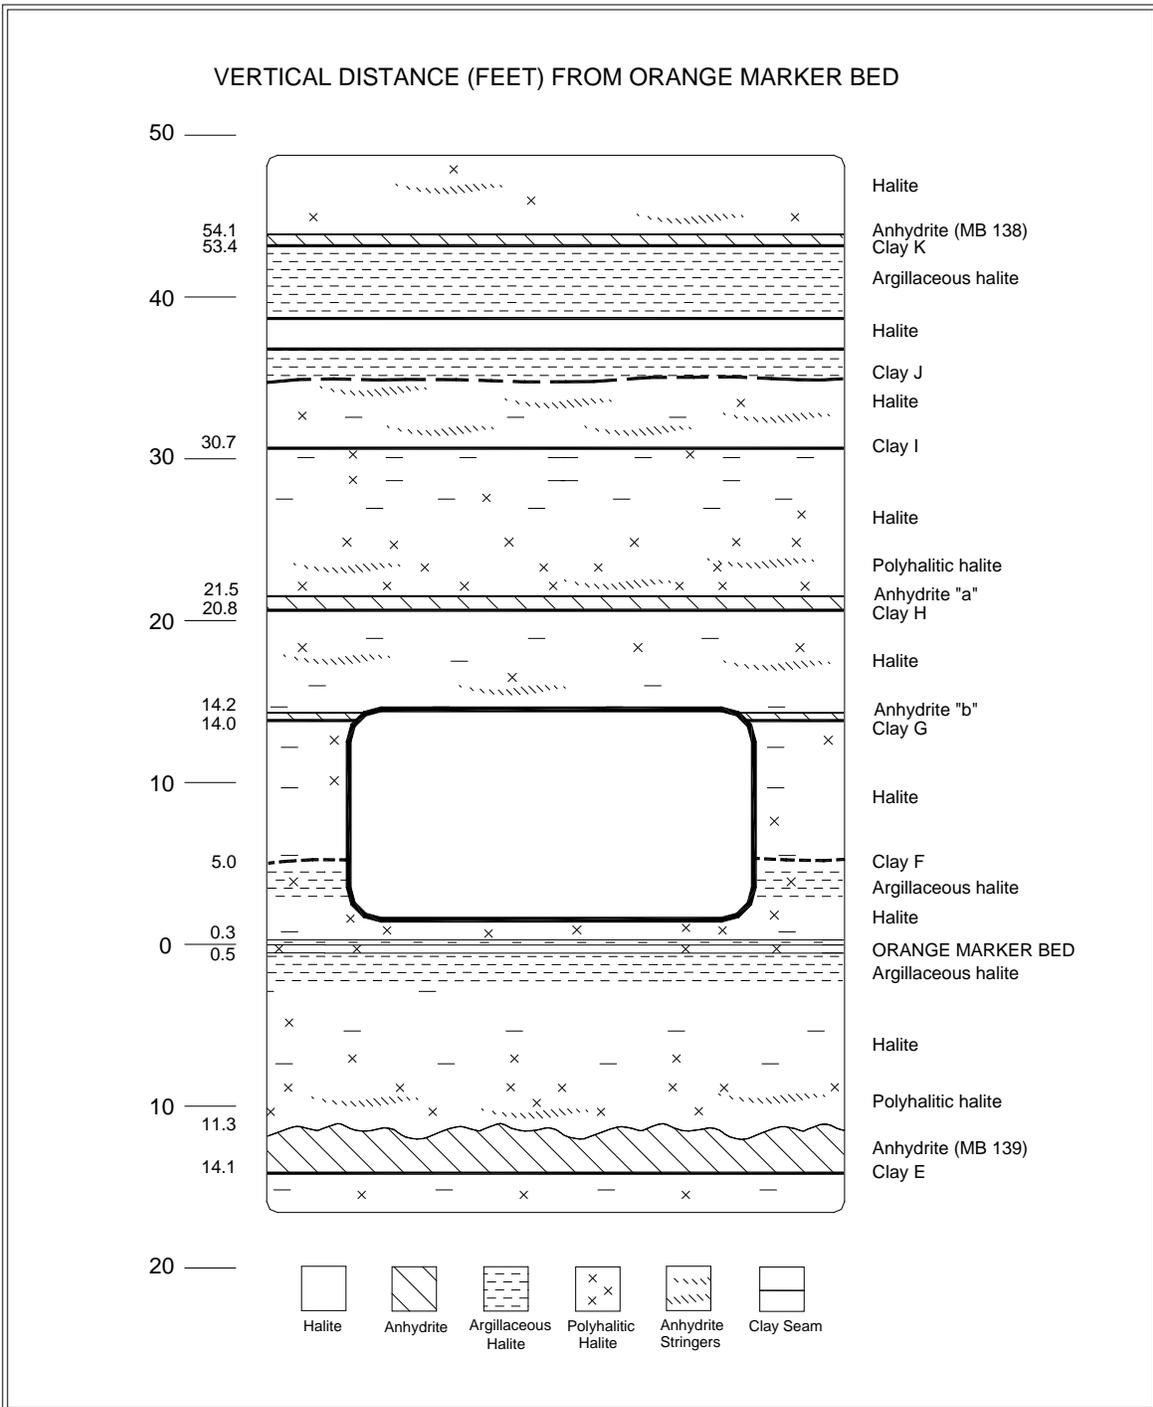
**Figure 2-3 Repository Level Stratigraphy of Panels 3, 4, 5, and 6**

Field observations and computer modeling indicated that moving the disposal horizon stratigraphically upward (so that the roof was located at Clay G) would improve long term ground conditions and provide a more stable roof configuration without significantly impacting repository performance. In 2000, the decision was made to implement this change by moving the mining horizon up approximately six feet. Subsequently, in 2000 and 2001, ramps were mined in the W-170, W-30, E-140, and E 300 drifts between S-2620 and S-2750 (Figure 1-2). As a result, the disposal horizon for Panels 3, 4, 5, and 6, and the associated connecting drifts lies above the horizon for the other panels (Figure 2-3).

In this horizon, the OMB lies at or below the floor. MB139 lies about 12 ft (3.7 m) below the floor. The roof lies at or slightly above Anhydrite "b." Clay G/ Anhydrite "b" is used as the mining reference during excavation of this disposal horizon. Locally continuous anhydrite stringers are found within this that extends to Clay H at Anhydrite "a", generally concentrated in the lower portion toward Anhydrite "b". These effectively divide the roof beam itself into a series of thinner, independent beams thereby weakening the overall beam strength.

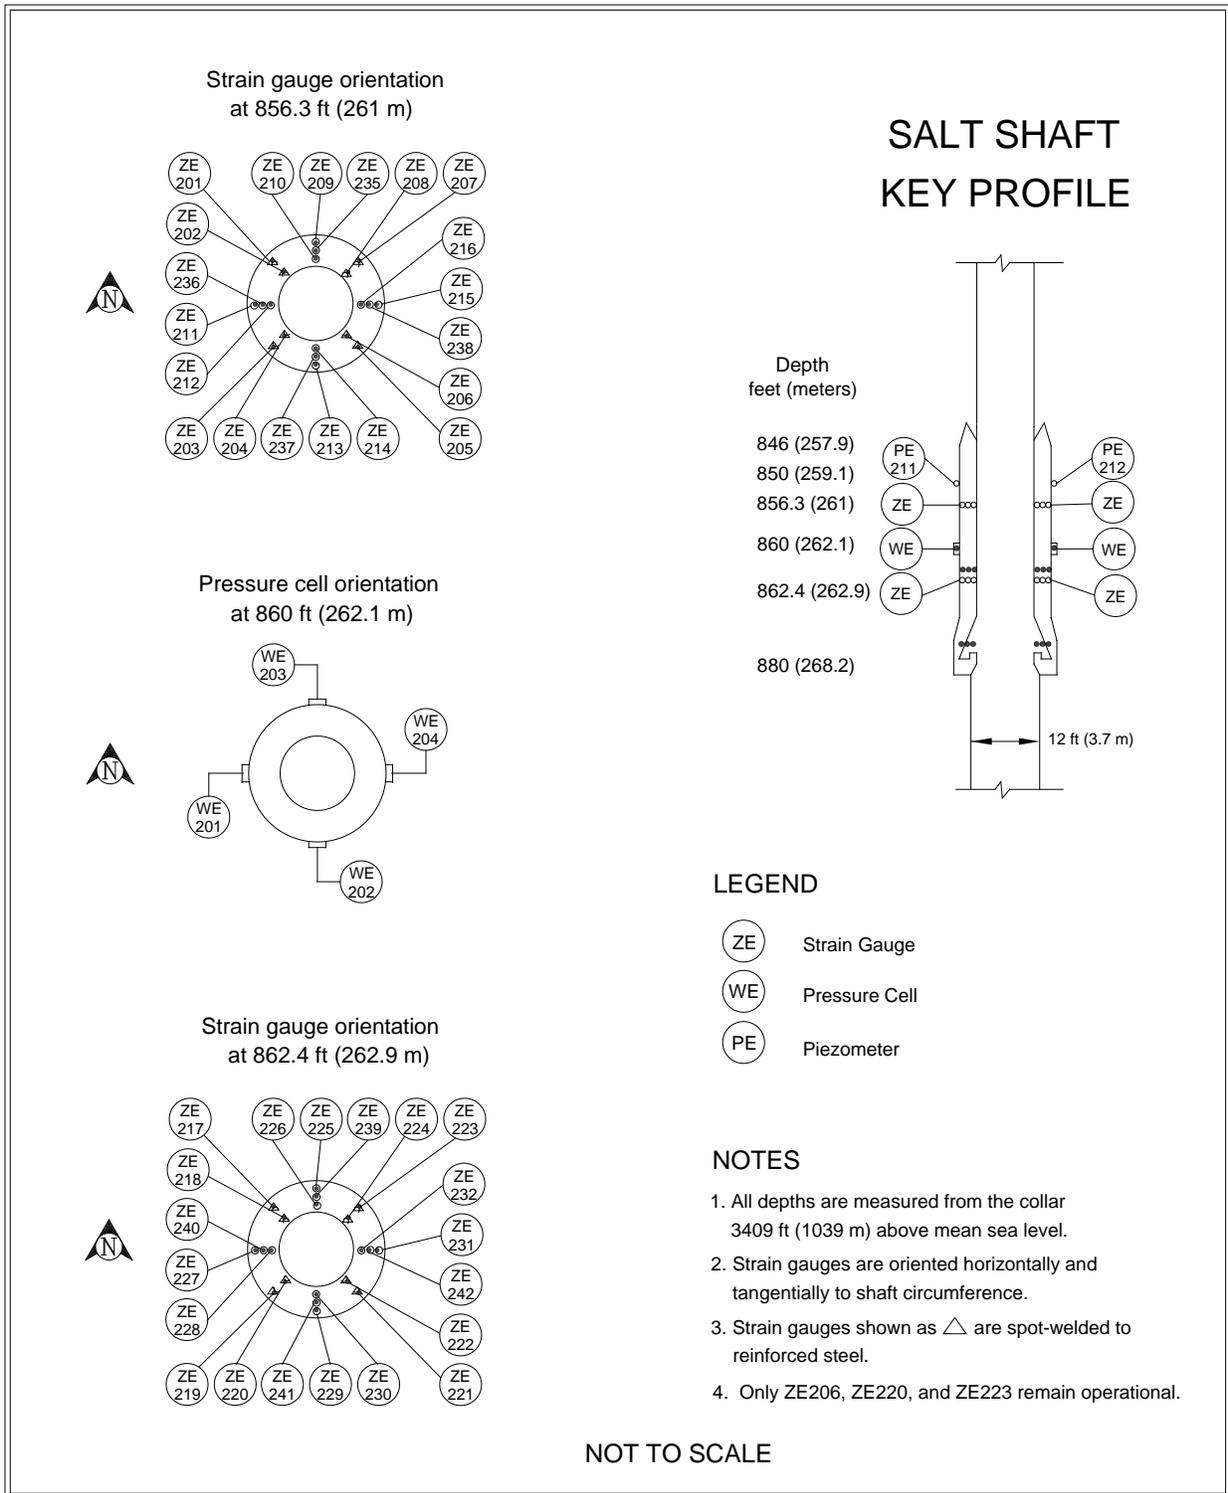
**Figure 3-3 Salt Shaft Key Instrumentation**

Sixteen spot-welded and twenty-four embedment strain gauges were installed on and in the shaft key concrete at both the 856.3-ft (261-m) level and at the 862.4-ft (263-m) level. Three spot-welded strain gauges are still functioning at these levels. Strain at the 856.3-ft (261-m) level recorded a maximum strain of 634 microstrain. Strains at the 862.4 ft (263 m) level were 921 and -1930 microstrain.

Fourteen embedment strain gauges are still functioning. The strains at the 856.3-ft (261-m) level ranged from -595 to 1005 microstrain. The strains from the two embedment strain gauges at the 862.4 ft (263-m) level were 299 to 407 microstrain. The strains recorded by the spot-welded strain gauges and the embedment strain gauges during this reporting period are similar to the strains recorded by these instruments at the end of the previous reporting period.

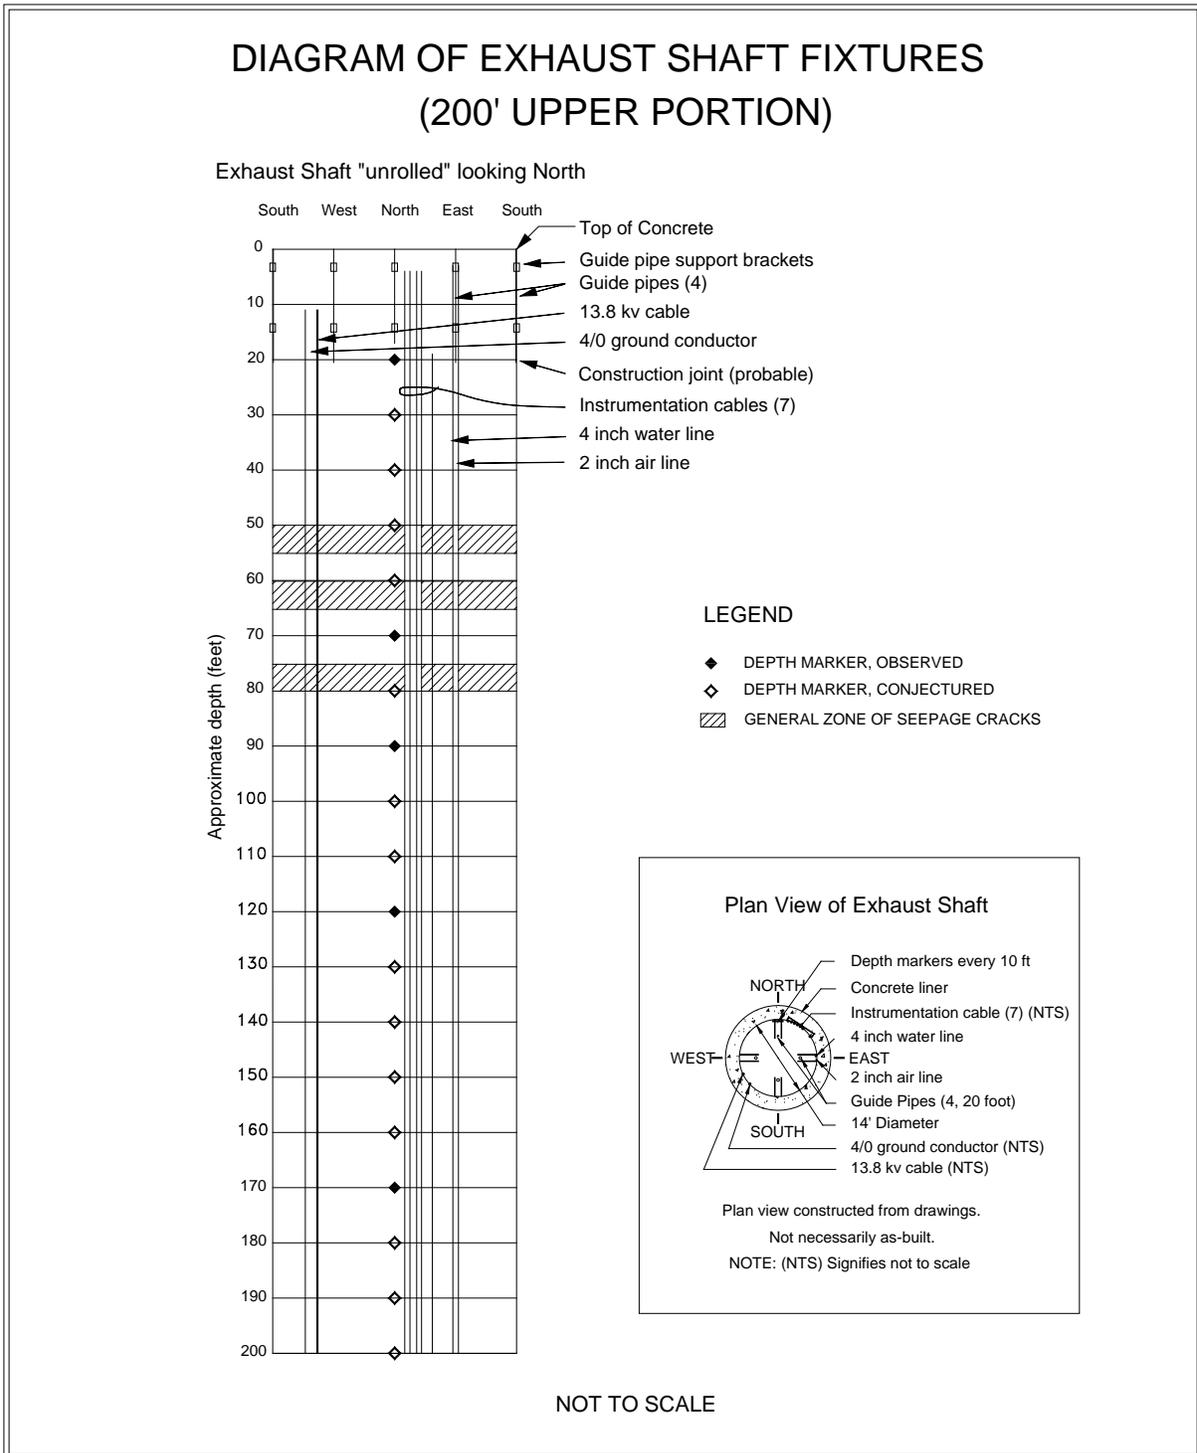
**Figure 3-9 Diagram of Exhaust Shaft Fixtures and Seepage Zones (Upper 200 ft)**

The Exhaust Shaft liner is examined for cracks, seepage, and general shaft stability. Currently, there are three principal zones of seepage in the shaft. The first is about 50 to 55 ft below the shaft collar (bsc). The second is about 60 to 65 ft bsc. The third is about 75 to 80 ft bsc, as shown in Figure 3-9. Monitoring of seepage horizons started before 1995. Water entering the shaft through these cracks is believed to originate from a perched –shallow water-bearing horizon at the base of the Santa Rosa Formation that is being recharged as the result of surface modifications at the site. The fluid level in the Santa Rosa near the shaft is about 48 to 49 ft below the surface. Based on examination of inspection videos, the flow rate into the shaft during this reporting period

is estimated at about 1 to 1 ½ gallons per minute. Seepage cracks are confined primarily to the eastern side of the shaft wall.

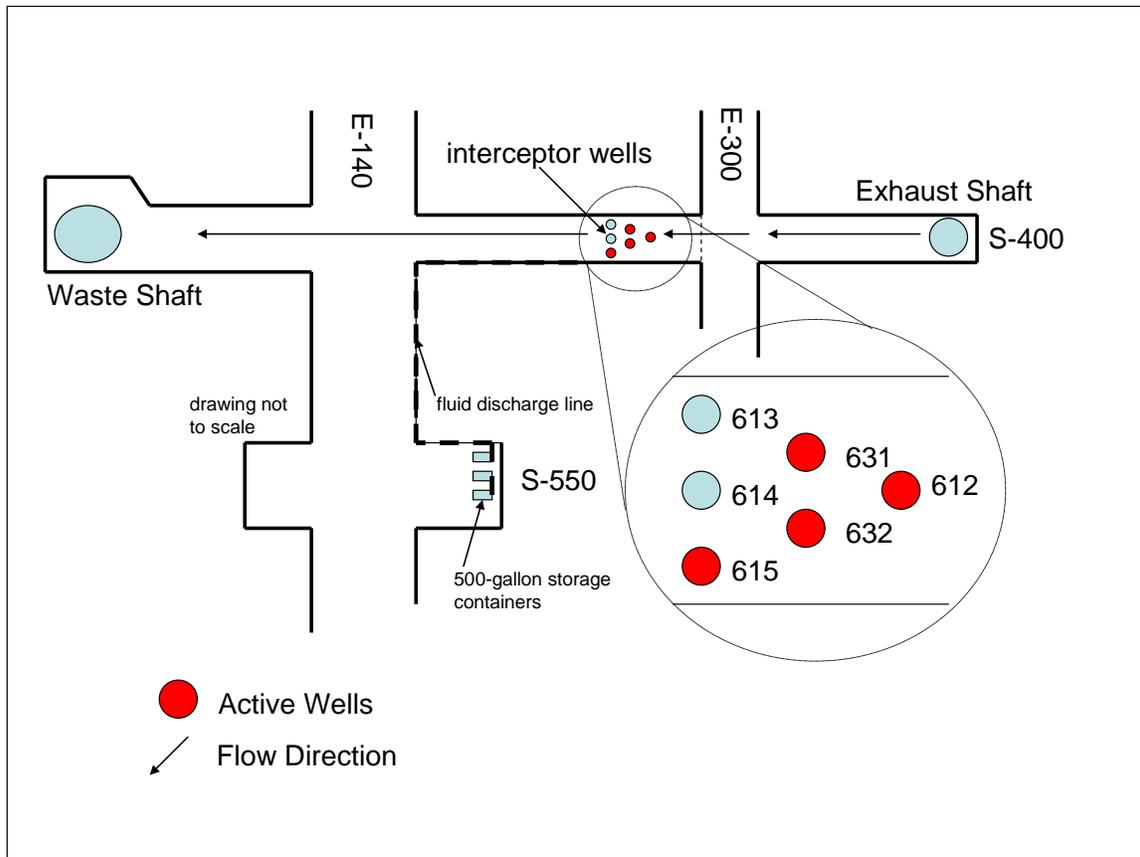
**Figure 3-10 Location of Interception Wells and Storage Containers**

When fluid was detected seeping into the shaft, a catch basin was designed and installed at the base of the Exhaust Shaft to intercept water and prevent it from draining into the Waste Shaft Sump. Fluid was removed from the catch basin from March 1996 through October 2005 as needed. The catch basin was damaged in 2004 by fallen debris, either salt or instrumentation cables or both. A new catch basin was fabricated and installed in December 2004. This basin was damaged in August 2005, most likely the result of fallen debris. An interception well system was installed between November 2005 and March 2006 to replace the catch basin. Interception wells were drilled down gradient in S-400 between E-140 and E 300 (Figure 3-10). The interception well system initially consisted of four 30-ft deep 9-7/8-in diameter fluid collection holes with a submersible pump and pressure transducer in each. Fluid is pumped from each hole to a series of storage containers in S-550. A data-acquisition system monitors the fluid level in each hole, turning the pump on and off between set limits as needed.

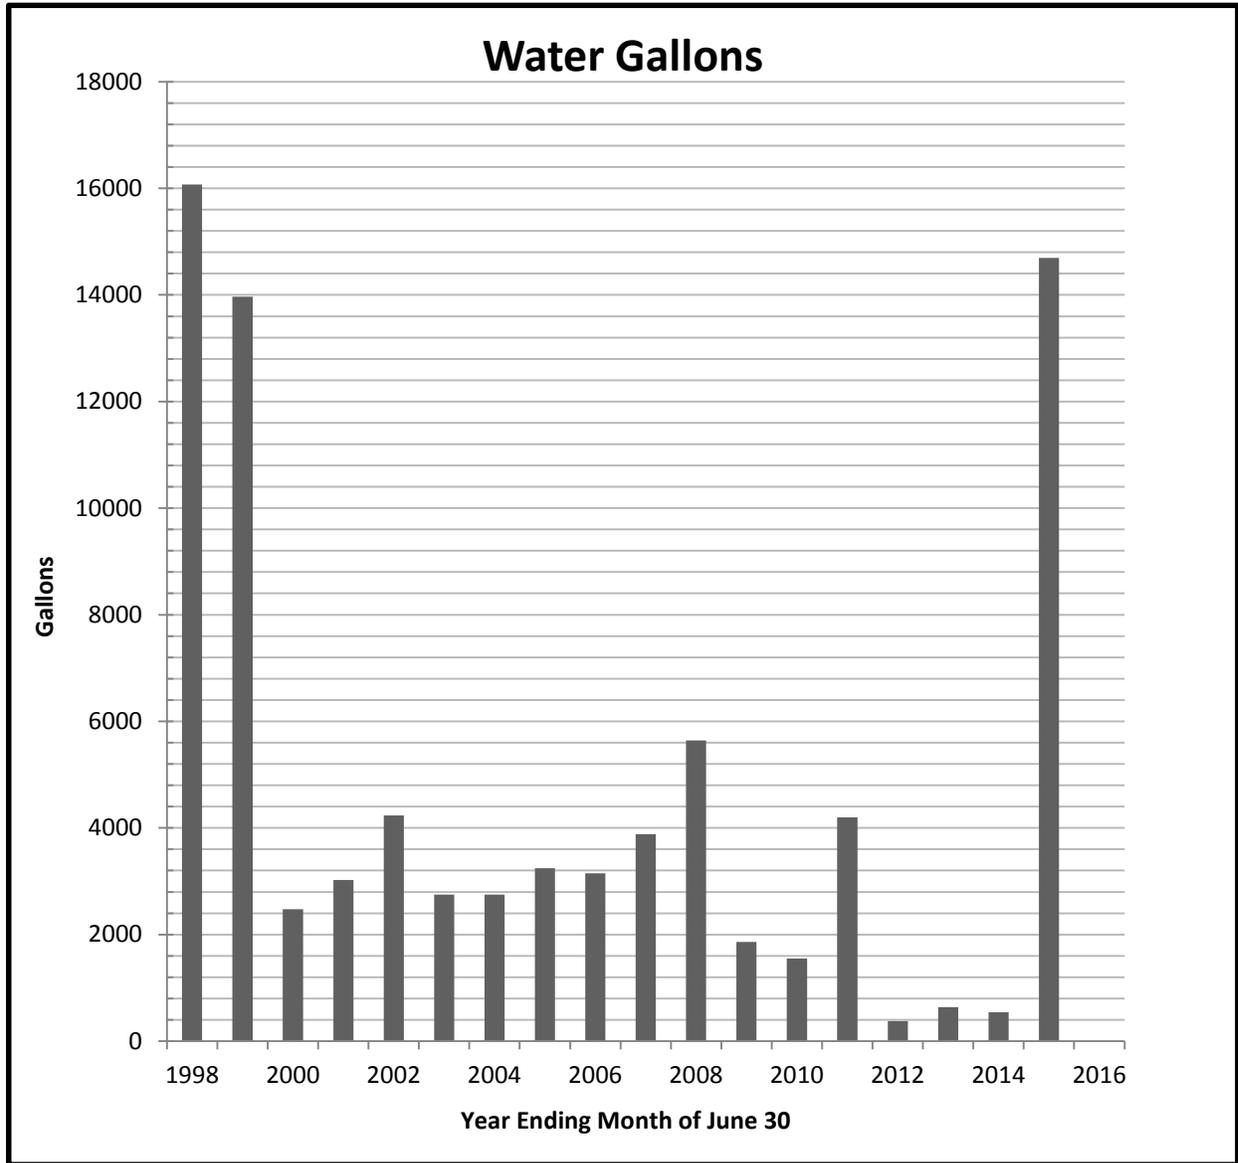
Figure 3-11 Water Removed from the Exhaust Shaft Catch Basin and the Interception Well System

Figure 3-11 presents the volume of fluid removed from the catch basin from July 1997 through June 2006, and by the interception well system from July 2006 through June 2015. The largest reported volumes are typically associated with periods of reduced ventilation and increased humidity. For a discussion of the factors affecting the quantity of fluid produced in the Exhaust Shaft, refer to DOE/WIPP-00-2000, *Brine Generation Study*.

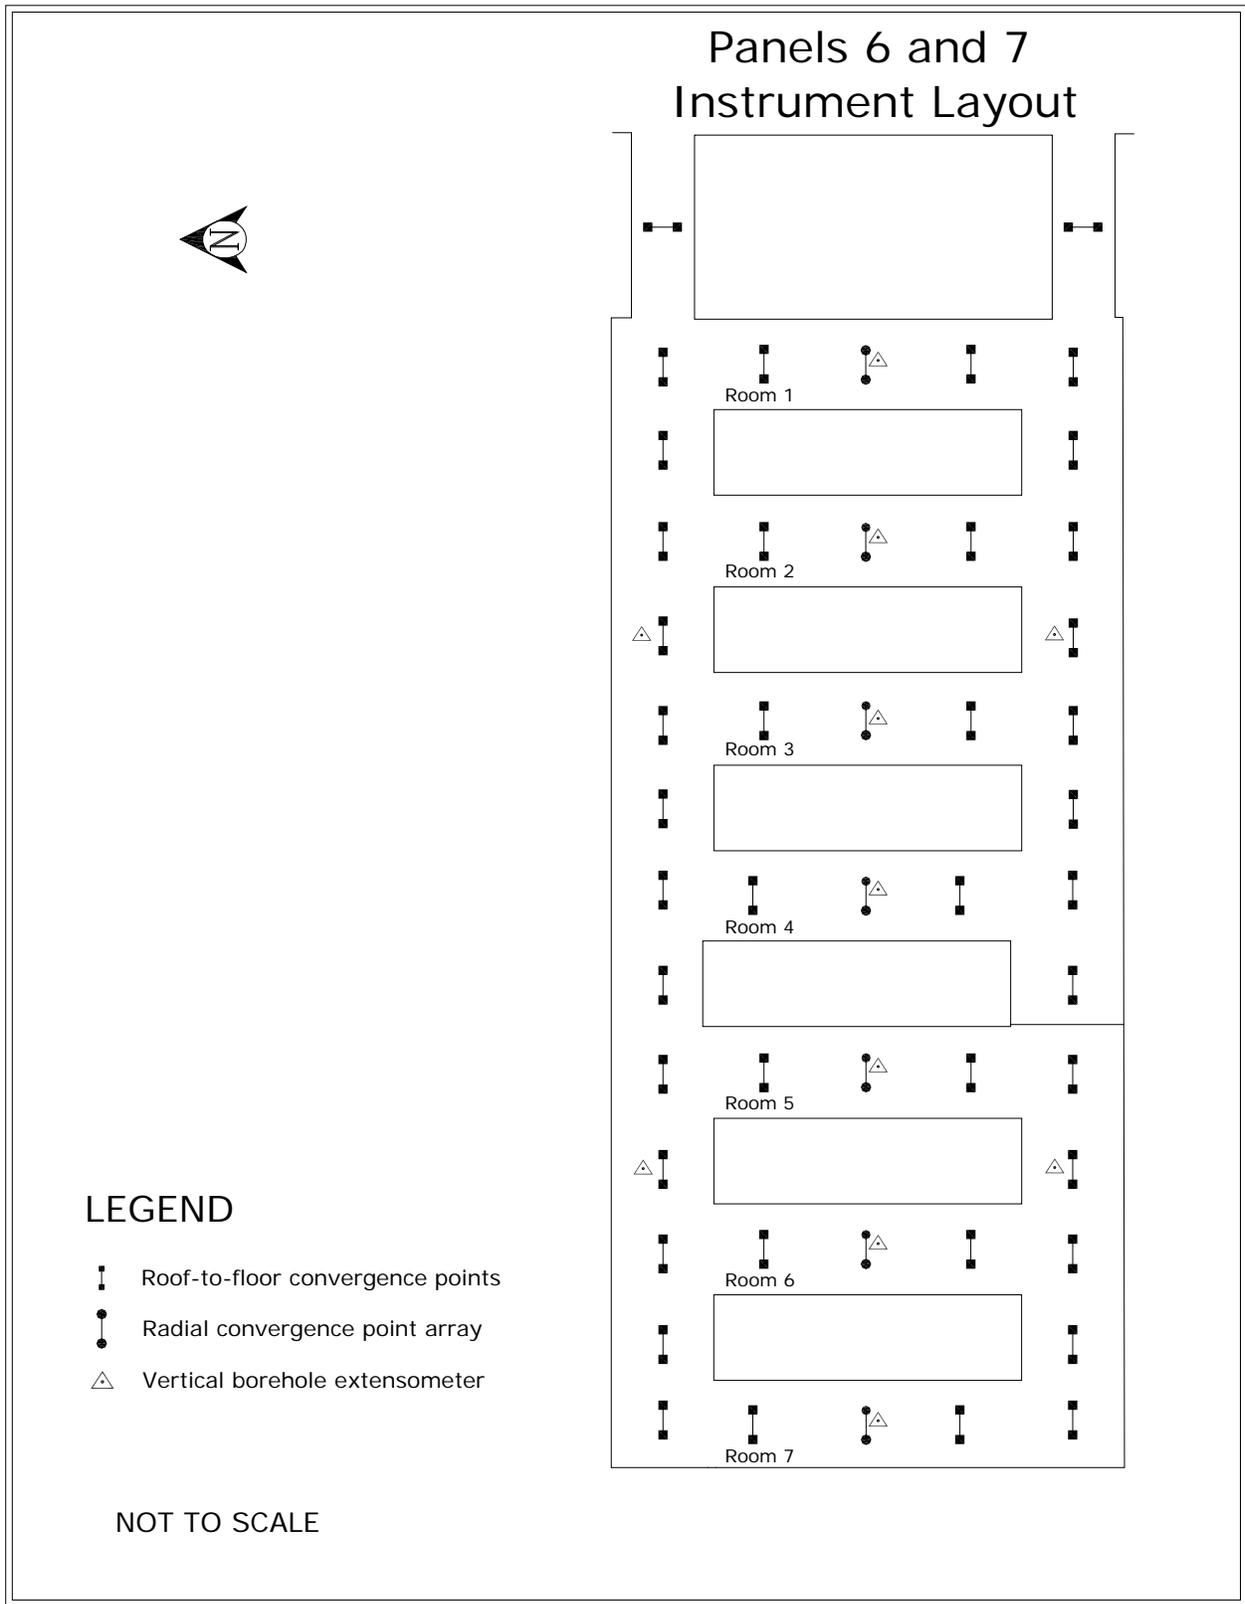
Figure 6-1 Location of Geomechanical Instruments in Panels 6 and 7

Although Panels 1 through 6 are closed, convergence monitoring continues in the panel entries between E-300 and the explosion isolation walls (Panels 1 and 2), and the substantial and isolation barriers (Panels 3 and 4) as well as, between W170 and the explosion isolation wall (Panel 5). As of the end of the reporting period the isolation of Panel 6 had not been completed. Monitoring has been discontinued in the Panel 4 intake drift (S3650) which is closed to access due to elevated volatile organic compound (VOC) levels and at S2750 (Panel 3 exhaust drift) due to ground conditions. Monitoring data indicate generally steady long term trends. Incidences of short term acceleration are largely attributed to creep deformation of the pillars, which results in increasing lateral loading of the roof beam and the growth of separations along anhydrite stringers.
