DOE/WIPP-22-3610
Volume 1

Waste Isolation Pilot Plant

Geotechnical Analysis Report for July 2020 – June 2021

U.S. Department of Energy
Carlsbad Field Office

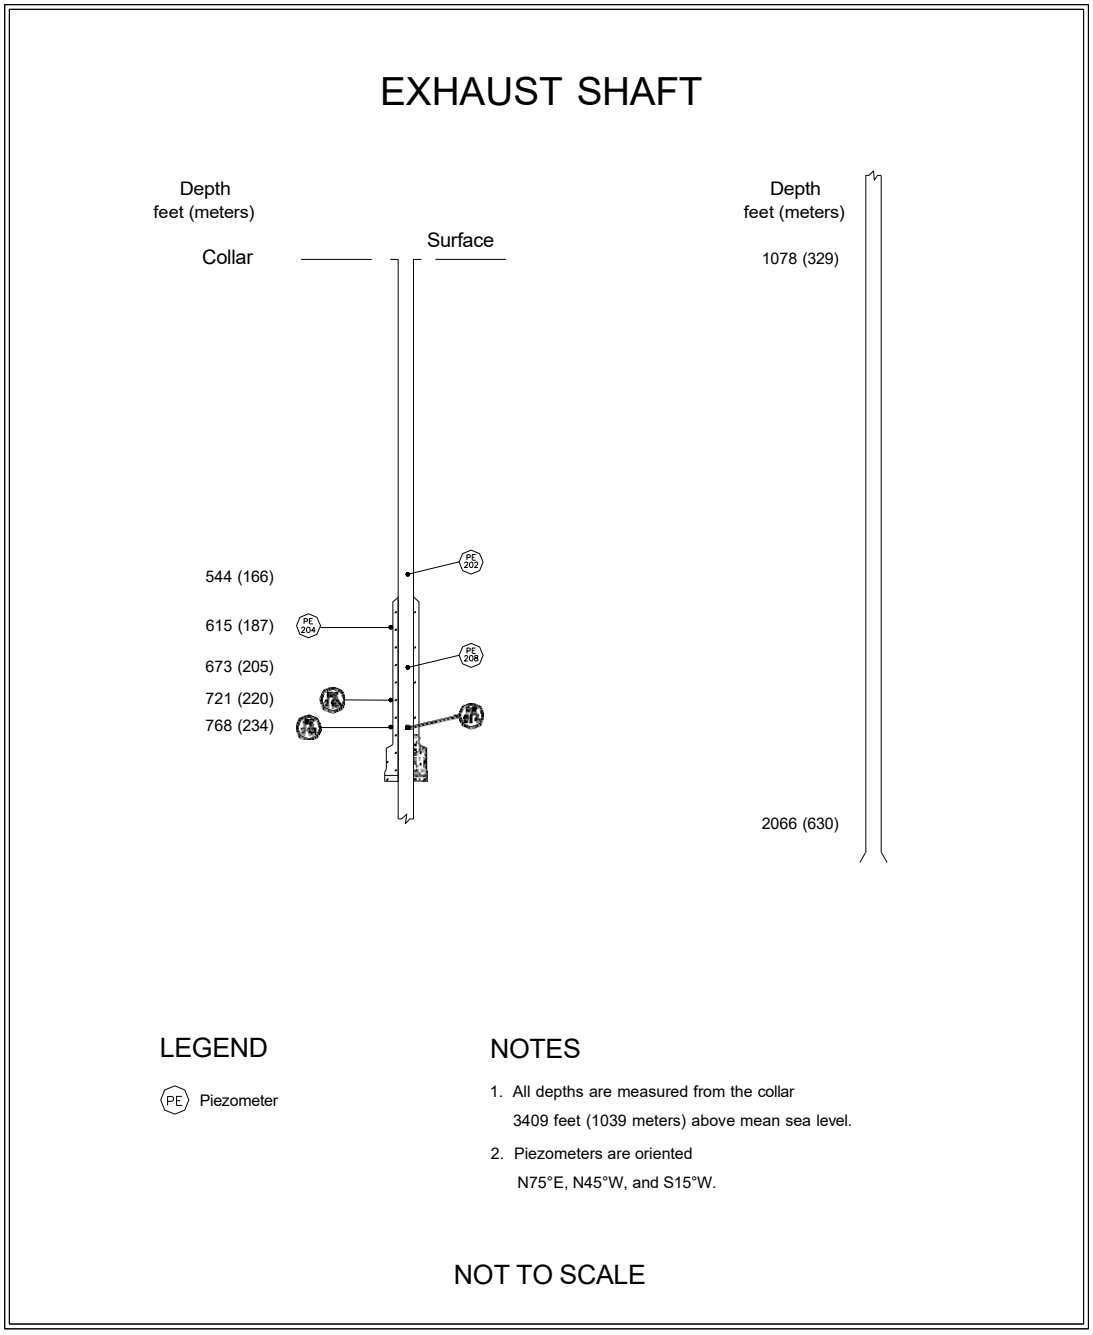
Figure 3-11 Exhaust Shaft Instrumentation

The Exhaust Shaft was equipped with geomechanical instrumentation in two stages. Earth pressure cells were installed behind the liner key in November 1984. Piezometers and nine multi-position extensometers were installed during November and December 1985. Figure 3-11 and Figure 3-12 show the instrument locations. None of these instruments currently provide data. Due to inaccessibility to the inside of the shaft, the failed instrumentation and associated cabling cannot be replaced.
