2022 – Emplacement Inspection Report

INSPECTION OF THE
WASTE ISOLATION PILOT PLANT
May 24–26, 2022

U. S. ENVIRONMENTAL PROTECTION AGENCY
Office of Radiation and Indoor Air
Center for Waste Management and Regulations
1200 Pennsylvania Avenue, NW
Washington, D.C. 20460

November 2022

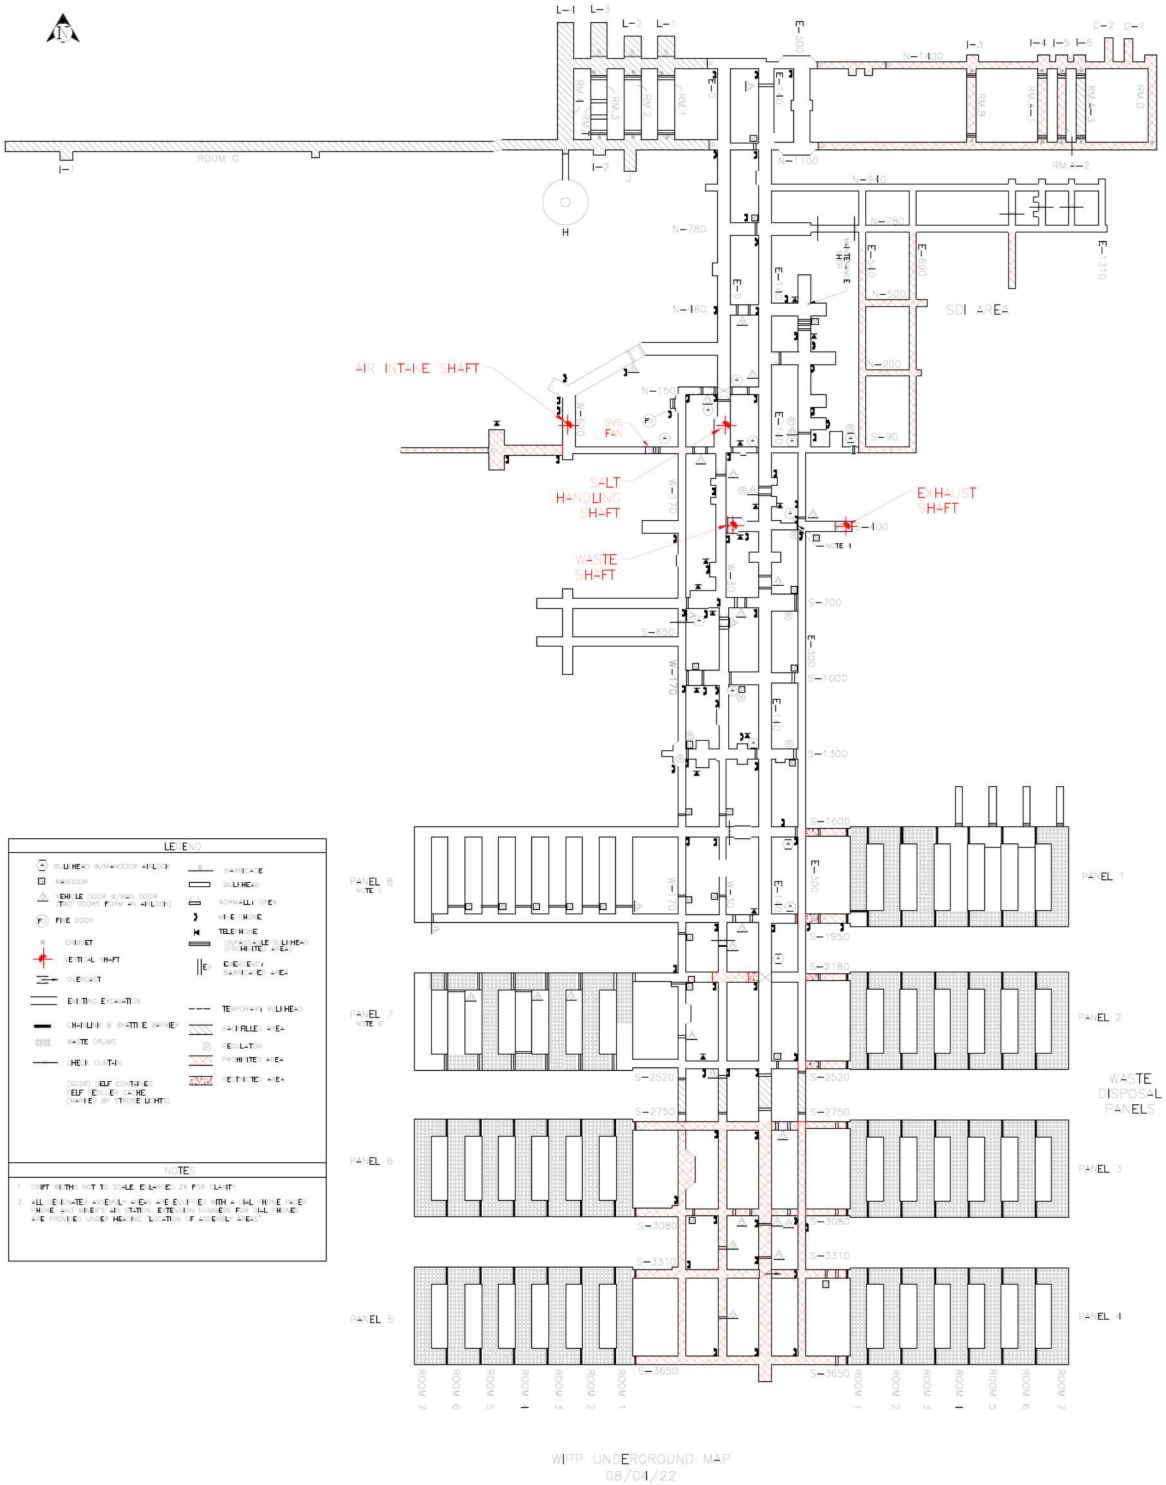
Figure 4. Underground emplacement map with selected waste dated May 18, 2022.
DOE-provided scan of paper copy.
