Jal Sinkhole in Southeastern New Mexico: Evaporite Dissolution, Drill Holes, and the Potential for Sinkhole Development

Dennis W. Powers
Consulting Geologist
Anthony, Texas

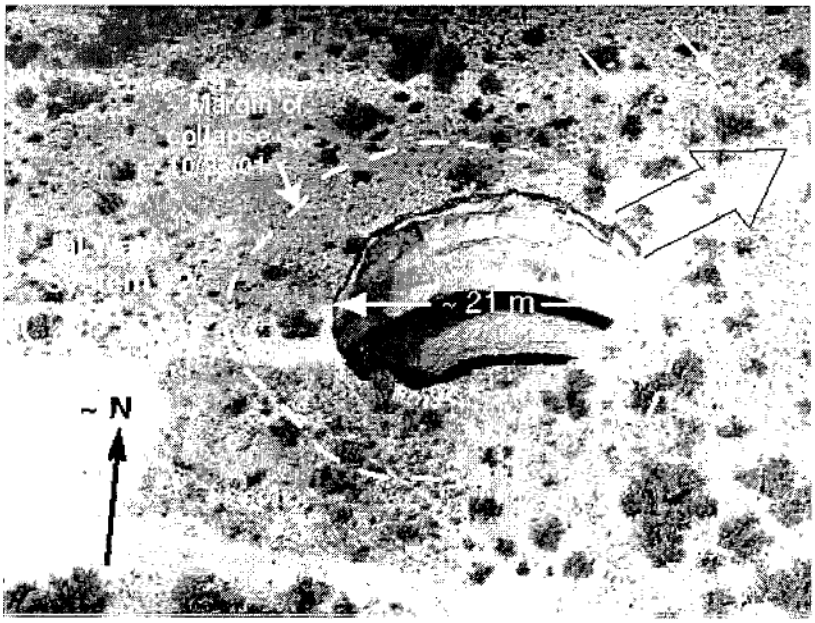
Figure 2. Low-angle aerial photograph of the Jal sinkhole, taken to the north. Small arrows show the location of some larger clasts of Ogallala caliche blown northeast (outline arrow) by the collapsing material. The drill pipe for the No. 2 Jal Water System well is circled. The dashed white line approximates the size and position of the surface collapse in October 2001 (see Fig. 4). Photo taken September 15, 1998, by D. W. Powers.

formed, but circumstantial evidence clearly indicates that at least part of it formed in seconds. Clasts of Ogallala Formation caliche are distributed along a lane northeast from the sinkhole, with some large clasts (about 3 ft [1 m] across) near the sinkhole (Figs. 2, 4) and clast sizes decreasing away from the hole. The aerial photograph also shows a lighter shading from caliche dust coating the surface of the light reddish brown sand. I suggest that the northeastern part of the sinkhole subsided first, whether by seconds or days, and that most or all of the southwestern part of the sinkhole then collapsed. As it collapsed into a void, it initially trapped and compressed air, which then released through a partially choked throat and blew Ogallala clasts from the collapsing mass and possibly from the northeastern lip of the sinkhole. The significance is that at least part of the sinkhole formed very quickly.

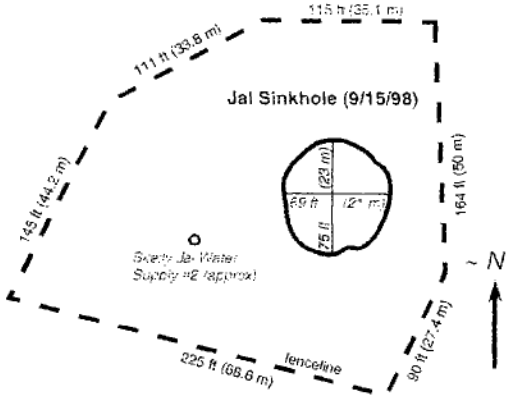
Some media reports of the sinkhole give dimensions of 170 ft (52 m) in diameter and 185 ft (56 m) in depth. I used dimensions provided for a fence placed at a distance around the sinkhole to estimate sinkhole diameter from low-angle aerial photographs that I took on September 15, 1998 (Fig. 3). The diameter appears to be ~75 ft (23 m) across. A similar low-angle aerial photograph (Fig. 4) taken October 23, 2001, shows that the surface diameter is about 50% larger. The approximate surface area in 2001 has been marked in Figure 2 (dashed white line) to show the difference. The collapse area appears to be offset somewhat to the west of the original sinkhole, closer to the No. 2 Jal Water System well.

Figure 3. Fence dimensions used to estimate the diameter of the original Jal sinkhole from low-angle aerial photographs. These dimensions are smaller than some other early estimates.

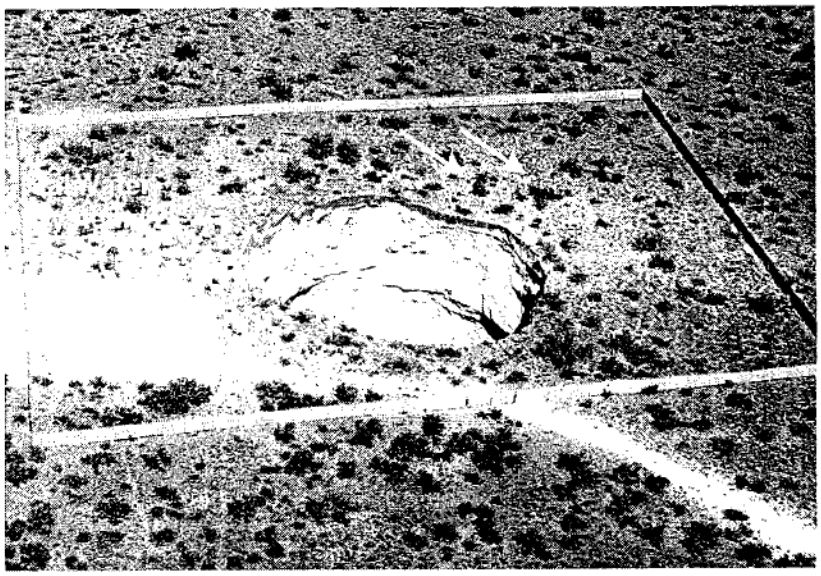
Figure 4. Low-angle aerial photograph of the Jal sinkhole, taken to the north, showing enlargement of the surface sinkhole with time. The approximate size and position are outlined on Figure 2 with a white dashed line. Arrows point to Ogallala caliche clasts, also shown in Figure 2. Photo taken October 23, 2001, by D. W. Powers.

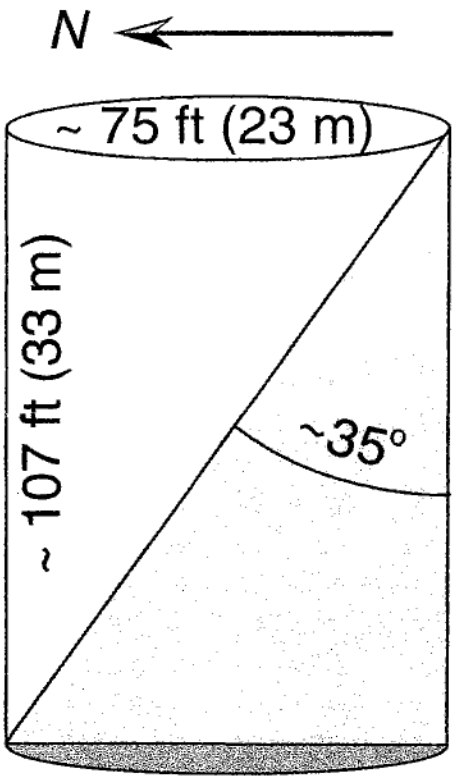
High-angle aerial photographs I took in September 1998 allow an estimate of the depth (Fig. 5). The sun angle on September 15 is about 35° from vertical in this area around 1 p.m. (MDT) when the photograph was taken. As the shadow just covered the bottom, the depth can be estimated at ~107 ft (33 m). The sinkhole is reasonably cylindrical, permitting an estimate of the volume as ~4.7×10^5 ft^3 (1.4×10^4 m^3). By October 2001, debris in the sinkhole from collapse of the sides had filled the sinkhole to a depth estimated to be ~60 ft (18 m).

Figure 5. High-angle aerial photograph (Fig. 2) taken about 1 p.m. on September 15, 1998, showed shadow projecting to about the depth of fill on the north side of the Jal sinkhole, as shown in this diagram. Based on the sun angle and estimate of diameter, the depth to fill is estimated at ~107 ft (33 m).

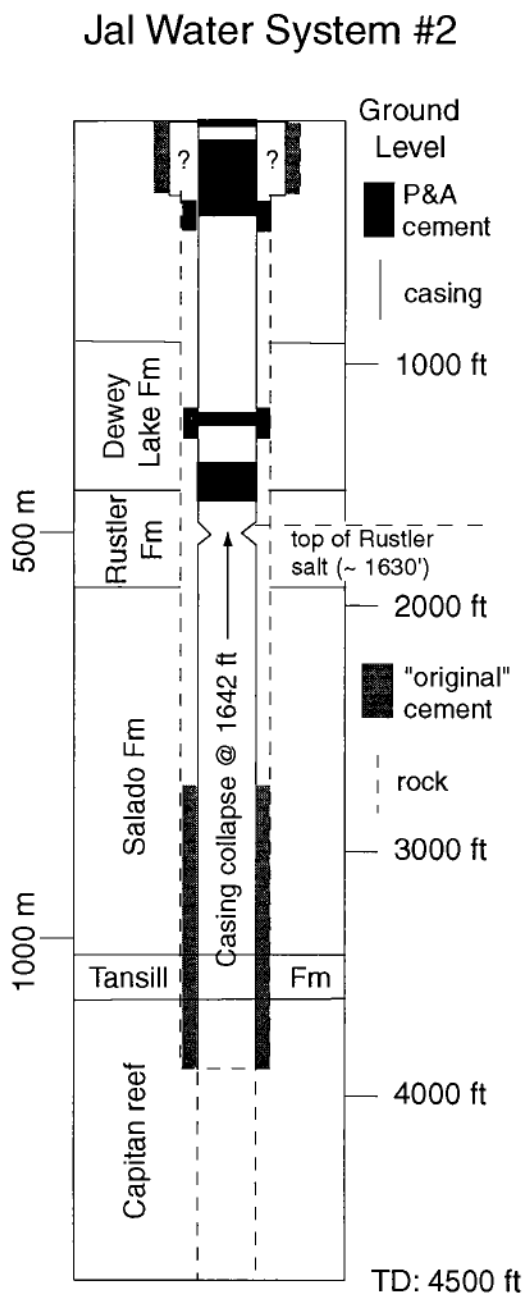
well was spudded October 3, 1967. A string of 13.375-in. (34-cm) casing was set to 353-ft (108-m) depth and cemented, with circulation back to the surface (Fig. 6). The well was then drilled to a depth of 3,890 ft (1,186 m). New casing was set and cemented with 300 sacks of cement; a temperature survey indicated the top of cement at 2,772-ft (845-m) depth. The well was drilled to 4,500 ft (1,372 m) and left as an open hole from 3,890 ft (1,186 m) to total depth.

In 1979, work in the No. 2 well showed that the casing had collapsed at 1,642 ft (501 m). The P&A worksheet shows a cement plug from 1,550 to 1,418 ft (473–432 m), two perforations at 1,250 ft (381 m) with cement displaced below a packer at 1,140 ft (348 m), two perforations at 400 ft (122 m) with cement from 414 to 72 ft (126–22 m), and a surface plug from 0 to 10 ft (0–3 m).

From the original drilling, I estimate that ~300 ft (91 m) of the upper Salado remained open behind the casing, as did all of the Rustler and most of the Triassic clastics. After P&A work, the plugs in the casing are from about the top of the Rustler and above. The lower perforated and cemented zone is at about the middle of the Dewey Lake. The upper perforated zone is estimated to be in the upper Dockum. The plugs apparently do nothing to prevent circulation through the production casing into the Rustler, and possibly Salado, through the collapsed casing.

Figure 6. General stratigraphy and casing and cementing record for the Skelly No. 2 Jal Water System well, drilled adjacent to the Jal sinkhole.

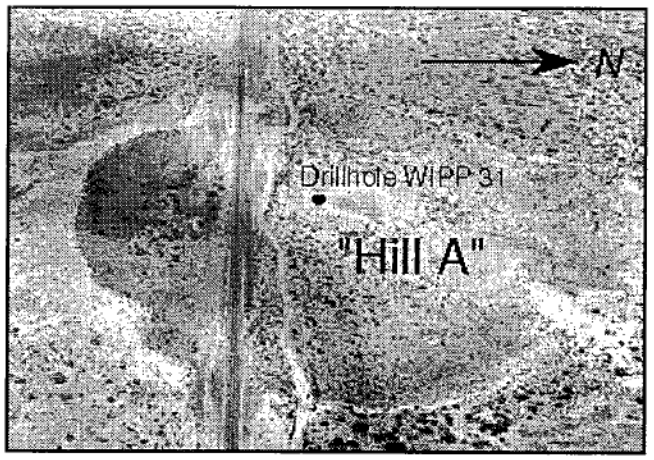
Figure 7. High-angle aerial photograph of the surface-collapsed dome structure of "Hill A," one of the breccia pipes over the Capitan Reef in the northern end of the Delaware Basin. Bachman (1980) and Snyder and Gard (1982) showed the relationship with the Capitan and showed that the doming was caused by lowering of the surrounding area by dissolution of upper Salado salt after collapse. Photo taken September 15, 1998, by D. W. Powers.

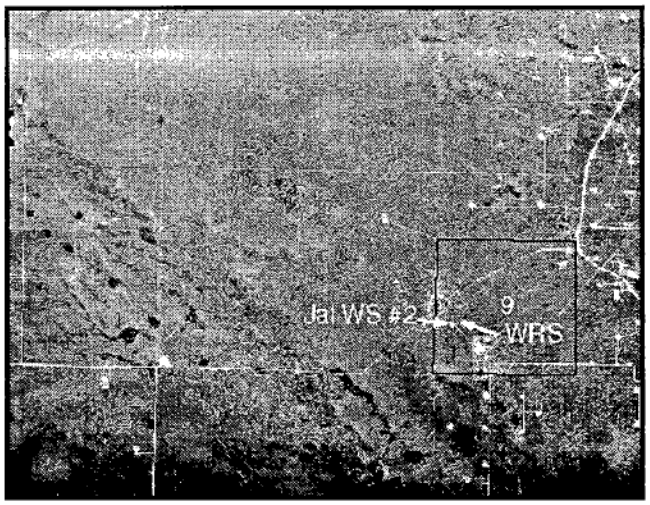
Near the Jal sinkhole, high-altitude aerial photographs (Fig. 8) do show circular features somewhat smaller (generally <300 ft in diameter) than known breccia pipes. Many of these features lie along lineations that trend about northwest–southeast. Bachman (1973) suggested that these features, which are observable over a much greater area, are aligned because they represent areas between long, linear dunes that are now gone or redeposited. Bachman believed that they represent areas where infiltrating water was concentrated between the dunes, which partially dissolved the near-surface Ogallala caliche. Based on soil surveys of Lea County, New Mexico, there is no evidence that these features are currently geologically active, though they do collect runoff. They are spread beyond the areal extent of the Capitan Reef, so they are not likely related to the deep-seated breccia pipes of the northern end of the Delaware Basin.

Figure 8. High-altitude aerial photograph of area around the Jal sinkhole prior to collapse. Outlined area is a square that is 1 mi (1.62 km) on a side. Note small, round, dark areas on the west (left) side of the photo along linear trends. Bachman (1973) attributed such features to caliche dissolution between paleodunes. Photo by National Aerial Photography Program, November 1977.
