# U.S. ATOMIC ENERGY COMMISSION
PLOWSHARE PROGRAM

Project
GNOME

Final Report

Geologic Studies
Project Gnome
Eddy County, New Mexico

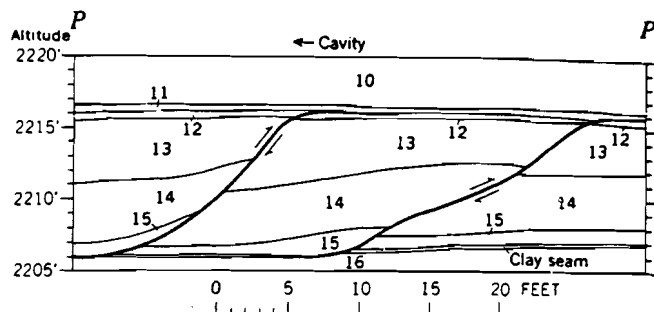
FIGURE 10.—Geologic cross section P-P' of drilling alcove, showing thrust faults. Right fault shown in figure 11A. See table 2 for description of numbered stratigraphic units.

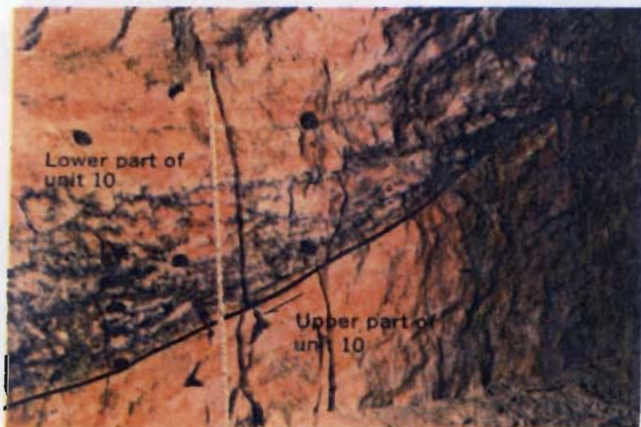
FIGURE 11.—Thrust faults, lithification, and brecciation resulting from the Gnome explosion. A, Thrust fault offsetting unit 15 (polyhalite) in drilling alcove. Fault originates in thin clay at base of polyhalite (left of hammer) and does not offset unit 16 (below hammer). B, Lithified salt bags. Note outline of bag shape top center indicated by arrows

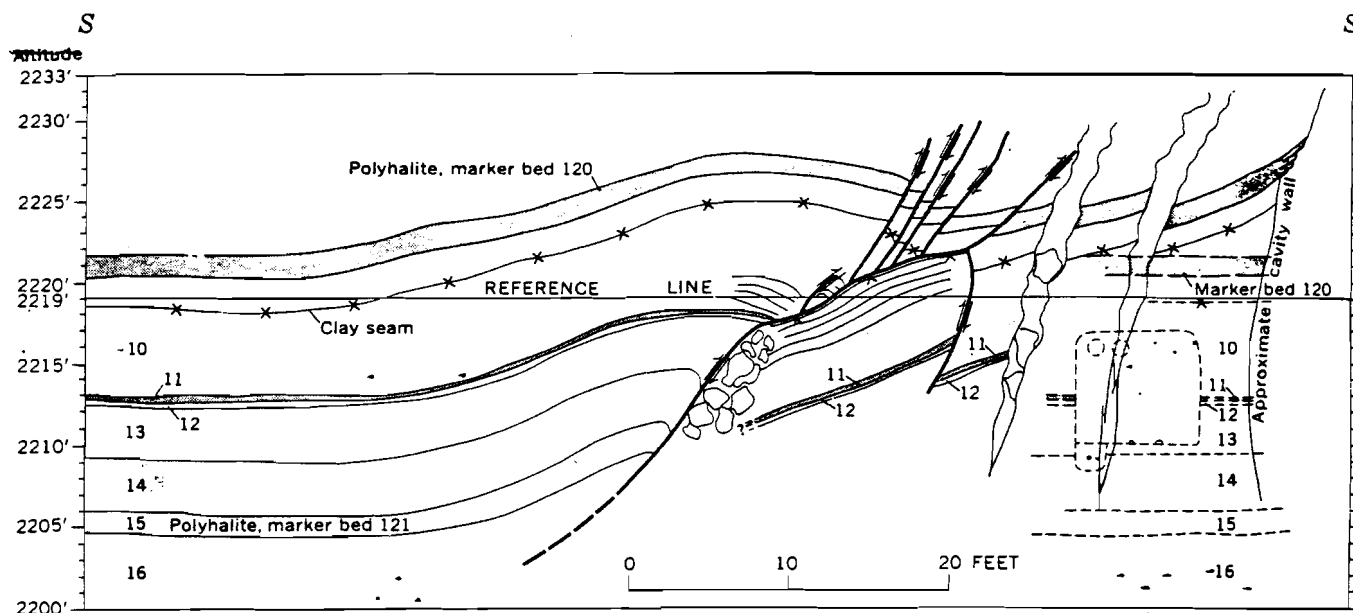
Faulting.—The rocks observed in the buttonhook reentry drift were complexly faulted. Several thrust faults can be seen along the right rib, and many of them contain melt. The section exposed in the left rib is unfaulted, but the beds lie about 4 feet above their preshot altitude. The thrust faults generally die out laterally in downcurving tear faults. The main rock unit involved in the faulting is unit 10, which has been thrust under itself. A small lateral driven toward the cavity revealed details of one of these faults (figs. 11C, 12).

FIGURE 12.—Geologic cross section S-S' through buttonhook reentry drift. See table 2 for description of numbered stratigraphic units. Dashed lines indicate original position of buttonhook drift and strata.

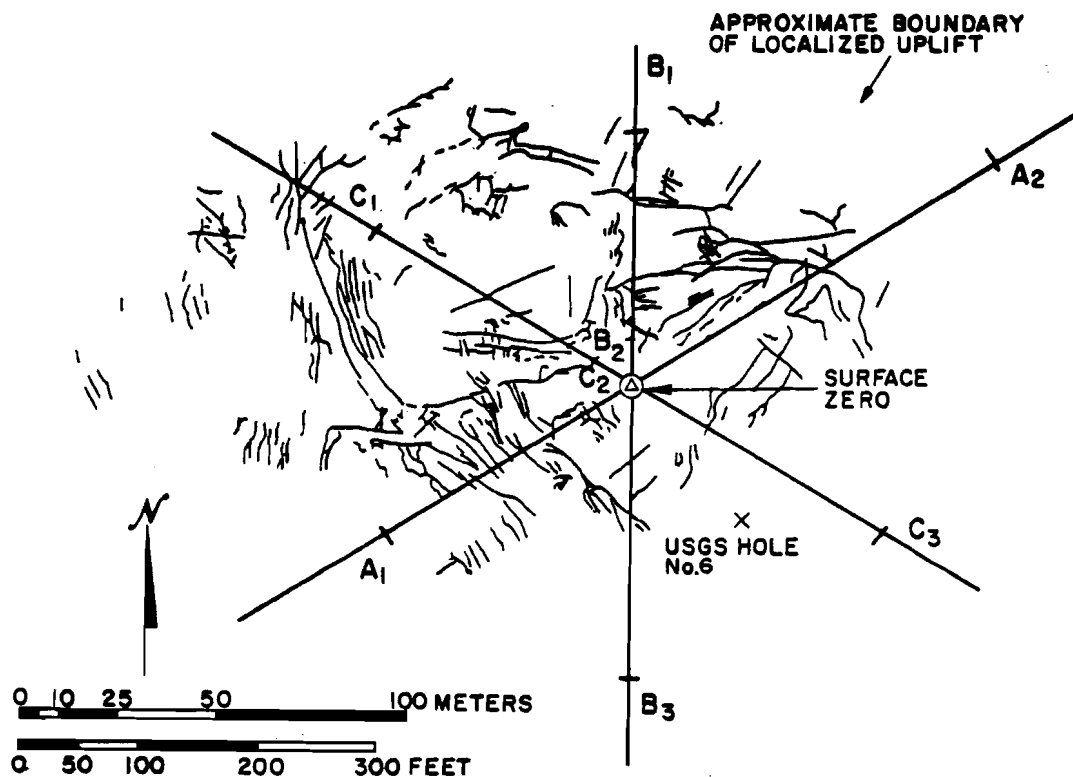
Fig. 4.1 Map of Gnome ground surface showing fractures and
approximate boundary of uplifted region (modified after Fig. 4.2 of
Reference 2).

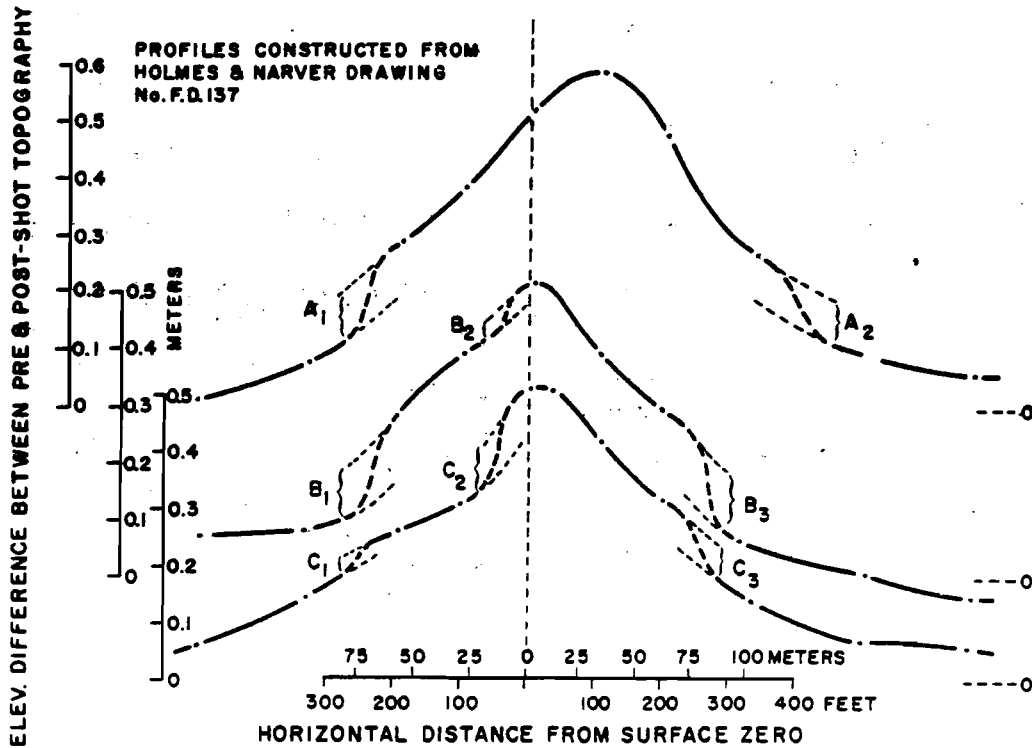
Fig. 4.2 Profiles of the Gnome ground-surface permanent displacements showing the uplifted region configuration (see Fig. 4.1 for plan view).

doming is not a smooth arch, but there are locations of abnormally large uplift or differential rock motion within fairly restricted zones (A_1, B_1, A_2, B_2, etc.). It is suggested that these zones may be the locations of the boundary of the uplifted region. Figure 4.1 shows the trace of these boundary zones based on the survey data and there

is a parallelism between this trace and the trace of observed surface fractures.

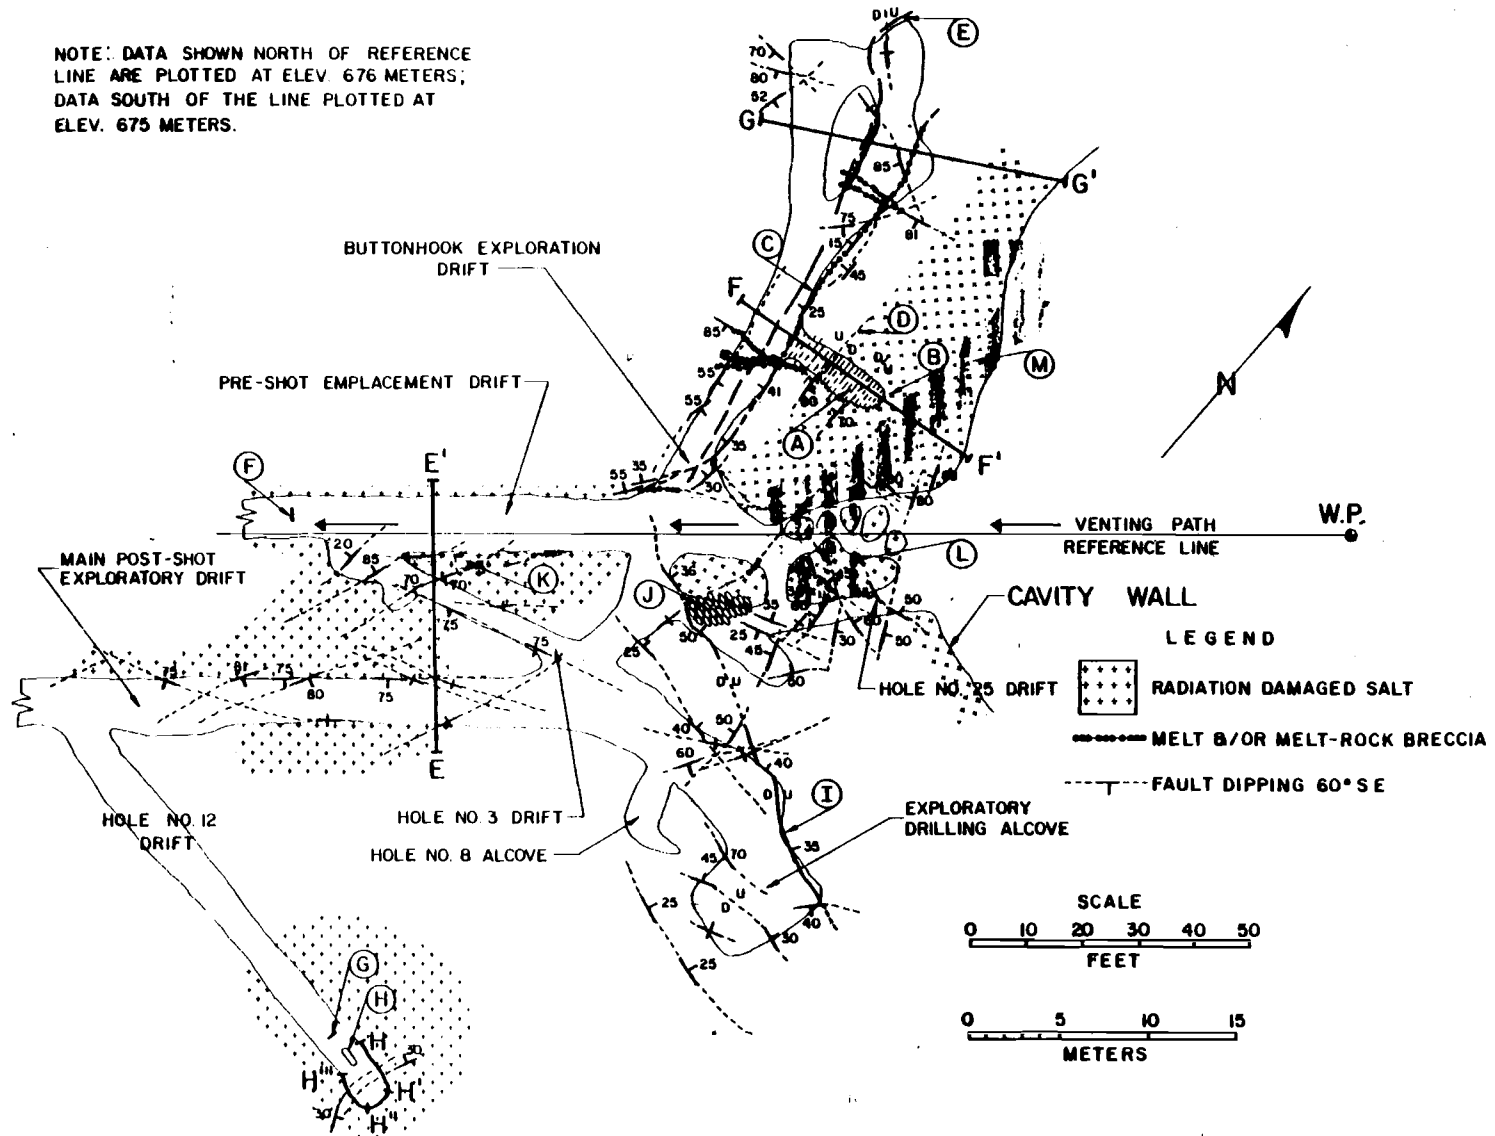
Fig. 4.3   Rock deformation revealed by postshot mining — plan view.

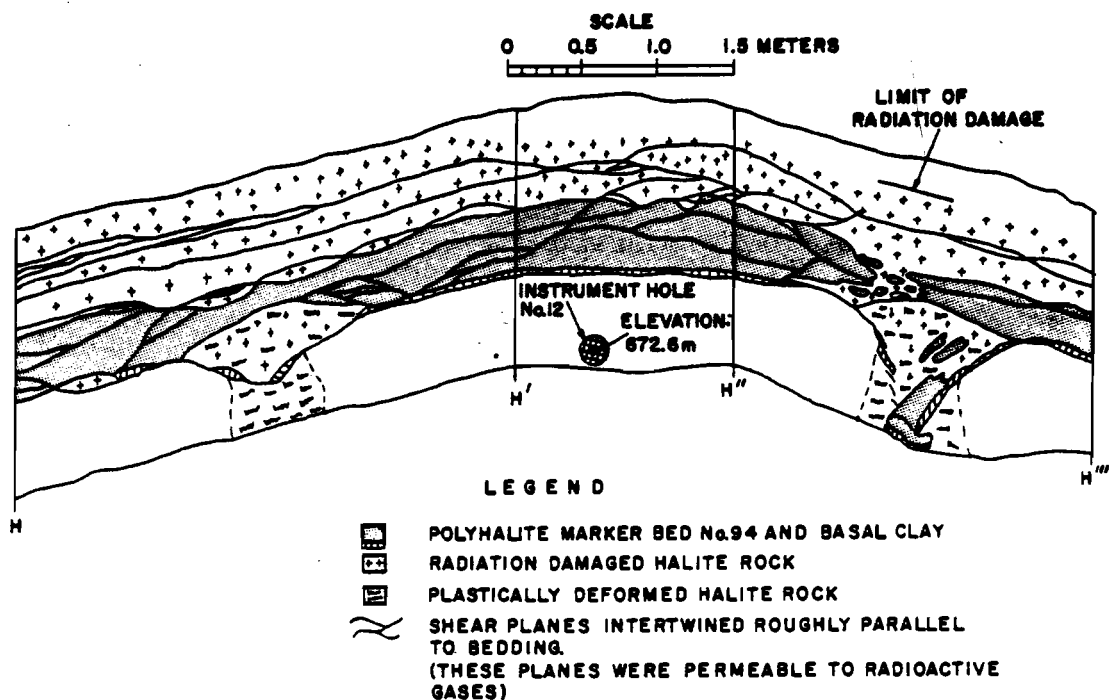
Fig. 4.4   Vertical section H-H''' showing deformation at end of hole #12 drift (see Fig. 4.3 for plan view).

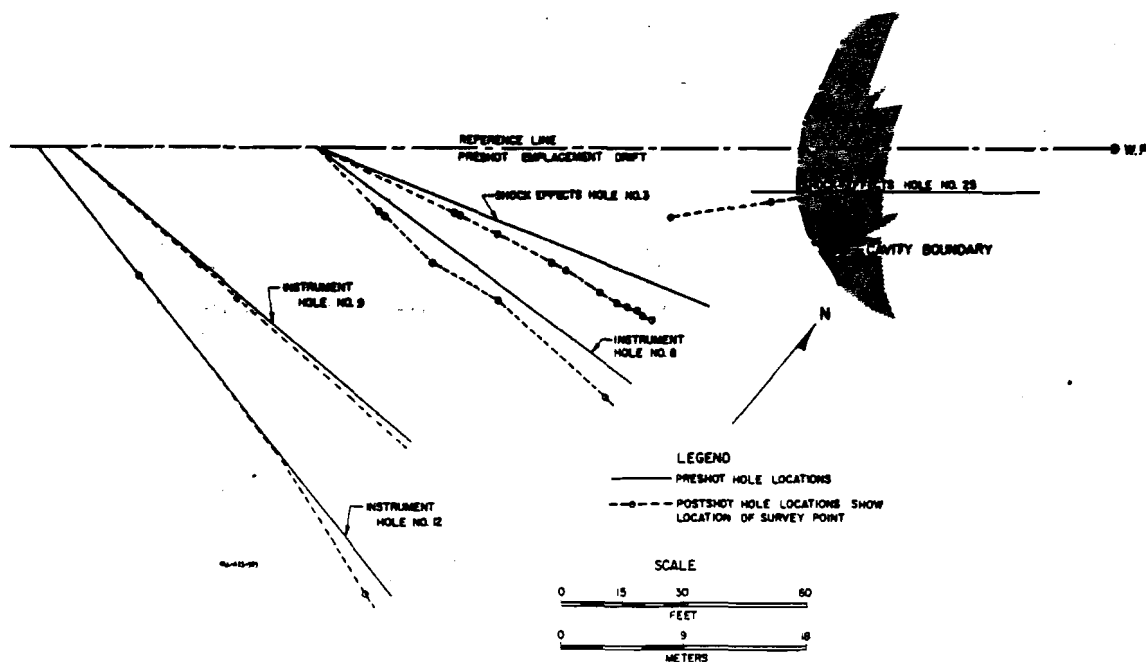
natural cavity in the salt near the instrument location that was col-
lapsed by the shock wave could be the explanation of this deformation.
Such cavities are known to occur in the Salado formation (C. Jones,
verbal communication) and are generally brine-filled. Figure 4.5
also shows the anomalously large radial displacements in that region.

Fig. 4.5 Displacement of underground instrument and shock-study
sample holes — plan view.

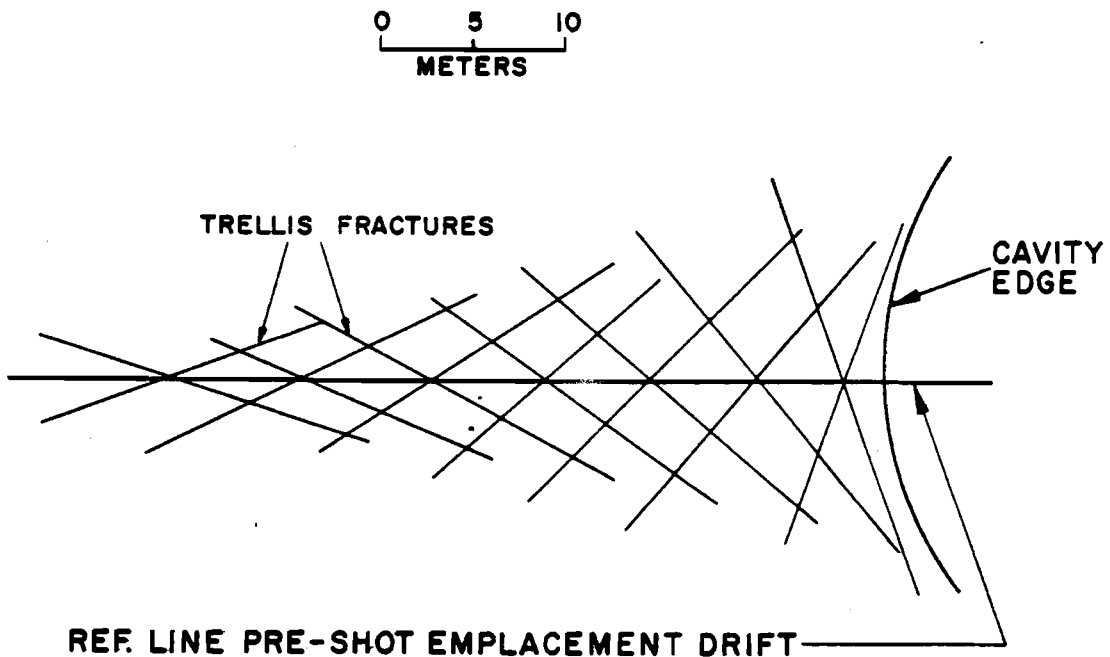
Fig. 4.7 Plan schematic of trellis fracture pattern associated with deformation along the line-of-sight emplacement drift.

interpretation is correct, it indicates that the rock bounding the drift failed in shear as the compressional wave passed and subsequent cavity growth distorted these weak zones.

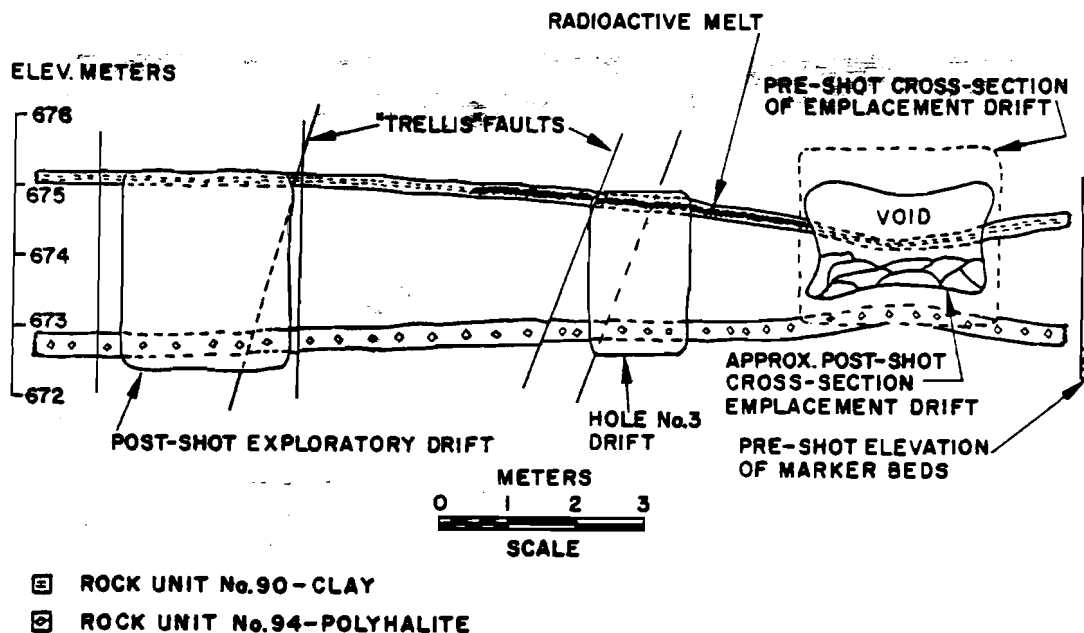
In addition to the trellis pattern of fractures associated with the deformation of the line-of-sight portion of the emplacement drift, the drift was noticeably constricted by plastic deformation.   Cross section E-E' (Fig. 4.8) located in plan on Fig. 4.3 shows the approximate size of the postshot emplacement drift at 53.3 m from the working point compared to its preshot cross section.   At this distance, the drift apparently squeezed nearly shut prior to venting and was

Fig. 4.8   Vertical section E-E' showing partial closure of preshot emplacement drift (see Fig. 4.3 for plan view).

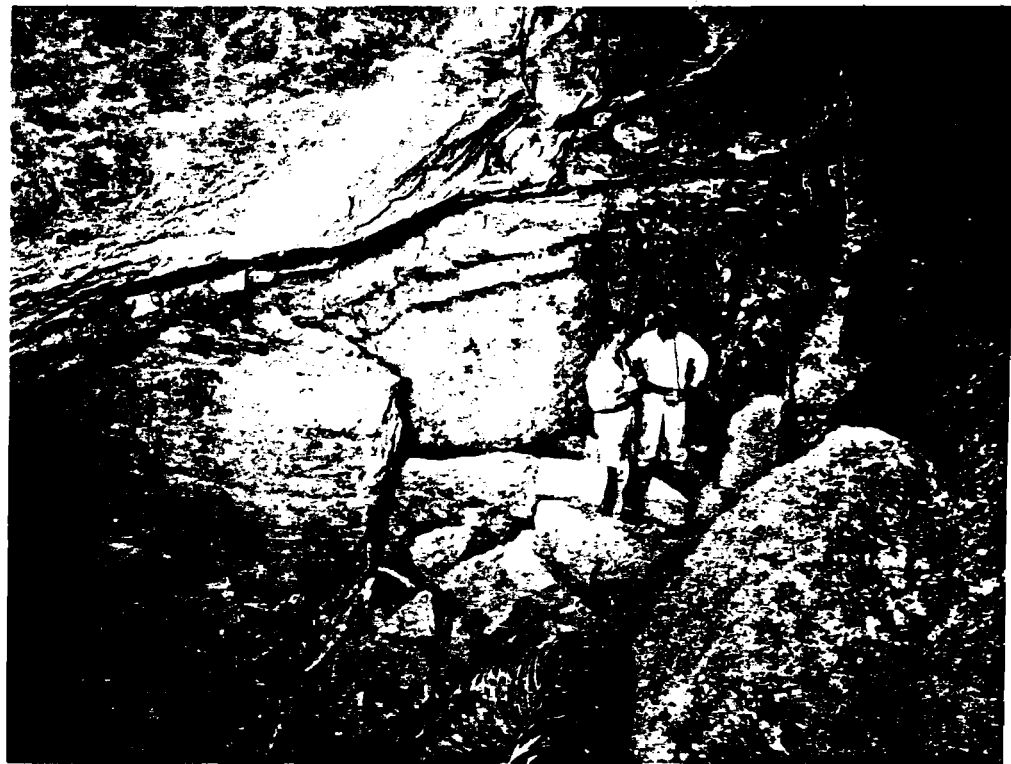
Figure 5.3a shows the drift at a distance of about 41 m from
the shot point near the end of the postshot location of the line-of-
sight portion of the emplacement drift. Here the salt is pock-marked
with many large etch pits caused by steam erosion. The smooth
dark patch in the center of the picture is a pond of water that con-
densed from the vented steam and the white crust is re-crystallized
salt left by evaporation of brine.

Figure 5.3b is a picture of a small portion of the breakthrough
region between the cavity and the line-of-sight drift. It is possible
to crawl from the cavity through to the drift.

Figure 5.3c is a view from inside the Gnome cavity looking
toward the portal to the vent path at the cavity wall.

Fig. 5.3 Vent path.

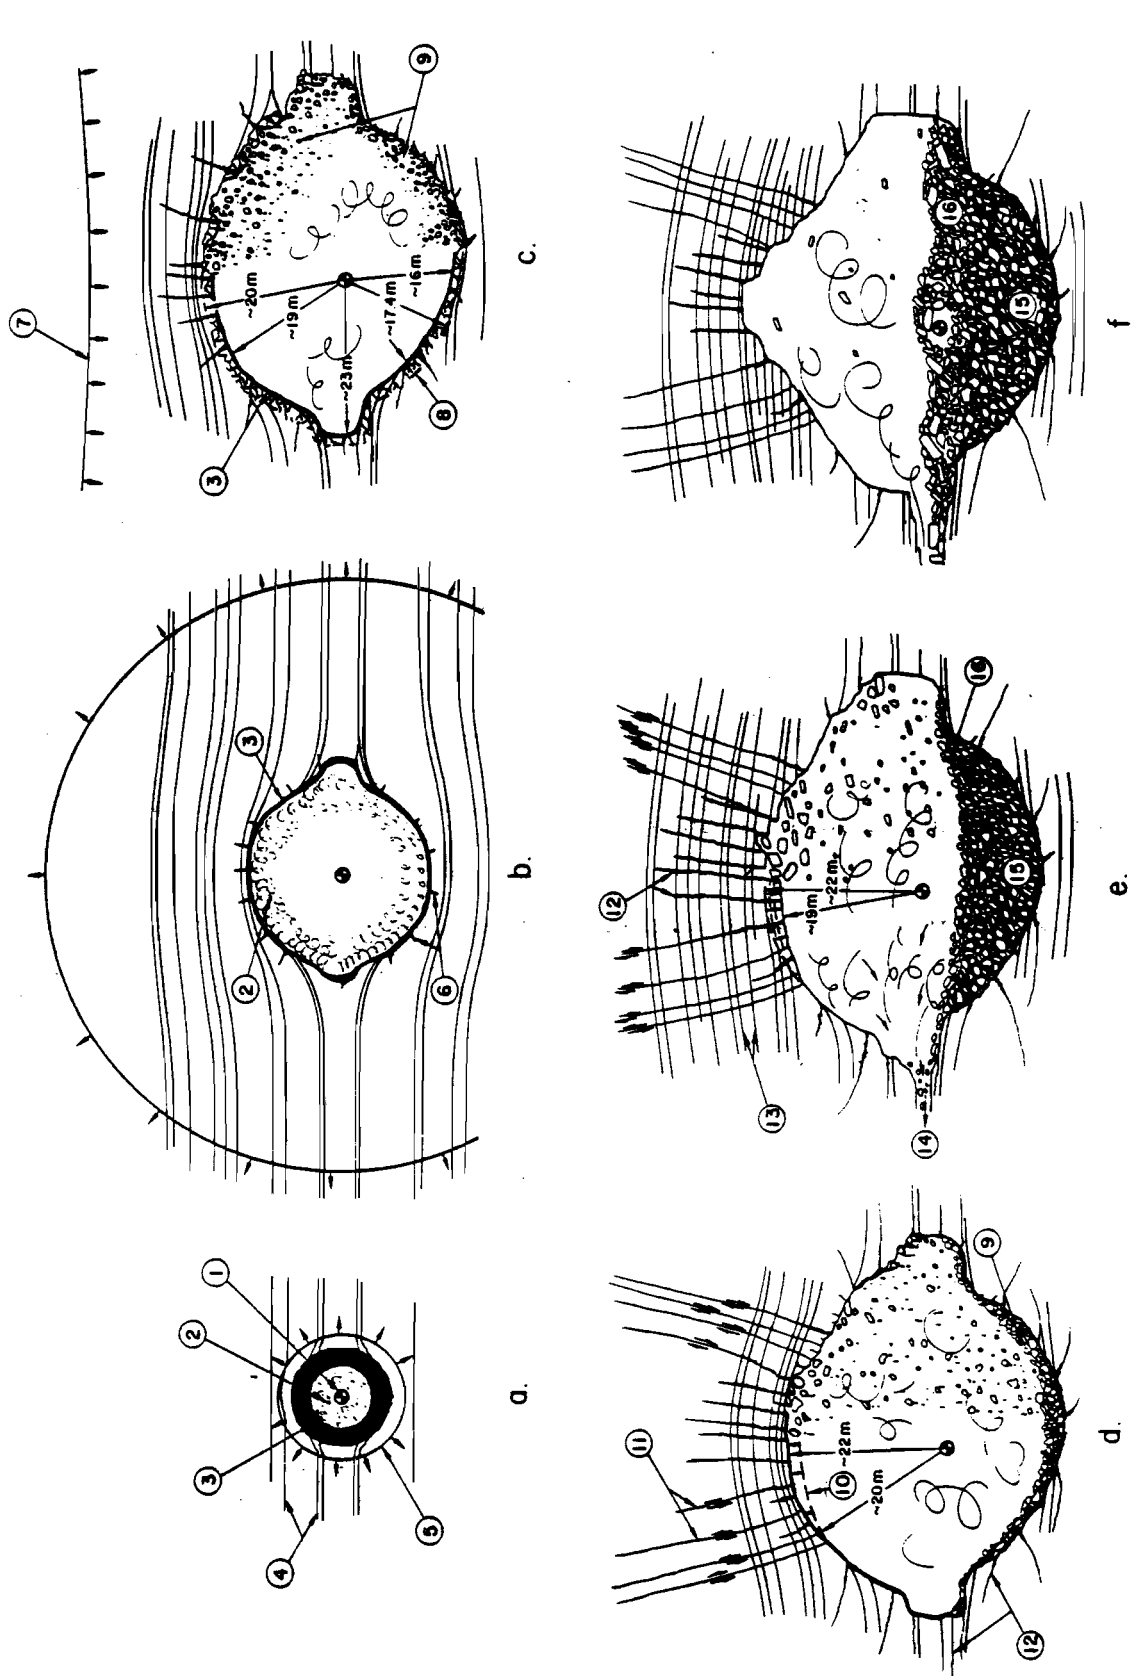
Fig. 6.1 Schematic vertical sections showing cavity development.
