U.S. Department of Energy Office of Environmental Management

Accident Investigation Report

Phase 1

Radiological Release Event at the Waste Isolation Pilot Plant on February 14, 2014

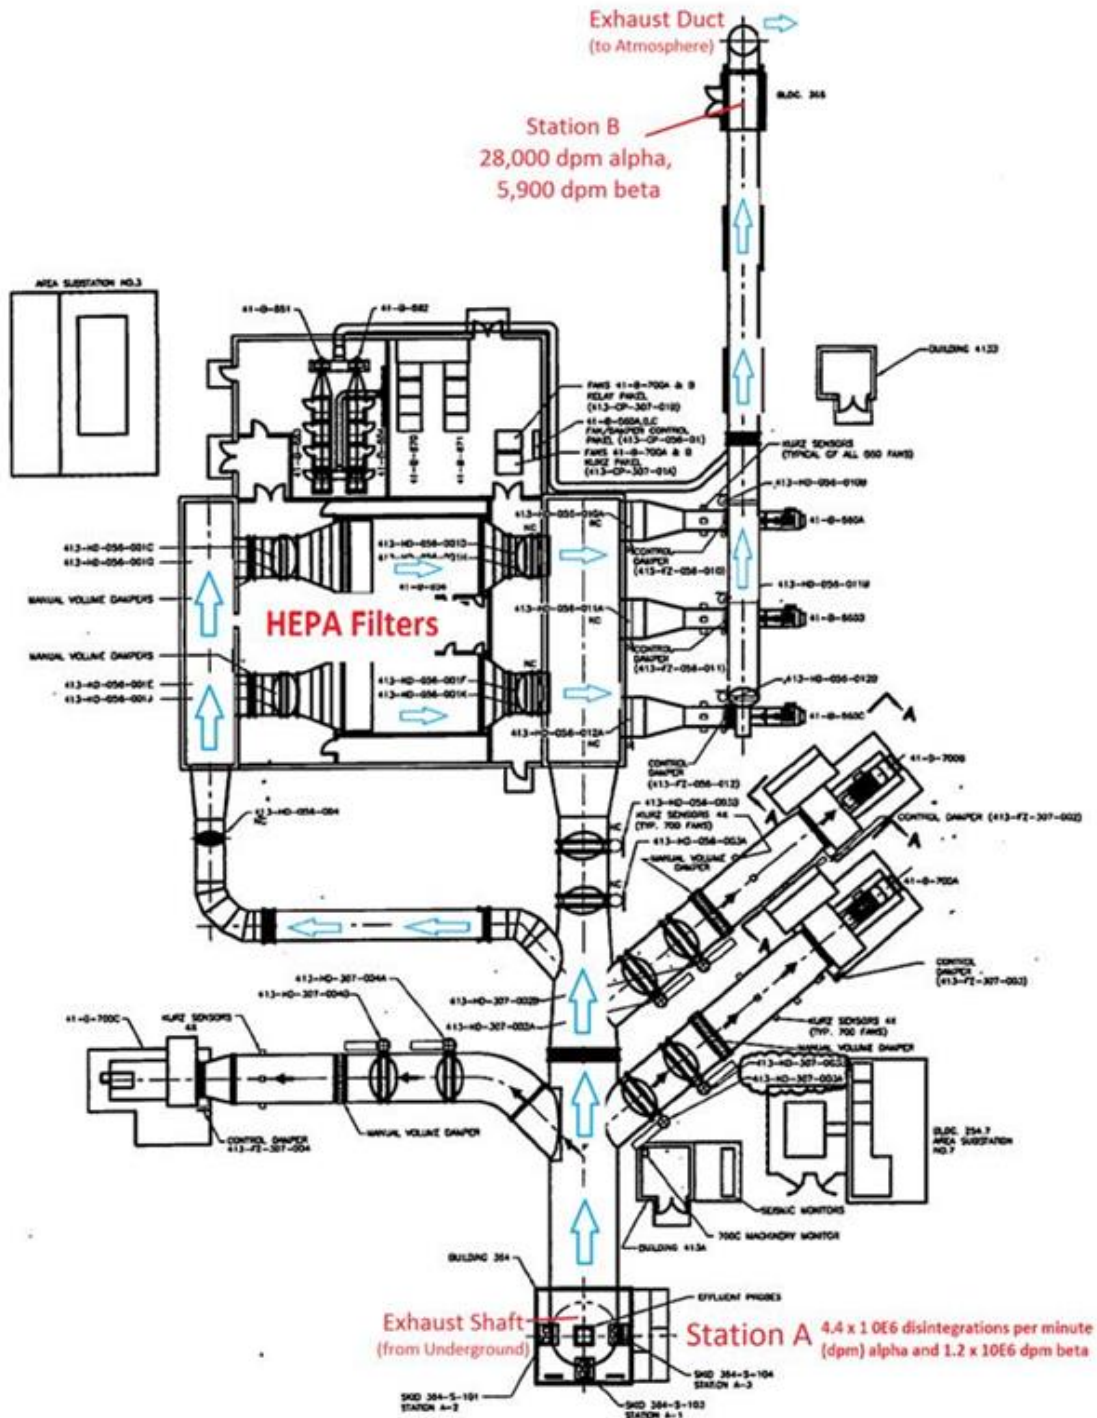
Figure 18: Exhaust Filter Building Ventilation Components Plan View

With regard to ventilation system design and operability: the filtration portion of the ventilation system has two HEPA filter bypass isolation dampers that provide a pathway of unfiltered exhaust into the environment. These isolation dampers are not suitable as a containment boundary and reduce the overall efficiency of the HEPA filter system. This is discussed further in Chapter 9, Underground Ventilation. This condition was never identified by the contractor, CBFO, or Headquarters in any of the revisions and updates to the WIPP safety basis documentation.

The exhaust fans serving the underground ventilation are located on the surface. A combination of six fans provides airflow for the U/G ventilation system. Three large main (700) fans rated nominally at 260,000 cfm discharge directly to the atmosphere. Three smaller 860 fans, rated nominally at 60,000 cfm, draw ventilation through HEPA filtration and discharge to a small stack monitored for radiological release. The 860 fans can also exhaust the underground directly through a filtration bypass duct. (Figure 18 and Figure 19)

On March 6, two ventilation system dampers that were known to have design leakage, and allowed a portion of the radioactive material to bypass the HEPA filters were sealed with a high-density foaming material.

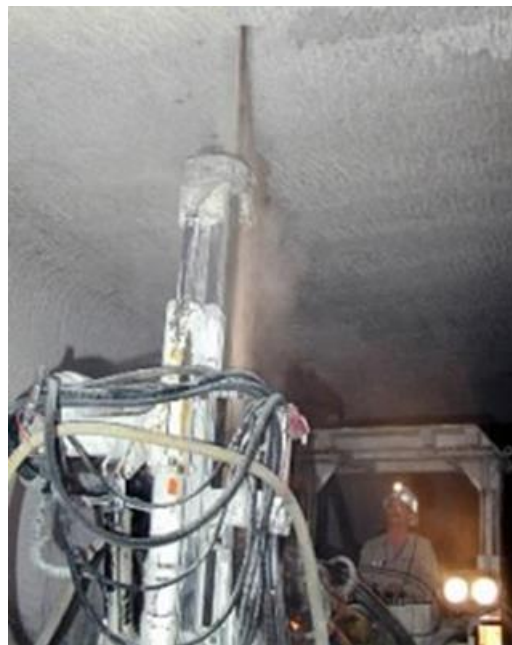
Figure 24: Roof Bolter Drilling to Install Roof Bolts

The back of an area is taken as a whole with regard to longitudinal or transverse vertical fractures. A few vertical fractures may be an indicator of advancing deterioration, but they do not constitute reason for immediate remediation. Areas containing vertical fractures are closely monitored

visually and with geomechanical instrumentation. The type and extent of these fractures will affect the ground control system chosen for a given area. An area with only a few longitudinal fractures could probably be supported with a standard roof bolt system, whereas an area with extensive, connected fracturing, suggesting a breakup of the beam, might require a more extensive supplemental support system. (Figure 24) Areas receiving lesser ratings, based on the visual assessments, warrant closer monitoring. In these cases, the ground conditions are monitored more frequently, and additional instrumentation is installed when appropriate. When it is determined that ground conditions have reached a point where a safety hazard could develop in the short term, mitigation actions are implemented.
