OFFICE OF  
ENVIRONMENTAL  
MANAGEMENT

# **WIPP Underground Radiological Event Investigation Summary February 14, 2014**

**Ted Wyka**  
**Chairman, Accident Investigation Board**  
**March 2014**

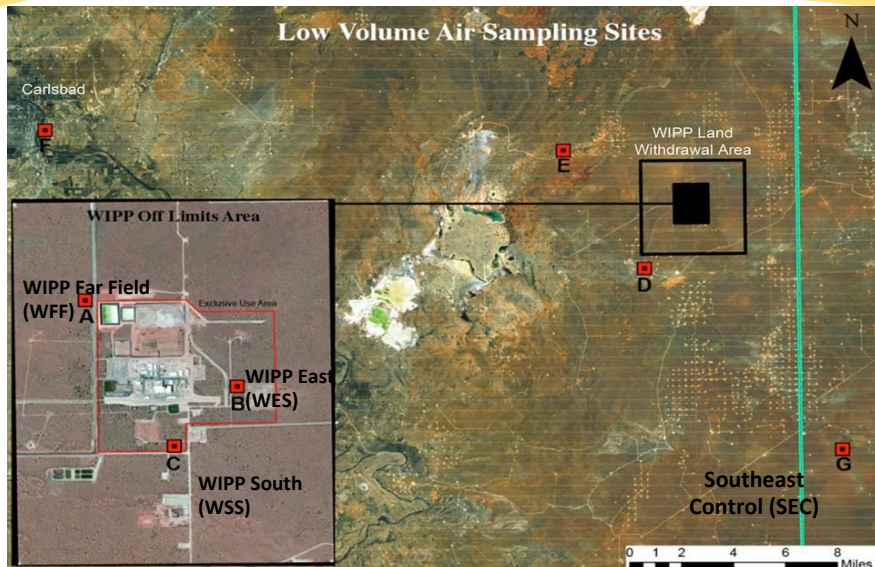
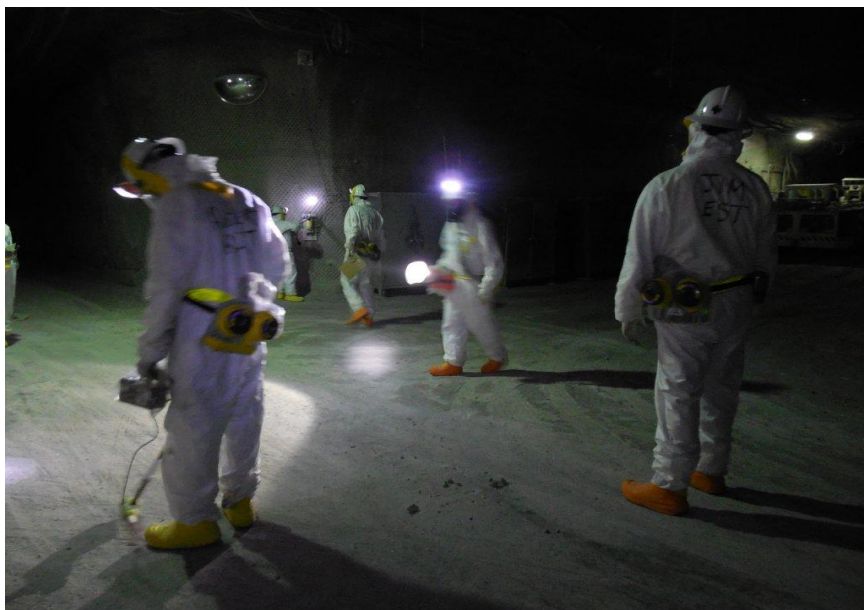
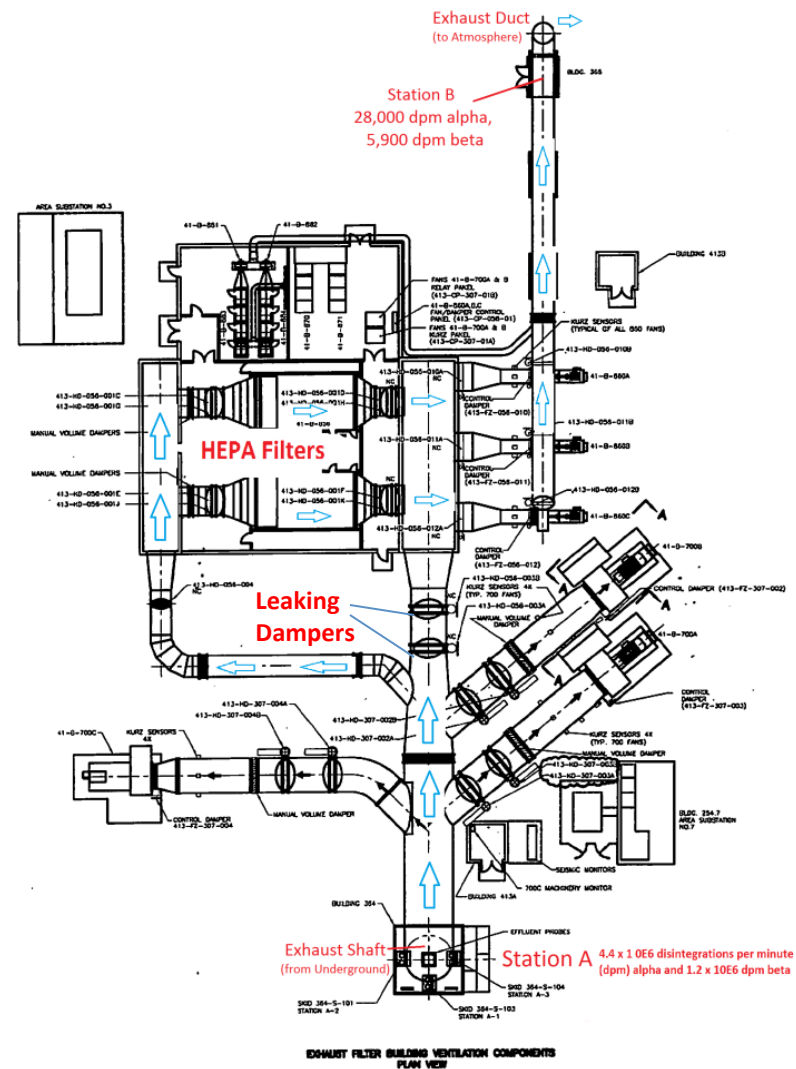
- On February 24, results of off-site environmental monitoring samples (Far Field) were received and indicted slightly elevated levels of  $\text{Pu}^{239/240}$  and  $\text{Am}^{241}$ . These levels were also well below a public or environmental hazard.
- On March 6, high-density foam was applied to seal the two ventilation system dampers which leaked and allowed contaminated air to bypass the HEPA filters.
- Manned entry into the underground to collect samples, assess conditions, and gather information, necessary to determine the physical cause for the release, is underway with great progress to date, but challenges ahead.
- Personnel bioassay was subsequently performed on 150 personnel to determine if there was any uptake of contamination.
