U.S. Department of Energy Office of Environmental Management

Accident Investigation Report

Phase 2 Radiological Release Event at the Waste Isolation Pilot Plant, February 14, 2014

April 2015

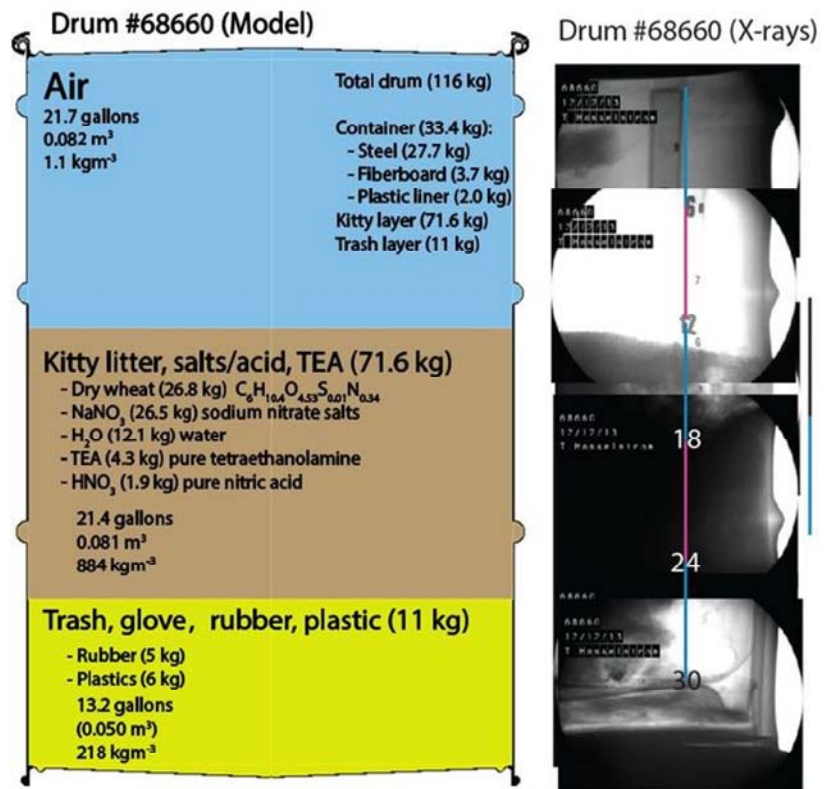
Figure 5-1: Drum 68660 Model Contents

On December 4, 2013, ES remediated parent drum S855793 in accordance with the glovebox procedure, producing daughter drums LA00000068660 (68660) and LA00000068685 (68685). Drum 68660 was repackaged by first adding some secondary waste including a tungsten-lined glovebox glove. Approximately two gallons of free liquid were decanted from the parent drum. The pH was measured and recorded to be 0 (zero). The pH was adjusted using KOLORSAFE® to an unspecified final pH. Swheat Scoop® organic kitty litter was added as the absorbent and was placed in the drum. Additional bags of nitrate salt were absorbed and placed in the drum. See Figure 5-1 for a drum contents model.

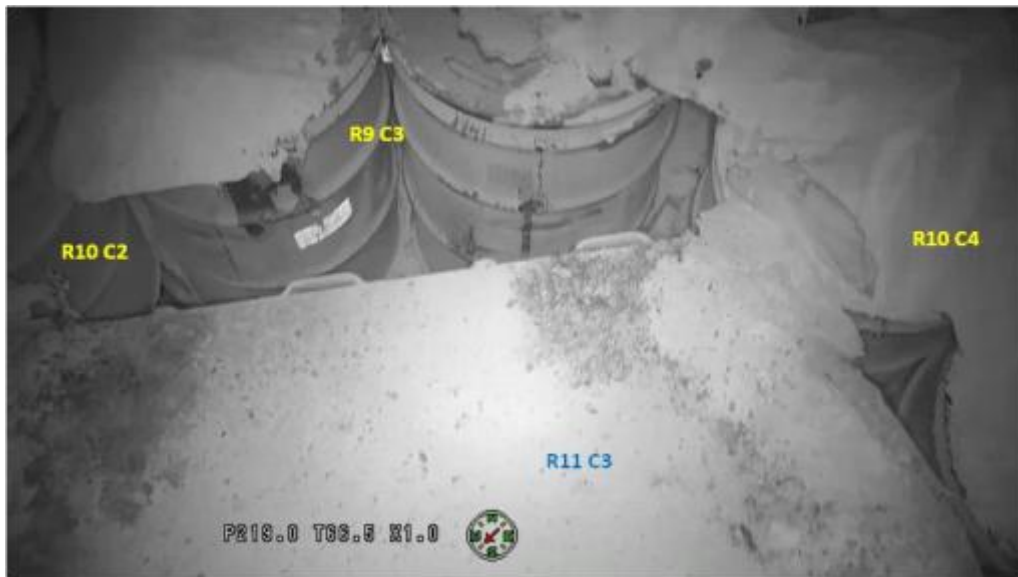
Figure 6-21: R9:C3 West Side

had no observable fire damage, stretch wrap at each of the other five stacks was damaged or missing. The 55GD assembly reinforcement plates at R9:C3 and R9:C5 melted, mixed with MgO, solidified on the drum lids, and cracked into pieces (Figure 6-19, Figure 6-20, Figure 6-21, Figure 6-22, Figure 6-23 and Figure 6-24). There was no evidence of reinforcement plate remaining between the drums. In some instances melting polyethylene formed streaks on the on the side of these drums. In addition, MgO slumped onto some of the drums in both locations.

The MgO super sacks in Row 10 were damaged, with most of the fabric melted or gone (Figure 6-21, Figure 6-22, Figure 6-24, Figure 6-25, and Figure 6-26). The residual MgO formed conical piles consistent with the outline of the waste containers on the top tier at each stack. At R10:C6 the 100GD assembly slip sheet, the middle tier reinforcement plate and slip sheet, were partially damaged and conformed to the outline of the drums (Figure 6-27). Many locations had

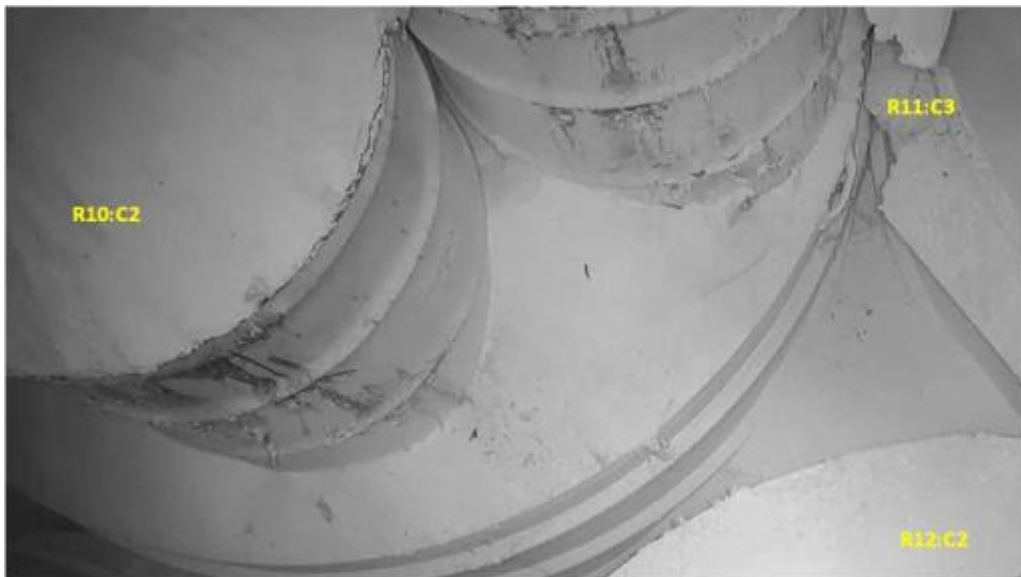
Figure 6-26: R10:C2

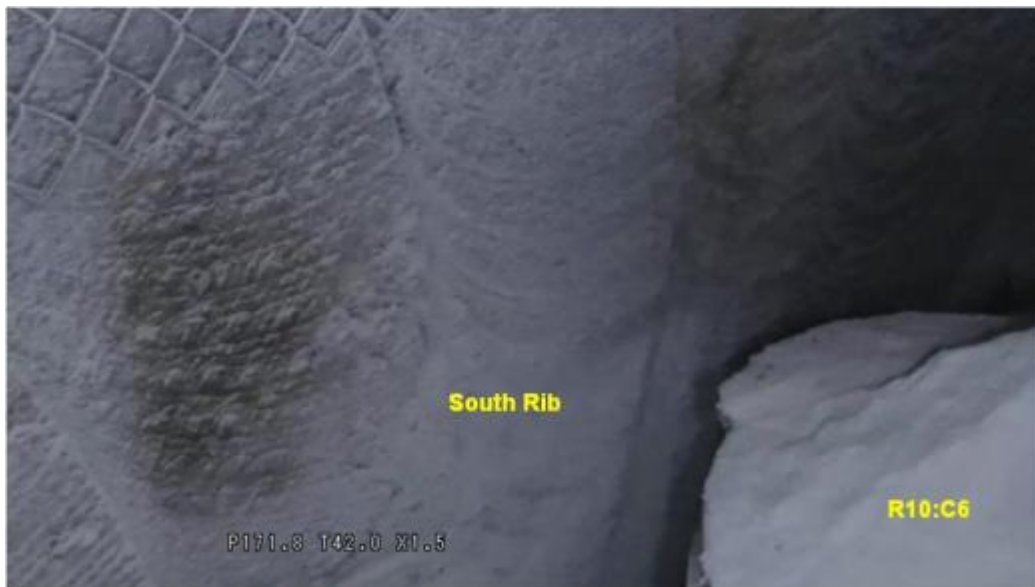
evidences of black discolorations on the sides of the waste drums. There was also evidence of flame impingement on the south rib (Figure 6-28).

Figure 6-28: Flame Impingement Evidence on South Rib near Row 10

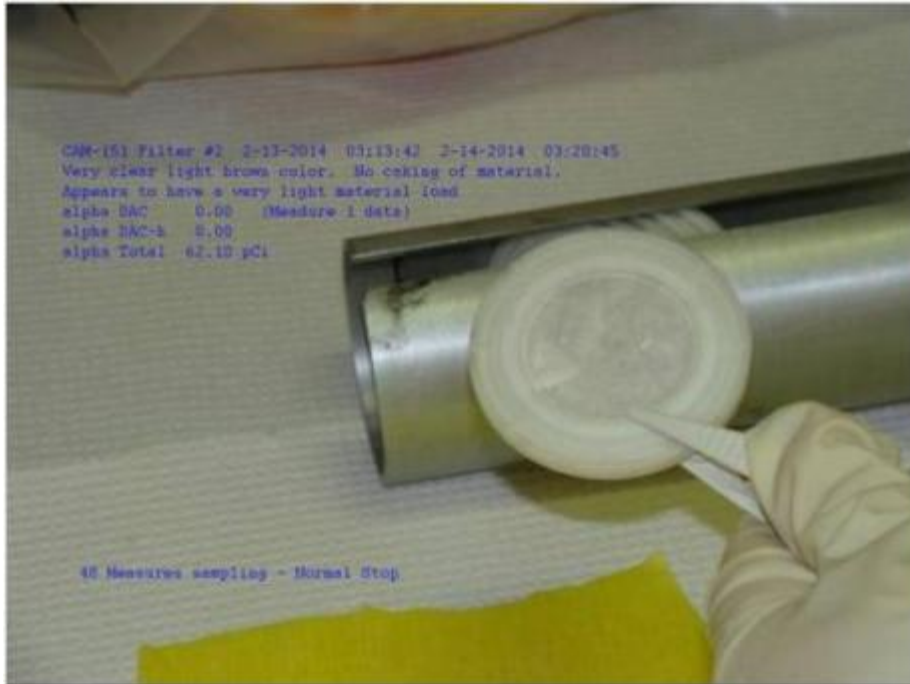
Figure 6-48: CAM 151 Filter #2

Following the event, the CAM (Figure 6-47) filter housing was disassembled at SRNL. Each filter was assigned a specific number based on the order in which the filters were removed from the CAM cartridge, visually examined, and recorded. Each CAM filter was then screened by gamma pulse height analysis. The first six CAM filters were white and had low levels of activity; three of these are from routine monitoring before the event took place. The following 10 sample filters had various shades of black and brown, and had high levels of activity. Table 6-5 summarizes sampling start and stop time for each CAM filter and the DAC-hr value as recorded by the CAM, as well as total gamma emitting activity as measured by gamma pulse height analysis. CAM 151 filter papers are numbered and described in the order in which the filter paper was removed from the cartridge. The CAM 151 cartridge is loaded with filter papers with the earliest filters first. This means that the first filter used by the cartridge is the last filter paper to be removed. The CAM cache records indicate filter labeling as December 27, 2013 - 6 Filter 01 (Figure 6-48) through December 27, 2013 - 6 Filter 13 (Figure 6-49) during the period starting from February 12, 2014, 0304:43 through February 15, 2014, 0005:34 when the CAM shut down after the radiological event.

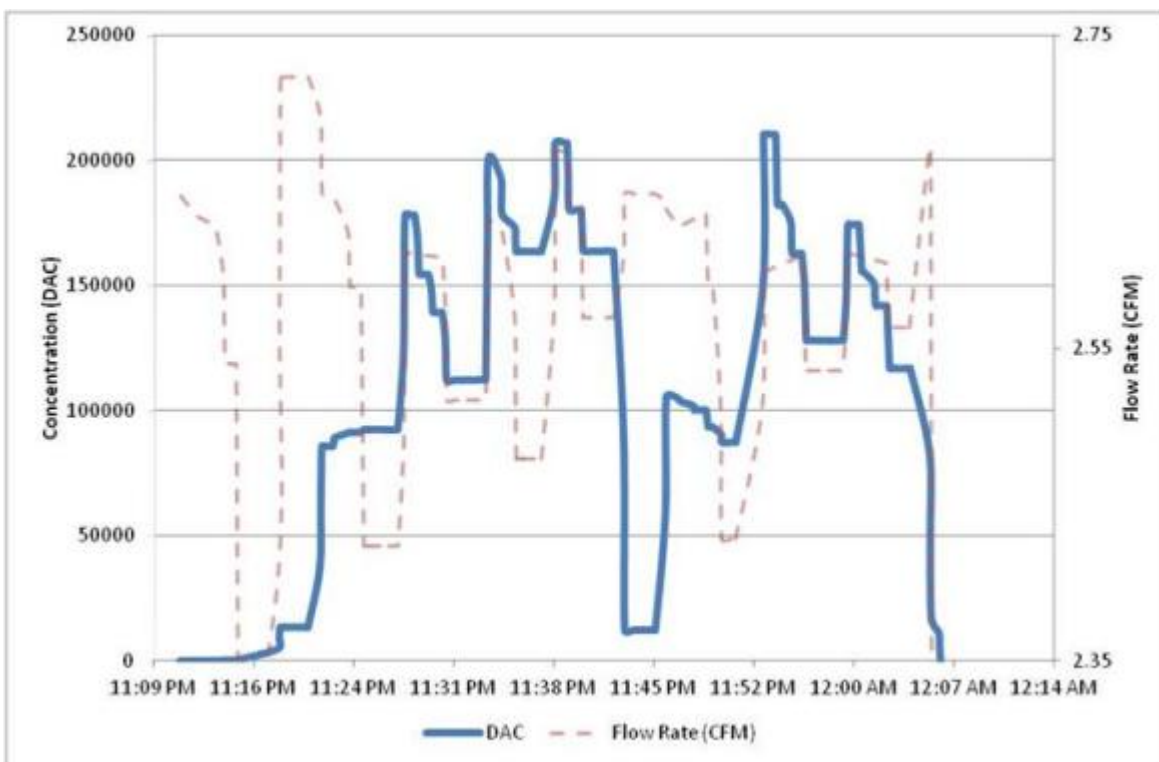
Figure 6-50: Real-Time Air Concentrations Measured By CAM 151 with the CAM Flow Rate

CAM airborne radioactivity data correlates with the timeline for the event initiation, progression, and termination. The data indicated rapid increases/decreases in airborne radioactivity concentration over the duration. Three CAM filters (2, 7, and 11) were selected for extended gamma assays and chemical analyses. Extended gamma assays on those three CAM filters measured an actinide signature similar to what was found on the FAS. Table 6-6 is summary of the results of the three selected CAM filters.

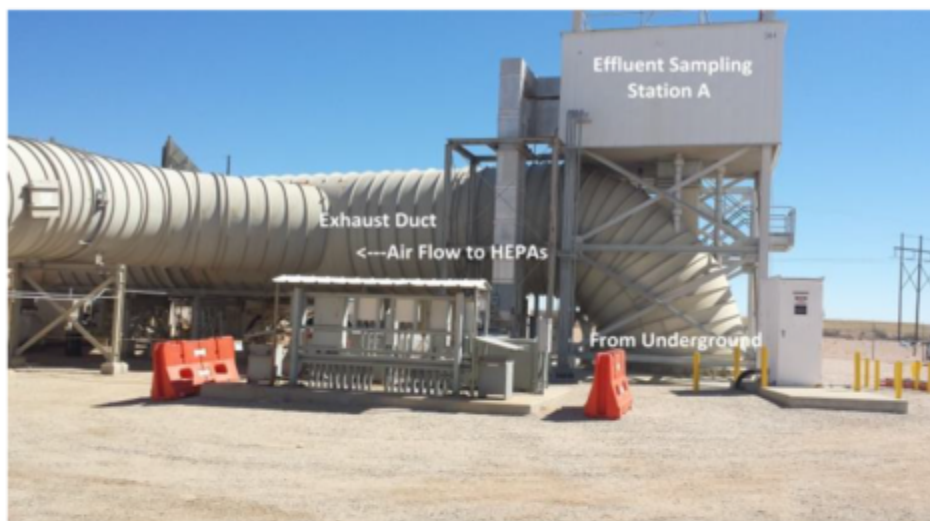
Figure ES-2: Exhaust Air Shaft and Effluent Sample Station A

On Saturday, February 15, 2014, the filters were counted at 0715; the RCM reported 4.4 million disintegrations per minute (dpm) alpha contamination on the filters from the effluent sample station upstream from the HEPA filters (Station A) (Figure ES-2). Preliminary data indicated the presence of TRU materials.
