# CARLSBAD TOWN HALL MEETING

U.S. Department of Energy  
Waste Isolation Pilot Plant (WIPP)

April 23, 2014

# **WIPP Underground Radiological Event Investigation Summary February 14, 2014**

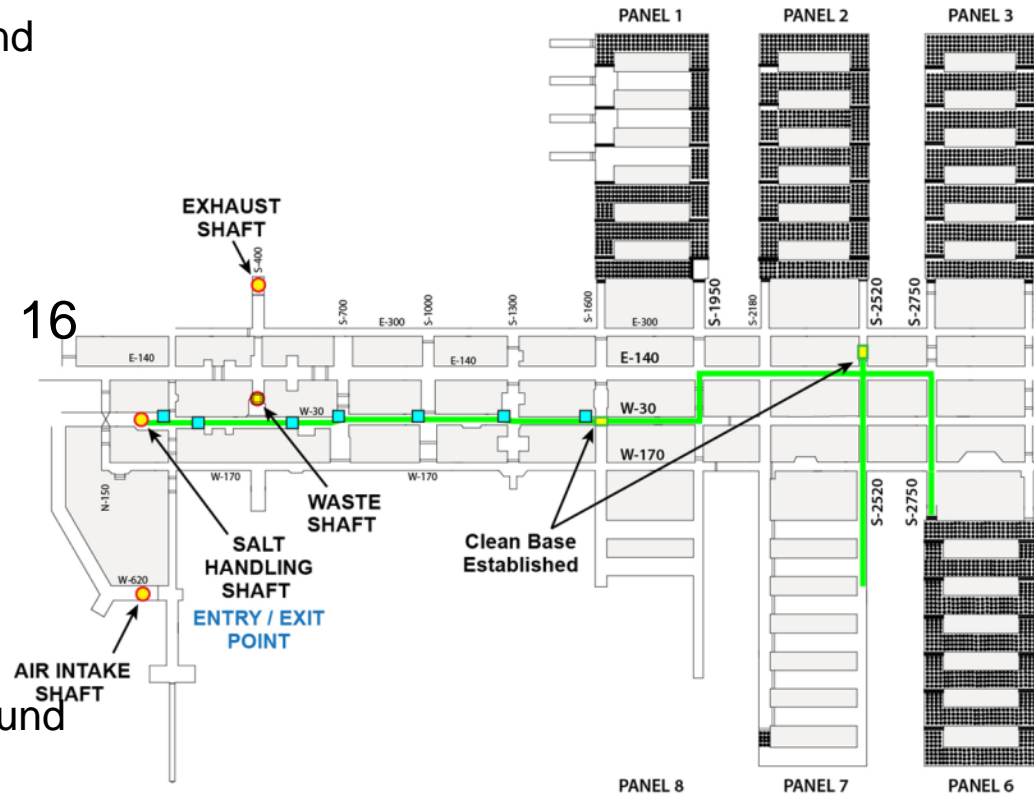
- Activity 1 – Completed April 12
  - Surveyed between W-30 and E-140 and E-140 to S-2000
  - No contamination found
  - Ground conditions were very good
- Activities 2 & 3 – Completed April 16
  - Surveyed down E-140 to S-2520; No detectible contamination found
  - Surveyed from S-2520 to W-170; at intersection, some contamination was found
  - Surveyed down E-140 to S-2750 and mouth of Panel 6; no contamination found
  - Entered Panel 7; passed Room 2 and began encountering contamination; turned back at Room 3 for safety reasons

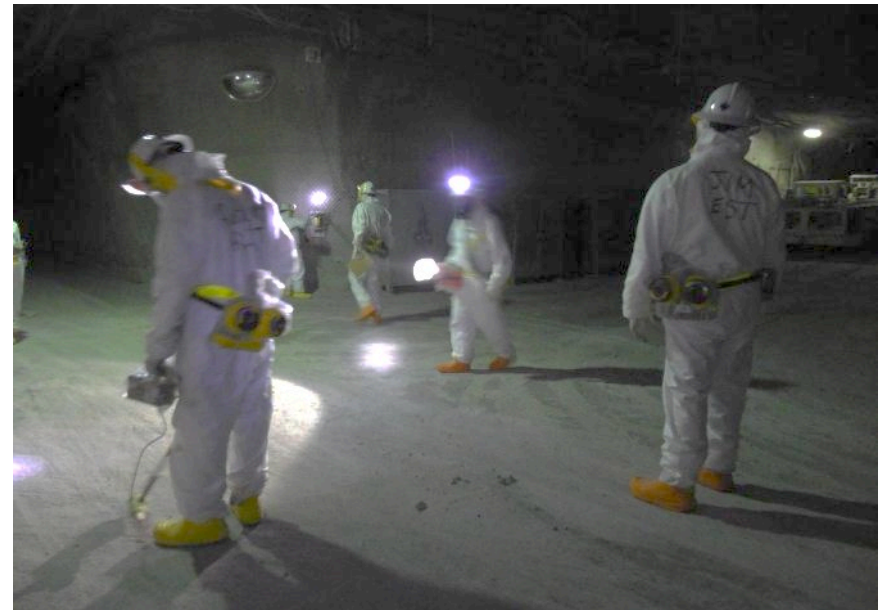
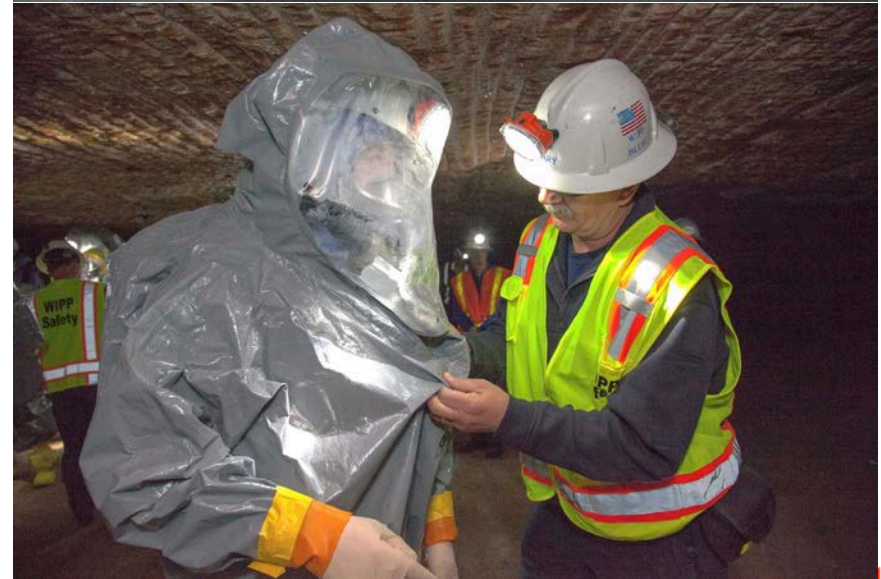
## Phase 3: Activity 4 Layout

- Activity 4 – Completed Wednesday, April 23
  - Three teams
    - Support Teams – 2 pair overalls and PAPRs
    - Exploratory Team – Level B and BG-4s
  - Three individuals approached the waste face in Panel 7
    - No cause of event source visible
    - Teams returned to Clean Base

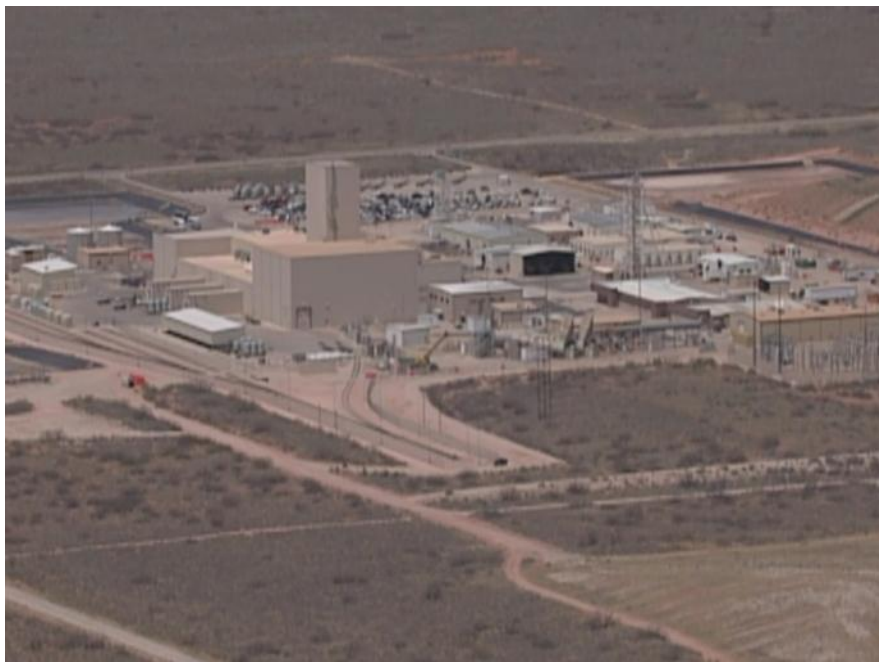
### **Continuous Air Monitor (CAM)**

The alarm was from a Continuous Air Monitor (CAM) in the underground that was monitoring an active transuranic (TRU) waste panel.

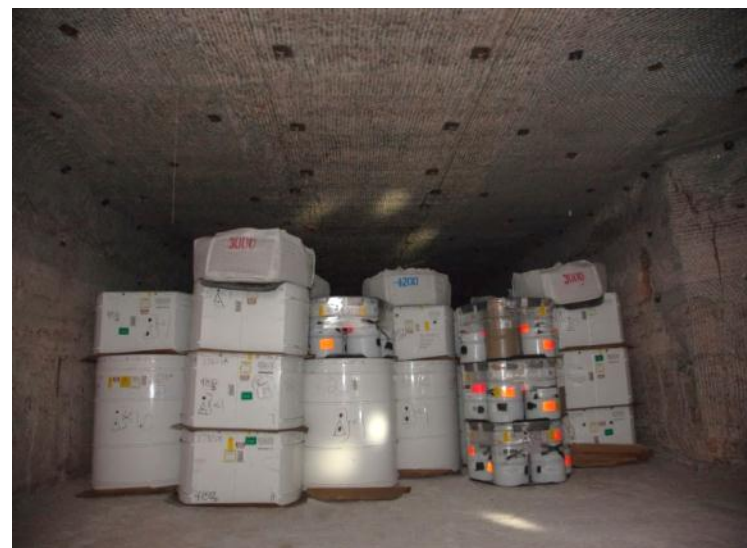
**Active Waste Face at Panel 7, Room 7**
