2015 – Emplacement Inspection Report

**EPA INSPECTION No. EPA-WIPP-10.13-22c
OF THE
WASTE ISOLATION PILOT PLANT
April 7-9, 2015**

2015 - Monitoring Inspection Report

**INSPECTION No. EPA-WIPP-4.07-09b
OF THE
WASTE ISOLATION PILOT PLANT
April 7-9, 2015**

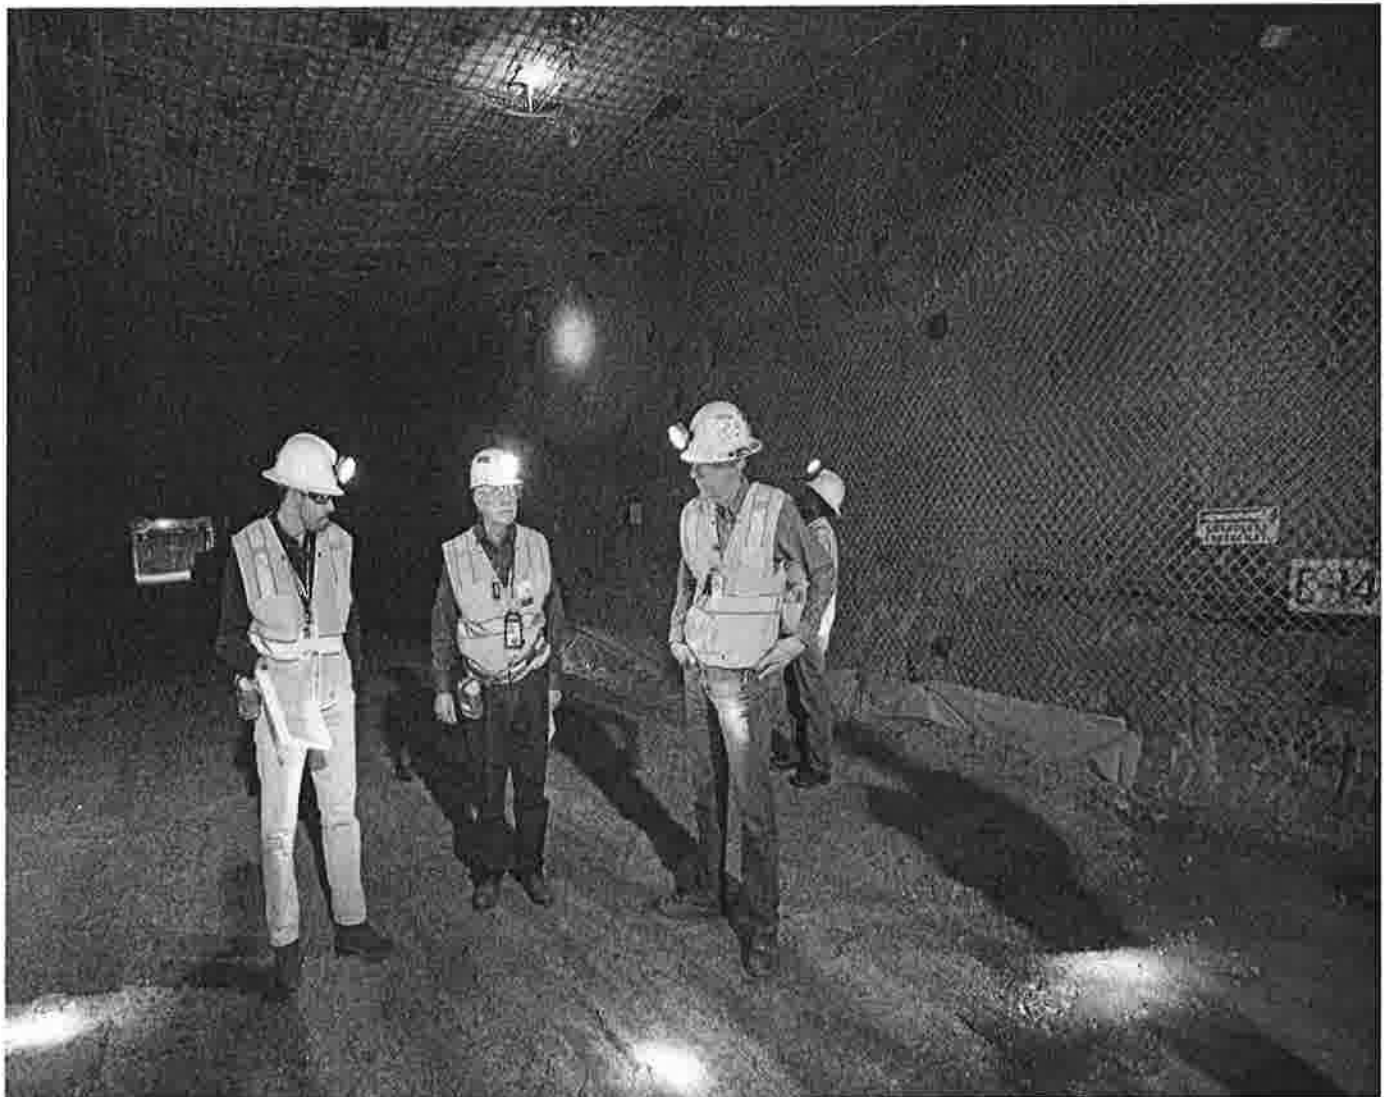
Figure 2
Inspection Team Observes
Test Section of Drift Rad Isolation

EPA inspectors accompanied CBFO and NWP personnel into the underground repository on the morning of April 9, in order to examine restoration of the underground including soot removal, decontamination methods, safety upgrades, and the transition zone to the potentially contaminated area of the underground. The inspectors observed the salt hauler vehicle and examined how the fire's location spread soot throughout the underground. EPA inspectors did not enter the potentially contaminated zone because EPA determined after the inspection of 2014 that the WIPP's ability to contain waste was not compromised by the salt hauler fire or the drum breach.

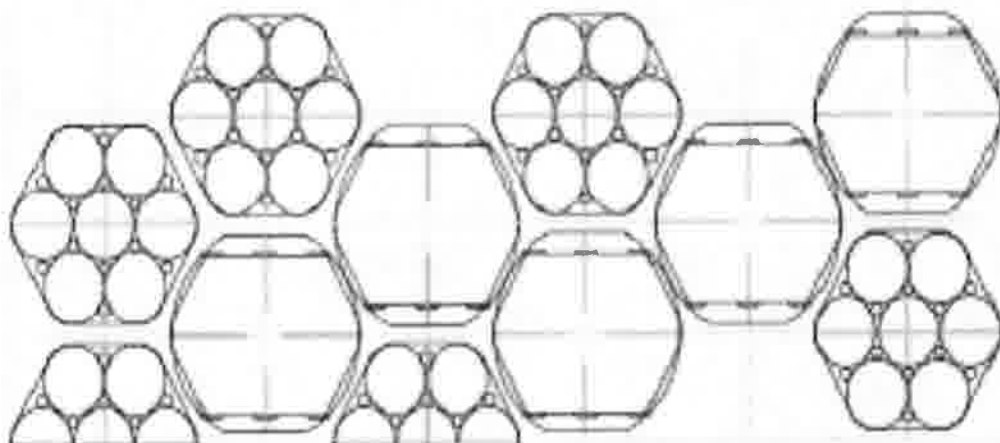
Figure 5
Arrangement of Disposed Waste in a Room

The repository is subdivided into panels, each panel consisting of seven rooms. At the time of the inspection, all waste emplacement had been suspended since February 5, 2014. CH waste containers are stacked in columns (waste stacks) combining SWBs, drum packs, and TDOPs (see Figures 5 and 6). TDOPs are always placed on the floor of the room, occupying the bottom and middle position of a waste column. SWBs and drums may be emplaced in any order, with most wastes emplaced as received. The waste columns are in a series of staggered rows, with a row consisting of three columns that span the distance of a disposal room from left to right (Figure 5). RH waste is placed in the walls on eight foot centers (Figure 7).

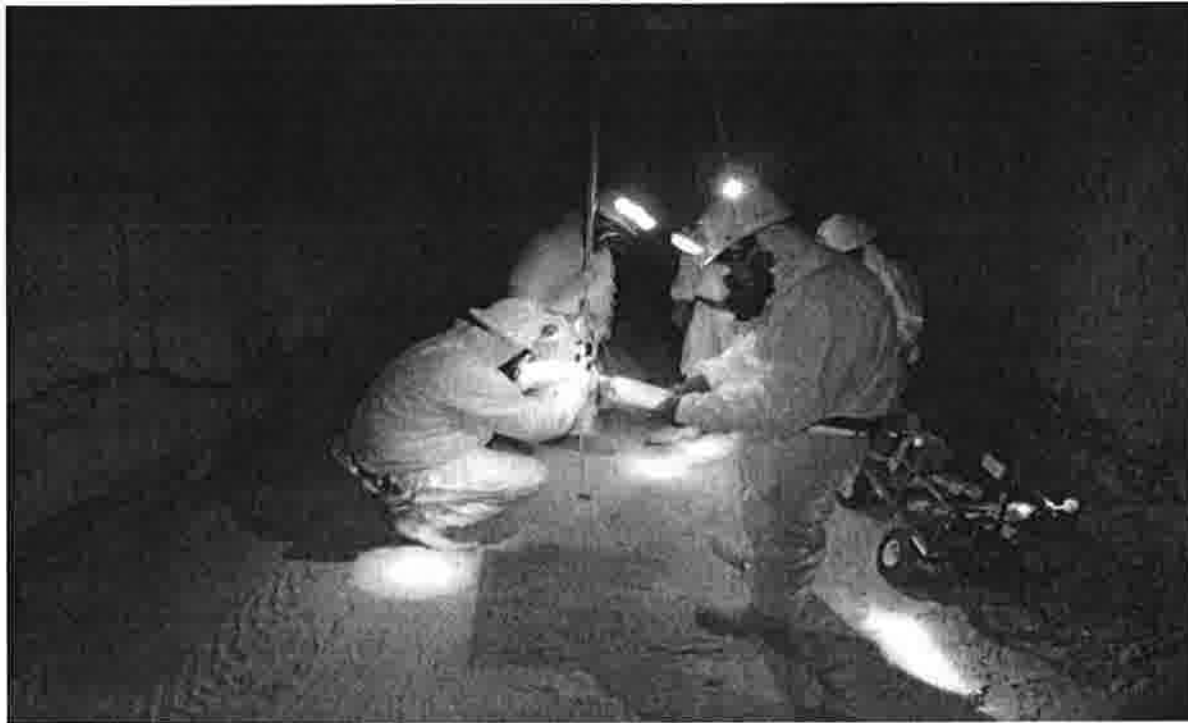
Figure 1: Geomechanical engineers in PPE, taking convergence measurements in a contaminated drift

Geomechanical monitoring was a major concern of EPA during this inspection. The radiological release prevented personnel access to the underground between February and April of 2014, and continues to greatly restrict access to many areas of the repository. This interrupted routine roof bolting and manual geotechnical measurements, and EPA needed to better understand the long-term impact to geomechanical monitoring. The inspection team met with Ed Lewis on the afternoon of April 7. He reported that the geotechnical program has adapted to the restrictions by training its engineers to enter contaminated areas using personal protective equipment (PPE) and then perform their routine functions. He was able to provide a photograph of this activity, included as Figure 1, below. At the time of the inspection, the program had successfully resumed all underground measurements, with the exception of the convergence points located in the exhaust drift of Panel 7 (S-2180), where the incident took place. Contamination levels in that drift still exceeded the limits on the current Radiological Work Permit. The E-300 exhaust drift had been measured the week prior to the inspection. The inspection team requested copies of extensometer and convergence point data from Panel 7, Room 7 (see Figure 2). An accelerated closure rate was observed in some areas, but not to a degree that would indicate instability of the drift. Prior to the inspection, DOE had reported a roof fall in one of the access drifts to Panel 3. This localized area had been identified as problematic, and was scheduled for ground control work at the time of the fire, when the mine was evacuated and typical operations stopped.

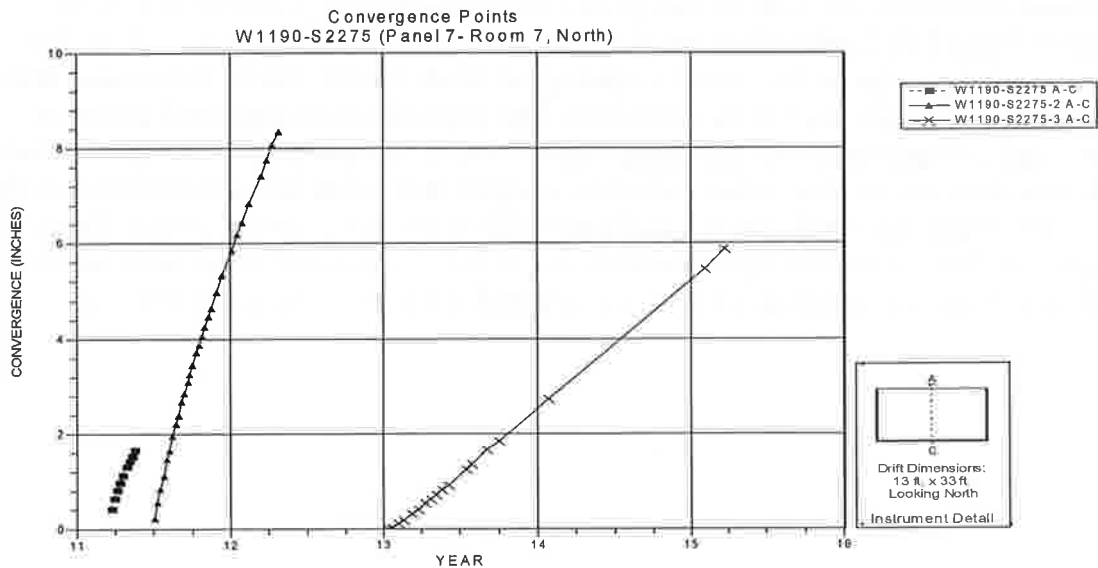
Figure 2: Convergence point data from Panel 7, Room 7

NOTES:
 1. Excavation date: February 2011.

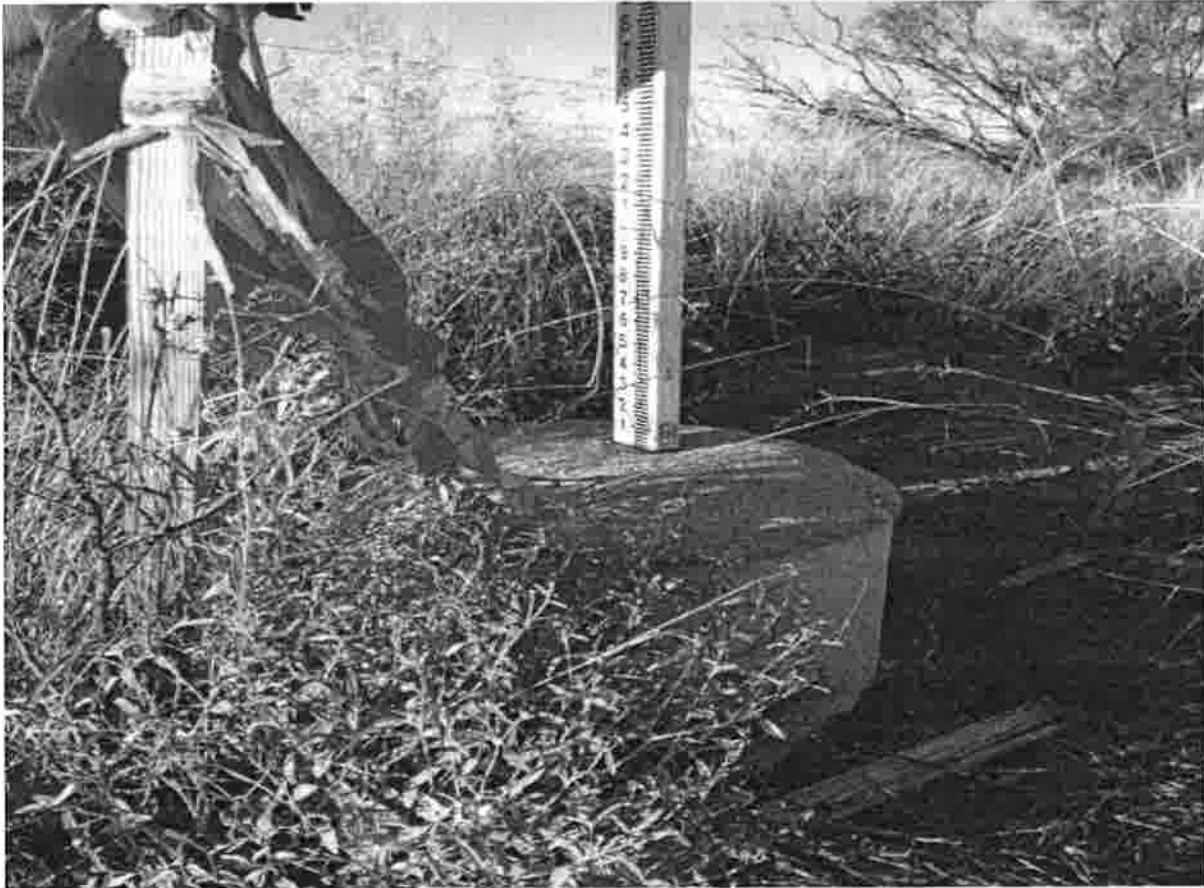
Figure 3. Surveying Rod on Monument S-24, taken during 2013 inspection.

On the morning of April 7, the inspection team met with Ty Zimmerly to discuss changes to the surface subsidence program. There was no interruption to the surveying schedule due to the operational incidents at WIPP. Since the most recent inspection in 2013, the only major change to the program was that the site purchased a new instrument, as planned, due to the difficulty of finding replacement memory cards for the older Leica NA3003. The instrument was replaced by the updated Leica DNA03, which is also an optical instrument, and the WILDsoft processing software was replaced by GeoOffice. Procedure WP 09-ES4001 was updated to reflect these changes, and the inspection team observed the processing of raw field data from Loop 6, beginning at step 1.31 of the procedure. The results of the data processing showed a loop closure of .0009 feet (Loop 6 data to control, DnaXn15 format). The inspection team reviewed the documentation for the use of the updated software, including the Software screening checklist EA16-2-1-0, Rev 6, signed 3/1/11, and the Software Installation and checkout form, EA16-2-3-0, Rev 4, signed 8/11/14.

Figure 3 shows use of a surveying rod to measure subsidence parameters. The updated Leica DNA03 instrument is fully compatible with the bar-coded survey rods currently in use.
